Frederick County Register of Historic Places

DESIGN GUIDELINES

2021 EDITION

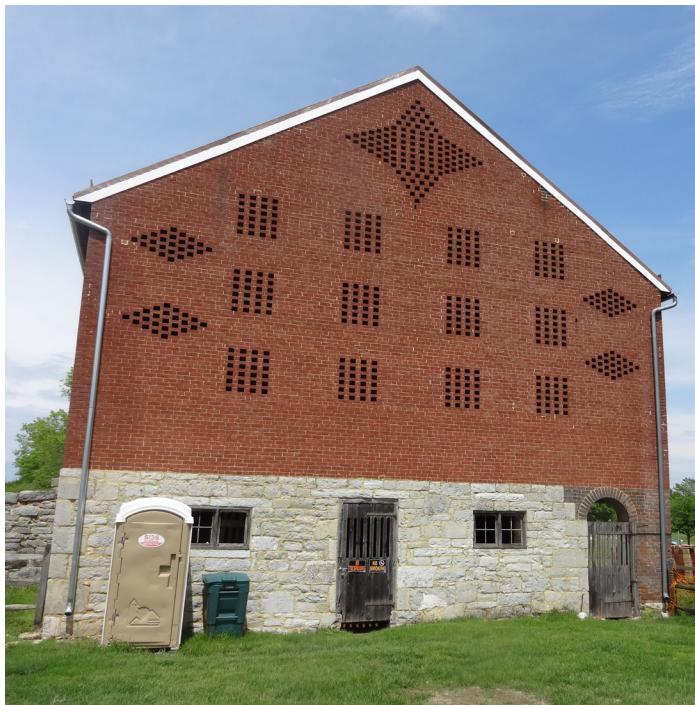
*Brick barn in Walkersville with distinctive decorative venting.
Photo by Gary D. Baker, RA.*

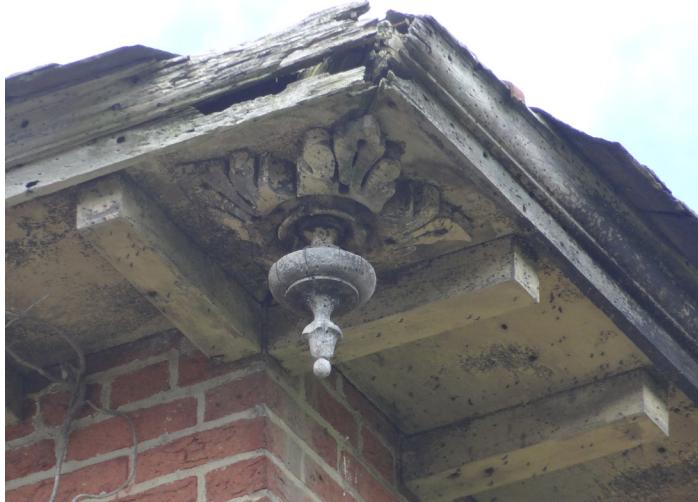
Deteriorating wooden pendant at the Point of Rocks Train Station. Photo by Gary D. Baker, RA.

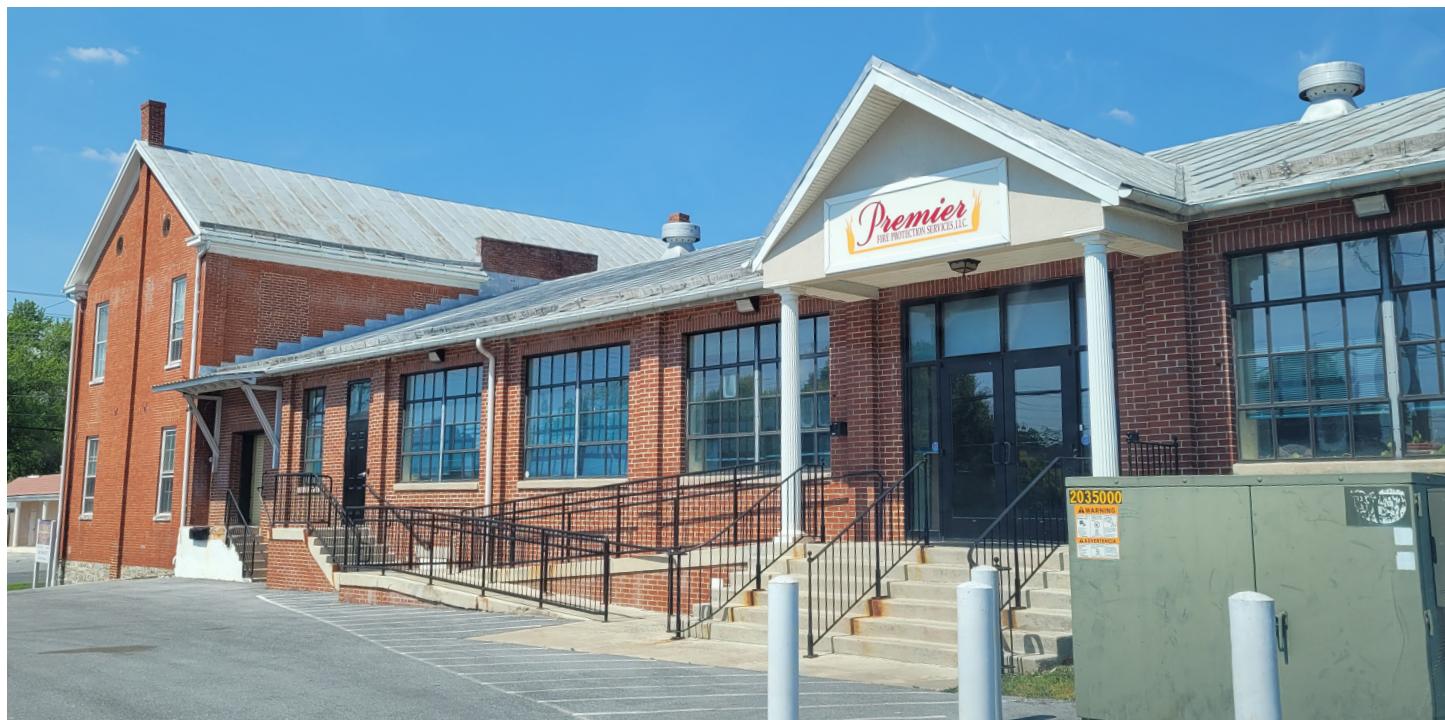
Known as the American Red Cross building in Walkersville, it was originally constructed as a public school in 1897. The two-story building was added onto in 1930 when it was converted to a garment factory. Photo by authors.

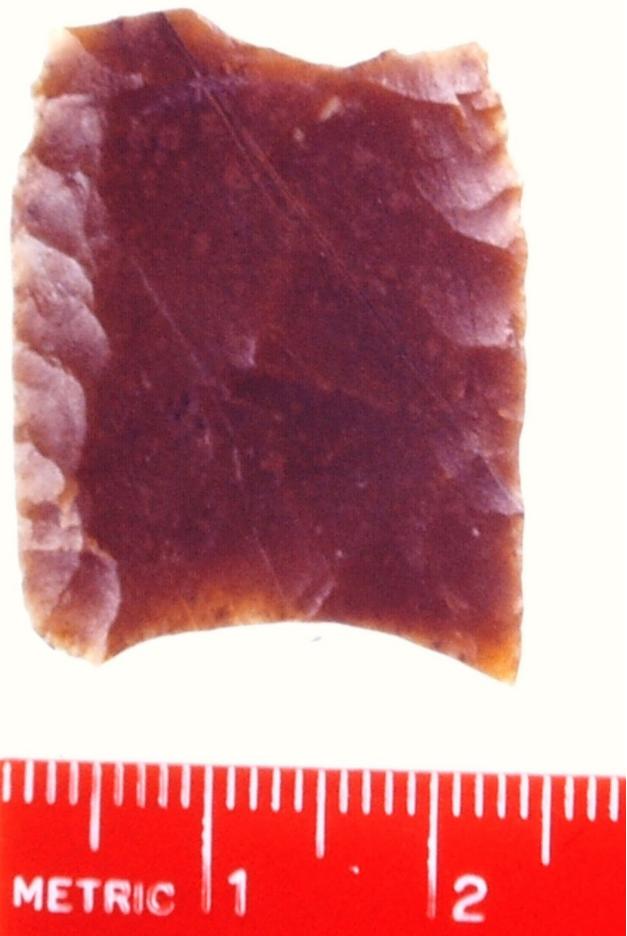
A Paleoindian fluted point (with a broken tip), manufactured from jasper, that was found on a terrace of the Monocacy River in Frederick County. The flute is a wide shallow groove created by removing a long flake starting at the base of a spear point. Image courtesy of the Maryland Historical Trust.

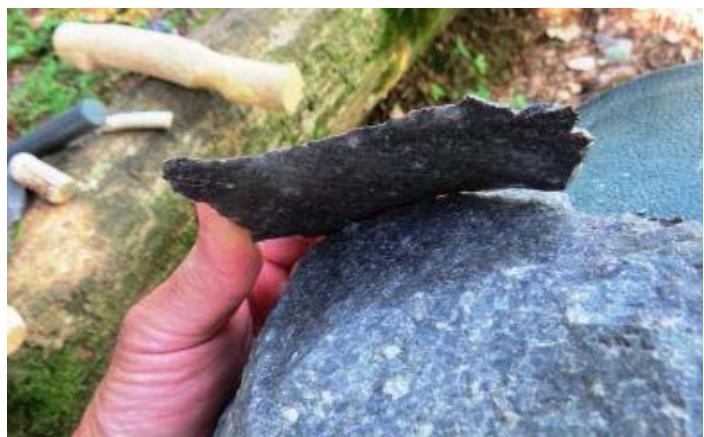
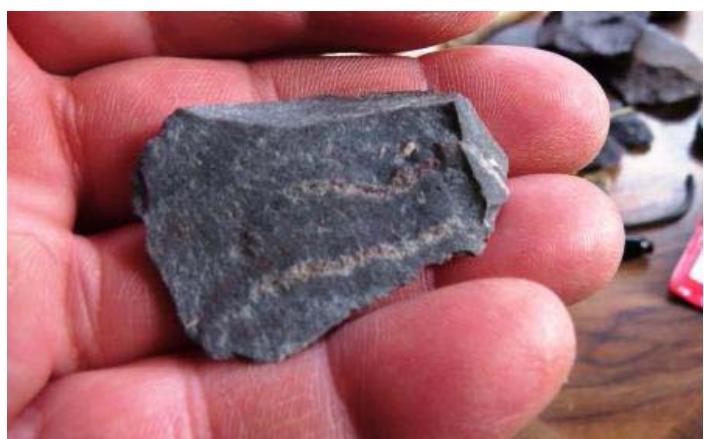
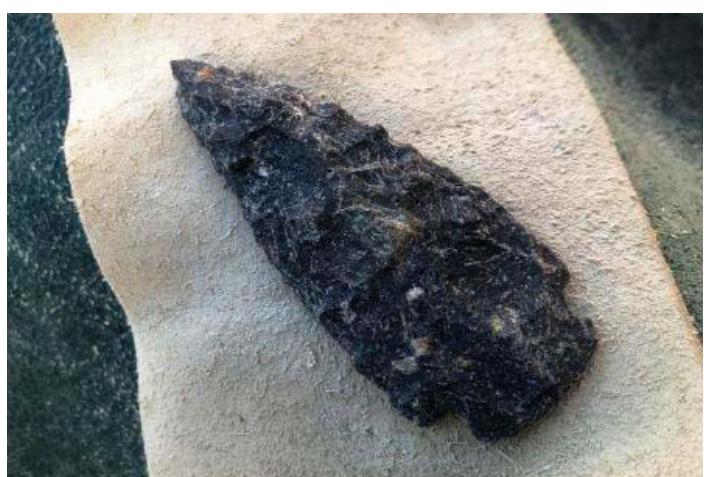
Rhyolite artifacts found in Frederick County (top to bottom) include a blade, flake tool, and spear point all made of rhyolite. Photos by Guy Neal.

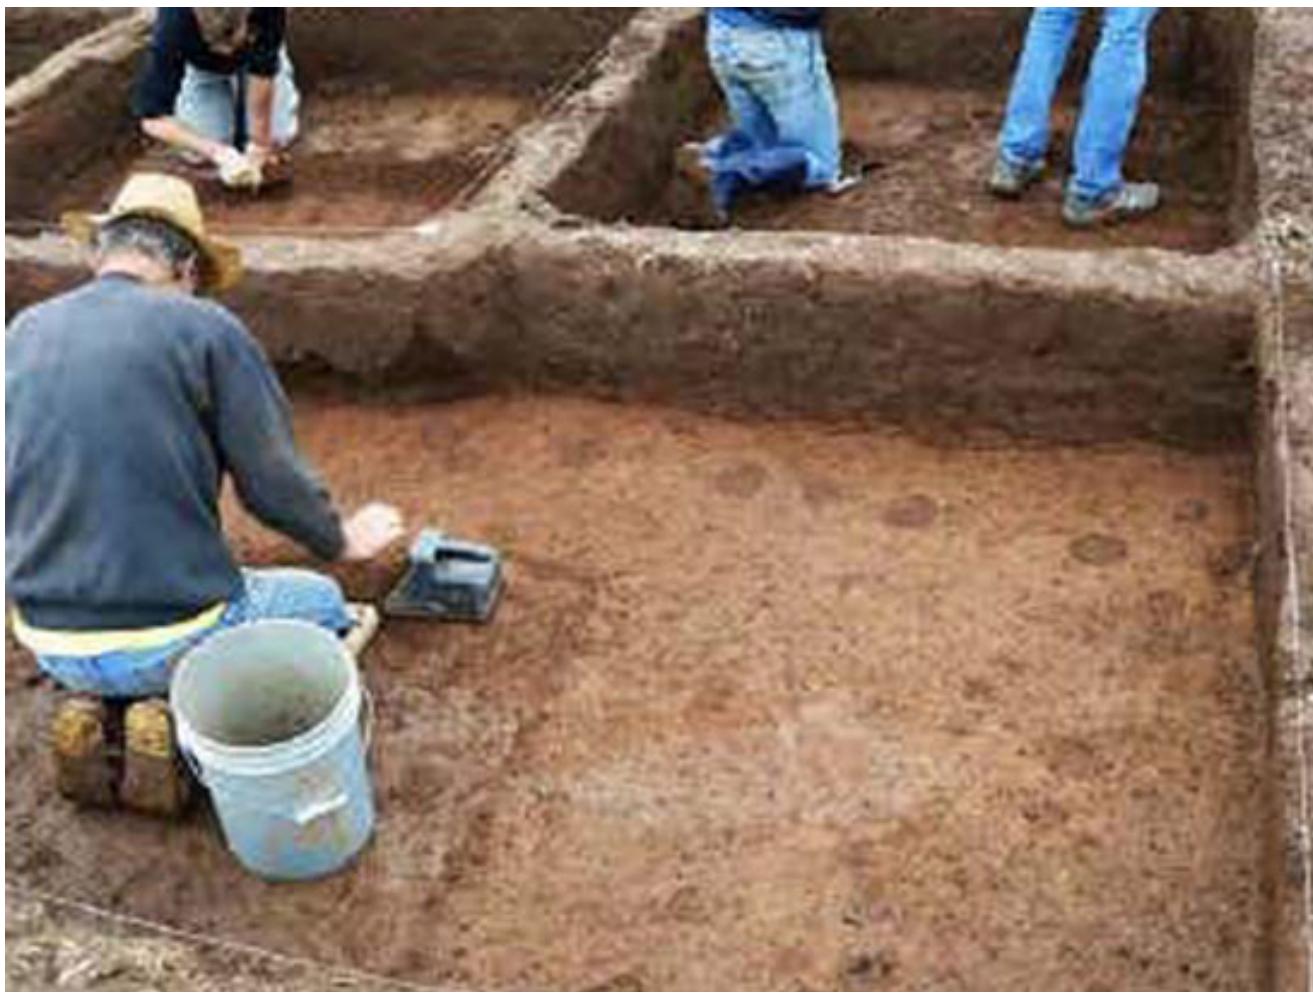
An alignment of distinct dark stains, which indicate the location of a palisade, were revealed during archeological investigations at the late prehistoric Biggs Ford village site in central Frederick County. Photo courtesy of the Archeological Society of Maryland.

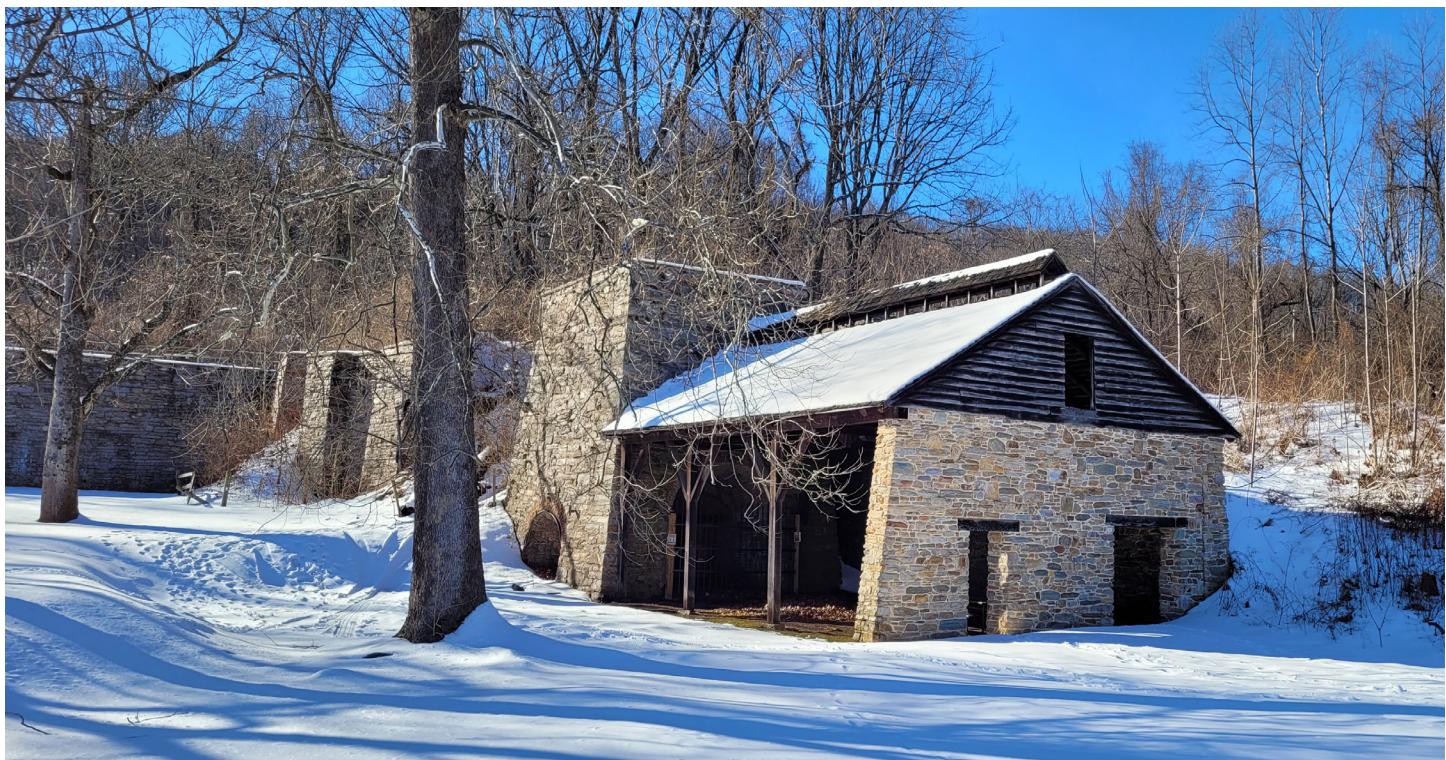
Remains of the steam-operated Catoctin Furnace, built in 1857, near Thurmont. The Catoctin Furnace complex illustrates the growth and development of the iron industry in central Frederick County between 1774 and 1904. Photo by authors.

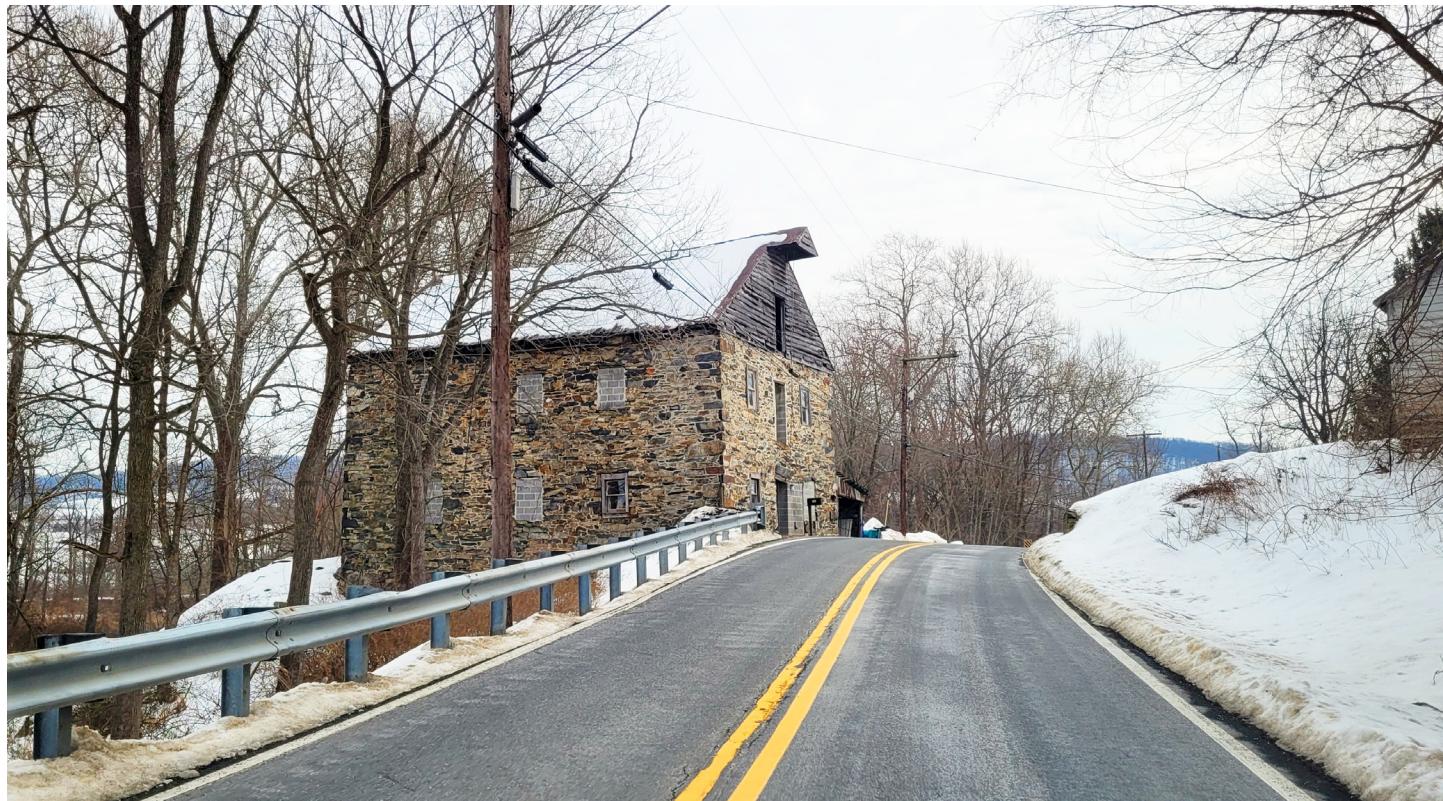
Kinna's Mill, Sabillasville. Owens Creek runs directly behind the mill (to the left) and was important for farming and milling activities. Photo by authors.

View across the David Harbaugh Farm in the Kinna's Mill Historic District, Sabillasville. This rural community was centered around the milling industry and buildings in the district were aligned with Owens Creek (see next image). Photo by authors.

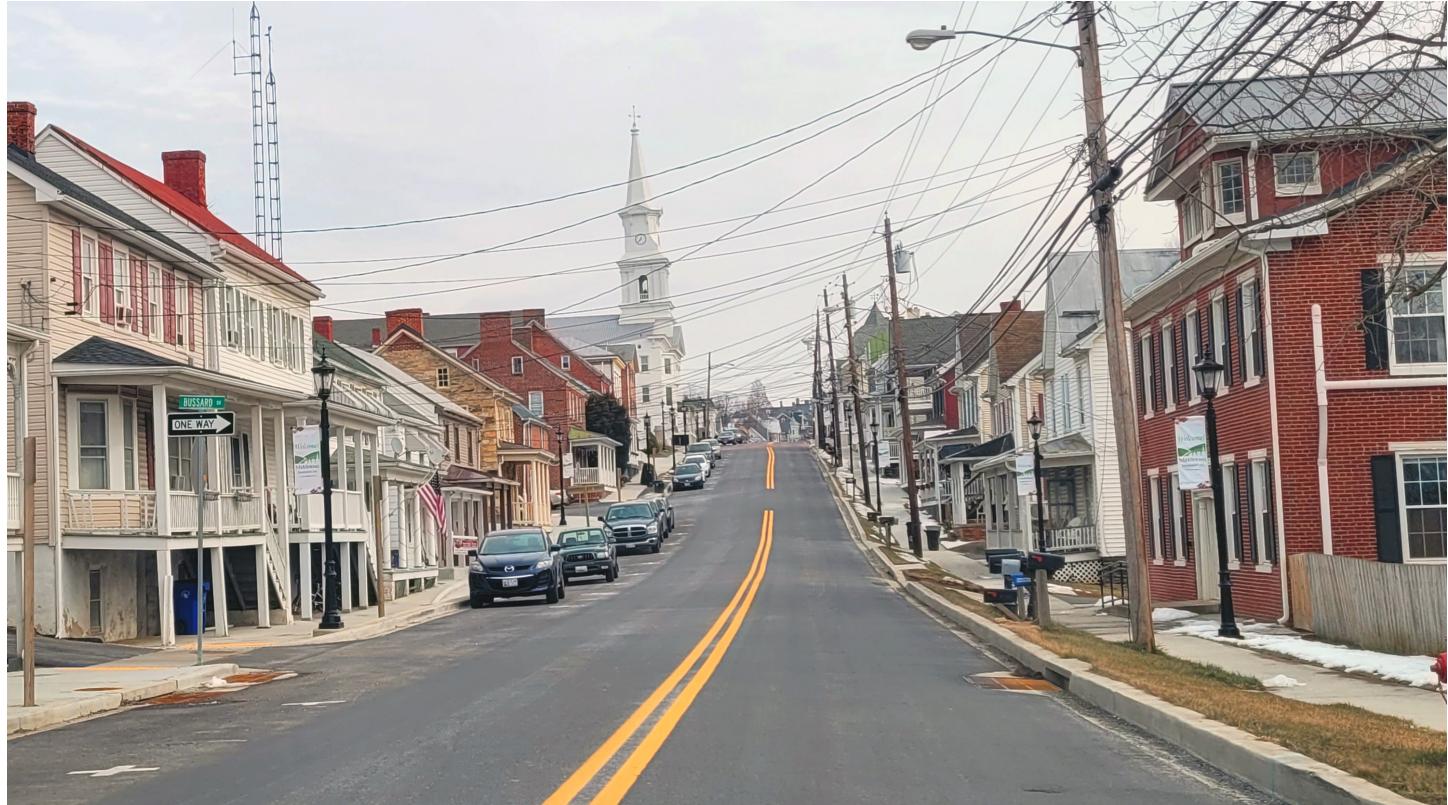
View of Main Street looking east, Middletown. The streetscape is characterized by its lighting, lack of vegetation, overhead utility lines, and concrete sidewalks. Photo by authors.

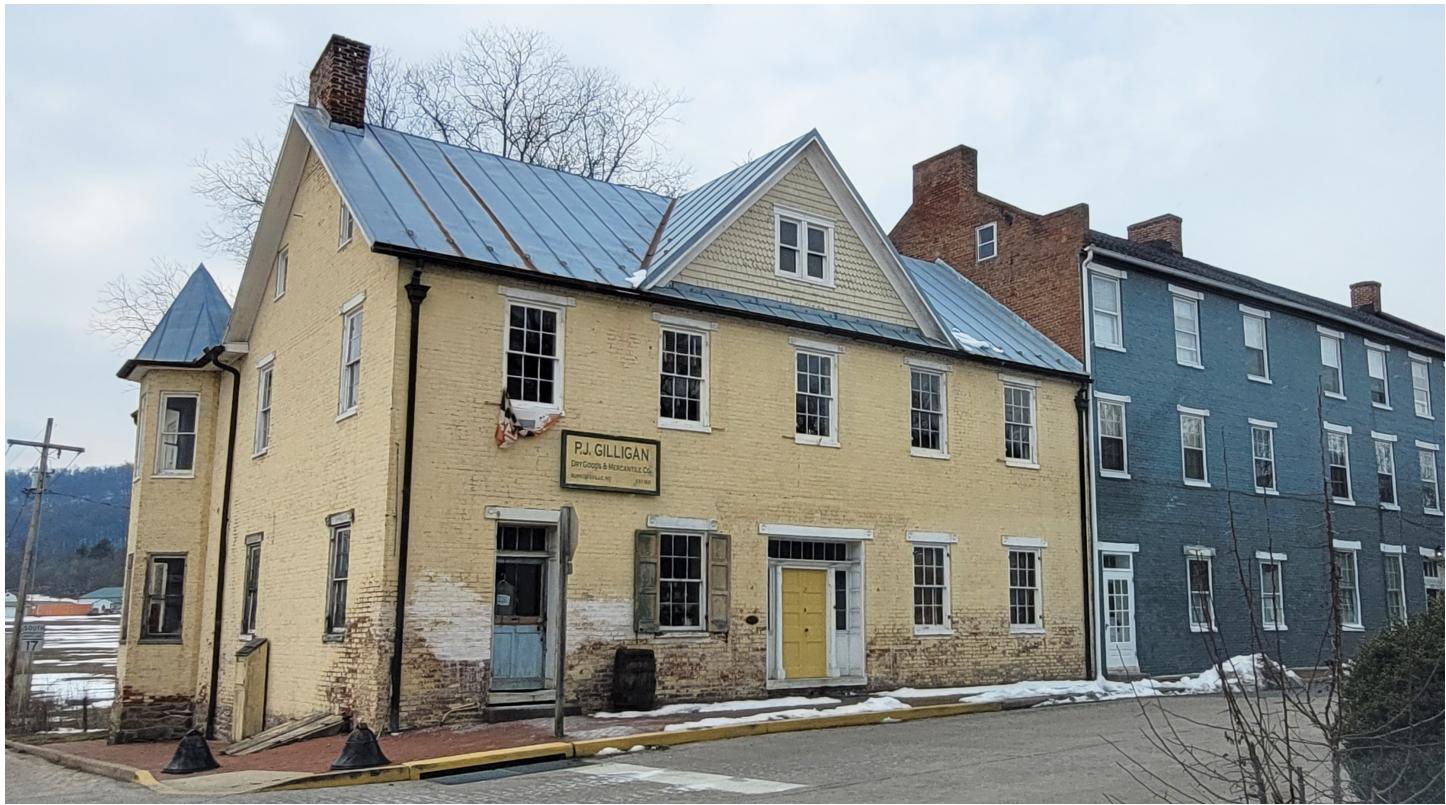
These commercial buildings on Main Street, Burkittsville illustrate some of the architectural principles of historic architecture. Their window and door openings are well proportioned to the overall size of the buildings and create a rhythm along the facades. Photo by authors.

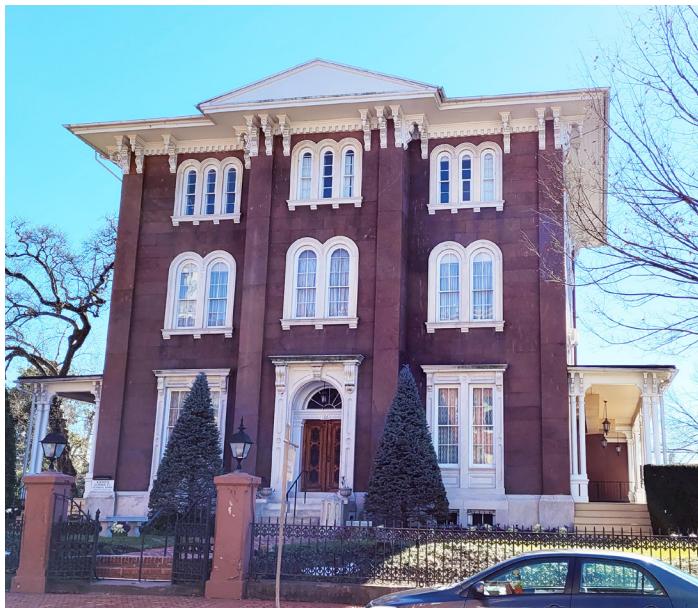
The Trail Mansion in Frederick is a wonderful example of Italianate residential architecture. The windows are ordered with the tallest at the first floor and they get smaller at each level. Photo by authors.

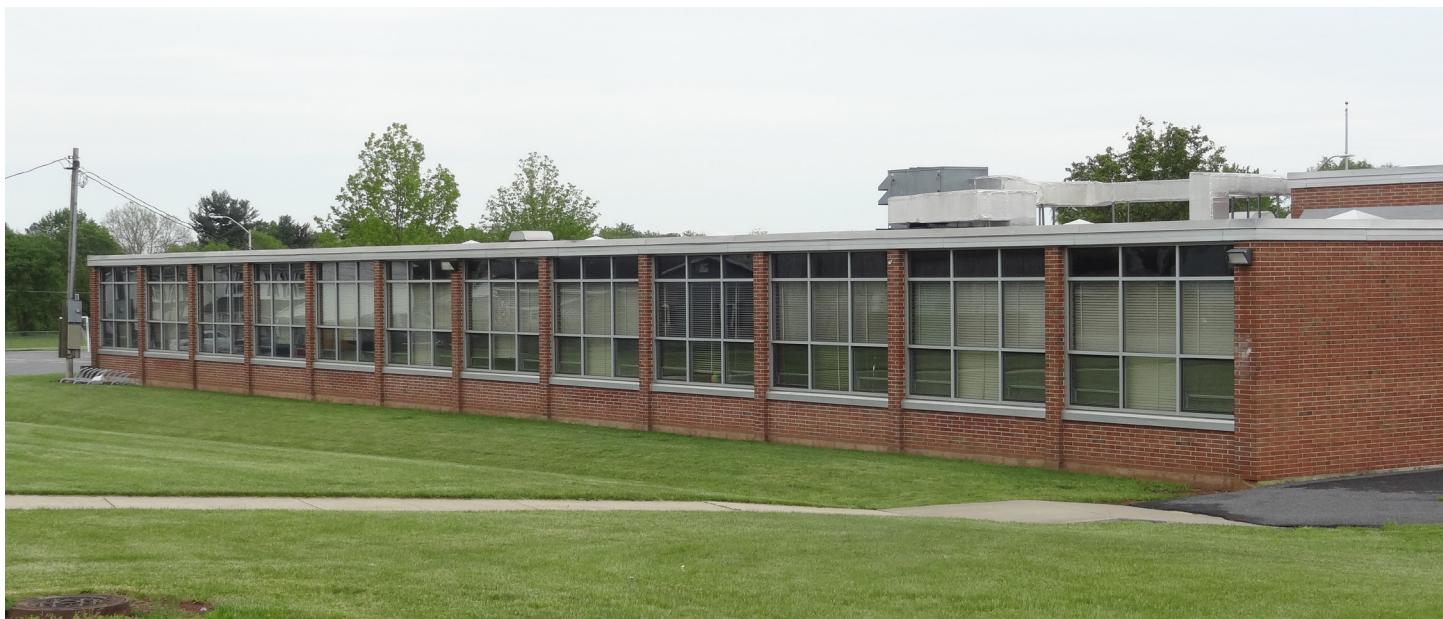
A regular rhythm is created along the facade of this mid-century school building in Emmitsburg with the repetition of window bays. Photo by Gary D. Baker, RA.

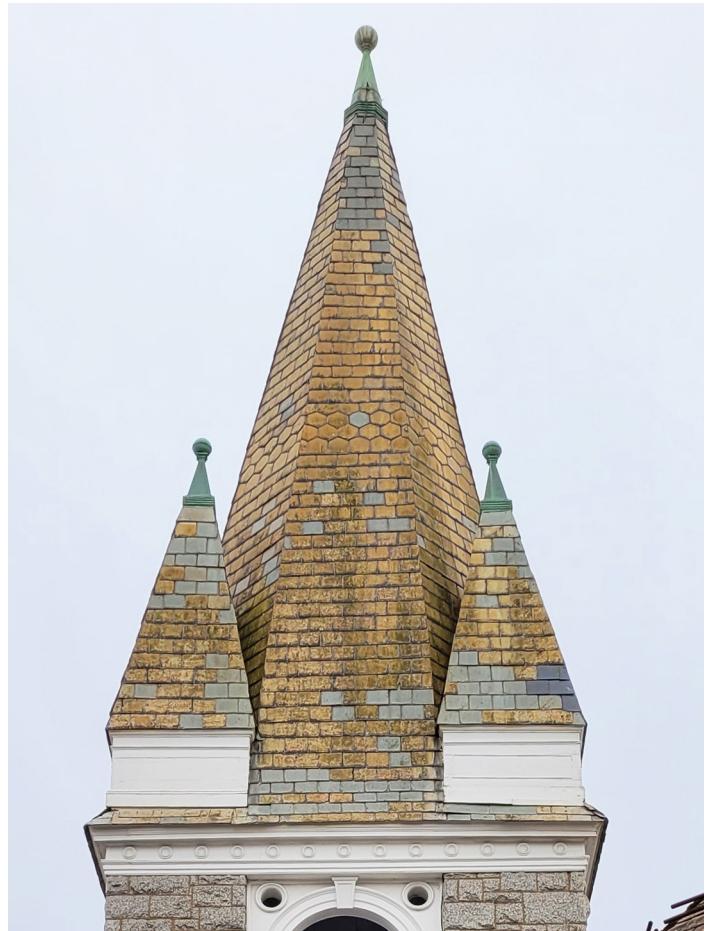
The belltower of the Buckeystown United Methodist Church is topped with a unique five pointed slate spire. The large central spire is hexagonal and the four corner spires are pyramidal. Each is topped with a finial. Photo by authors.

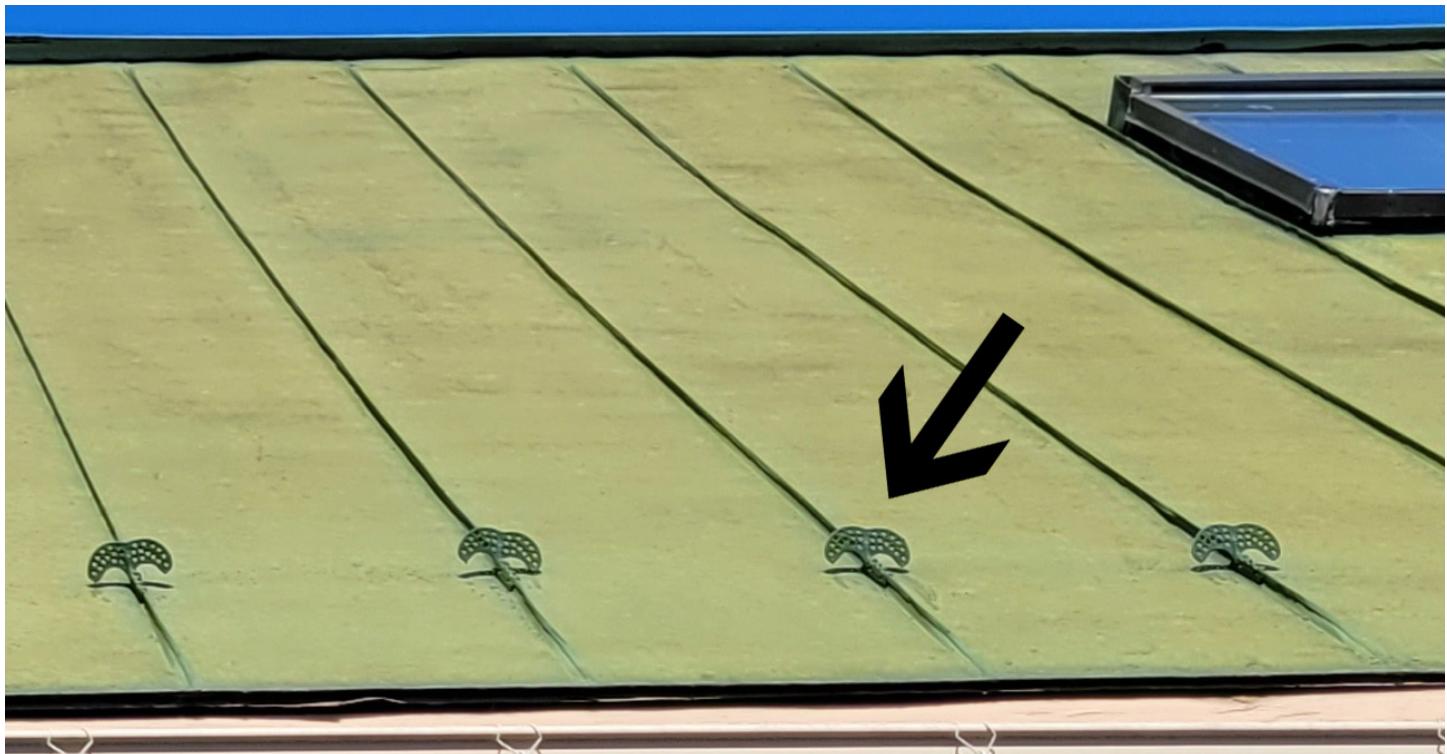
Snow birds are used to prevent snow from falling off the edge of a roof in large sheets. Photo by authors.

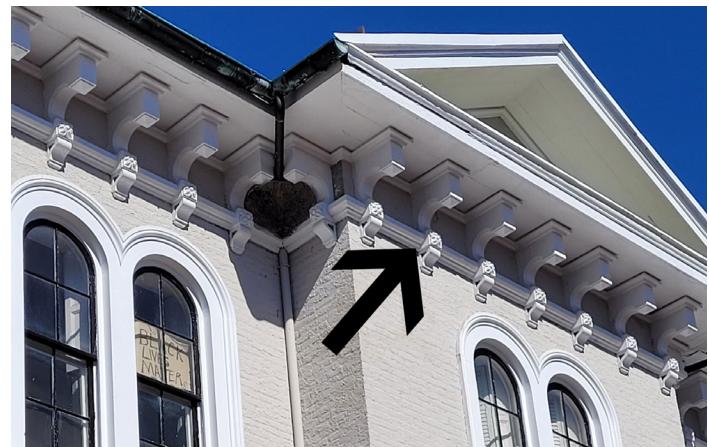
The cornice of Tyson Mansion on E. Church Street in Frederick has decorative brackets. Photo by authors.

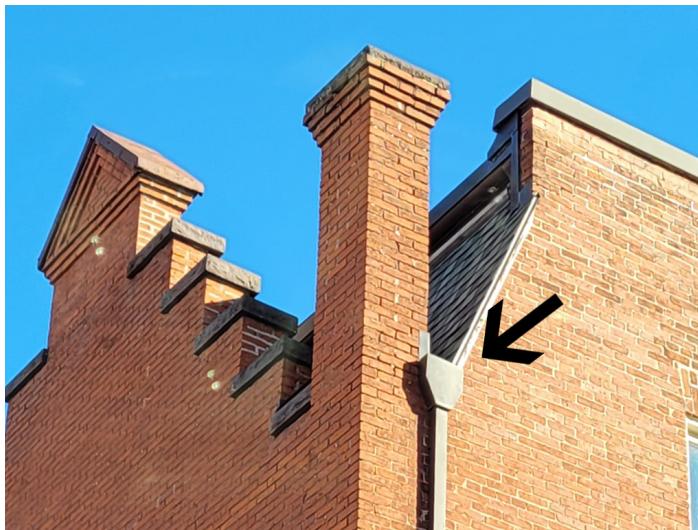
The gutters are concealed behind the brick parapet of the Sovran Bank Building in Thurmont. Photo by authors.

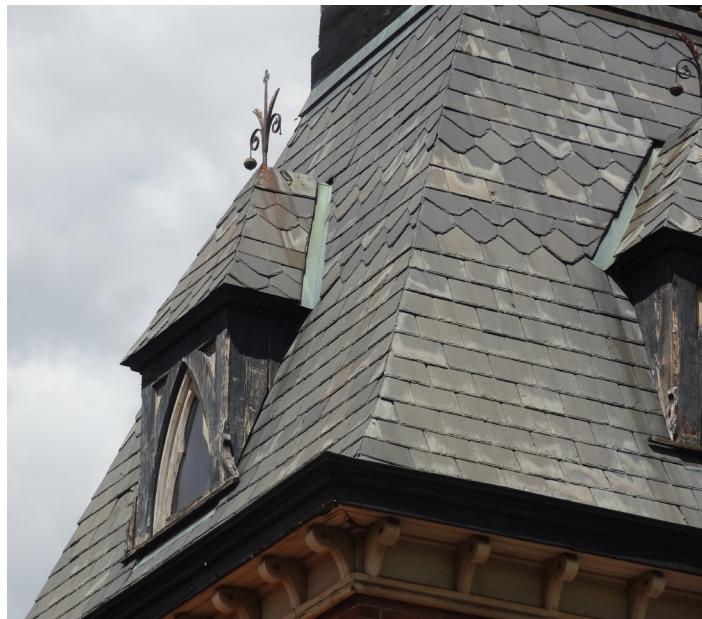
The slate roof at the Point of Rocks Train Station has dormer windows topped with finials. Photo by Gary D. Baker, RA.

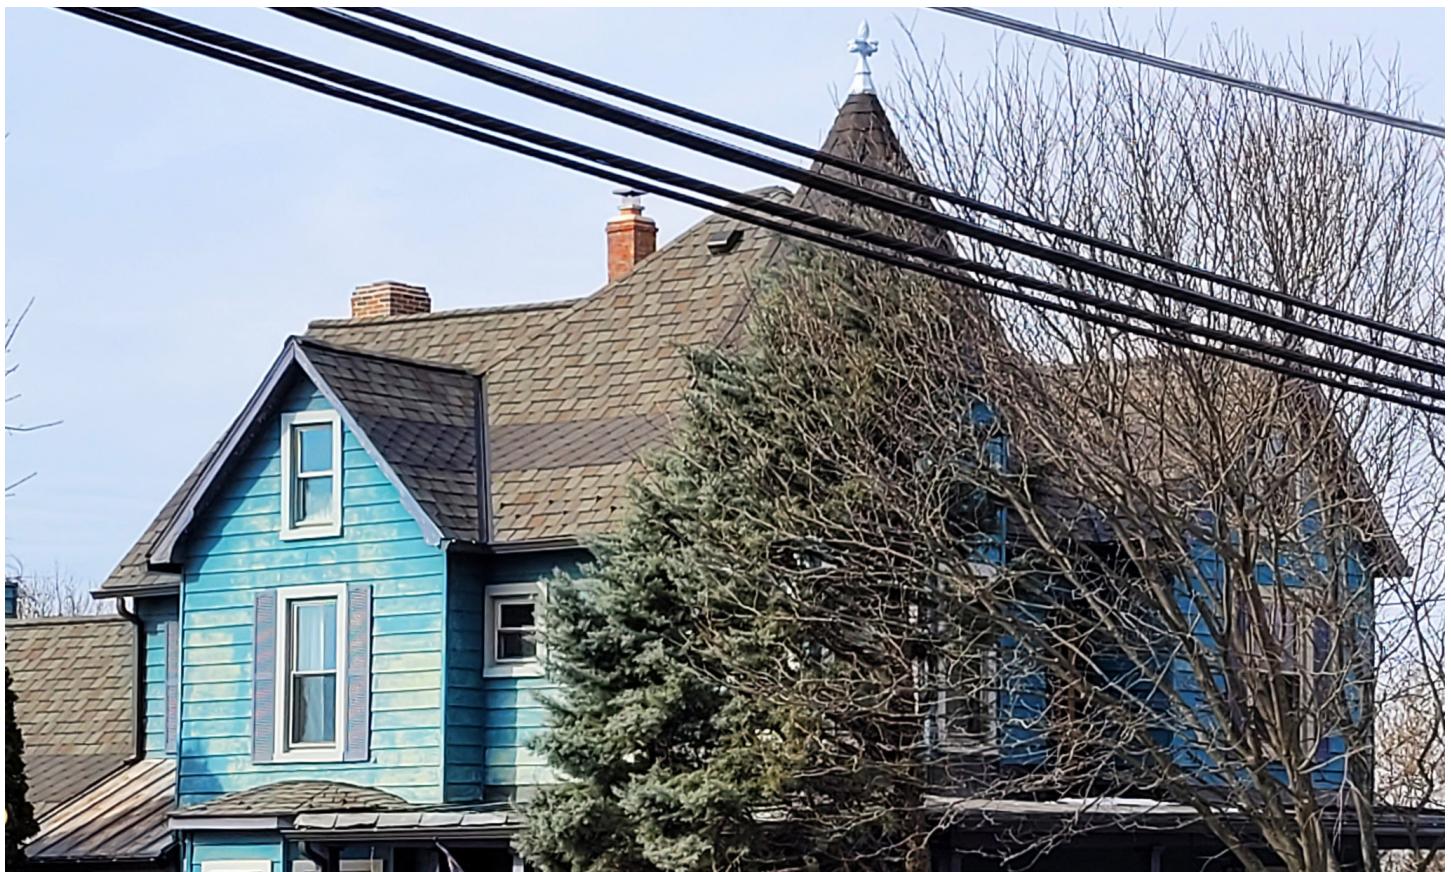
The slate roof of this home in Braddock Heights uses different shapes and patterns for visual interest. Photo by authors.

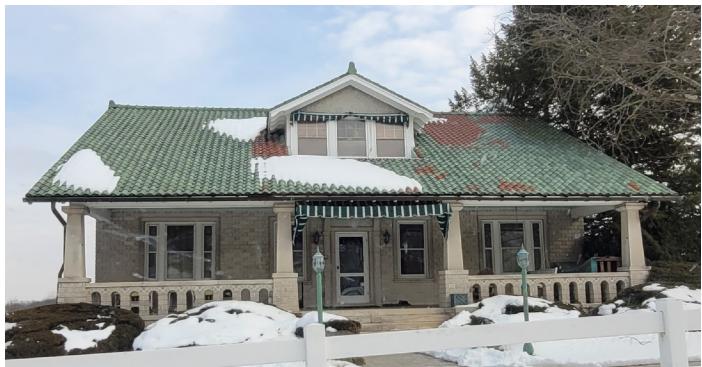
Clay tile roofing is not used frequently in Frederick County, but is seen here on this house in Braddock Heights. Photo by authors.

Clay tile roofing most commonly fails at the fastening system when metal nails or clips have corroded. Another weak point can be the metal flashing and gutter system. Tree limbs, hail, or walking across an unprotected surface can crack roofing tiles and lead to water infiltration. Water infiltration can deteriorate the roof battens, sheathing, or rafters eventually leading to structural failure, particularly due to the weight of the clay tiles.

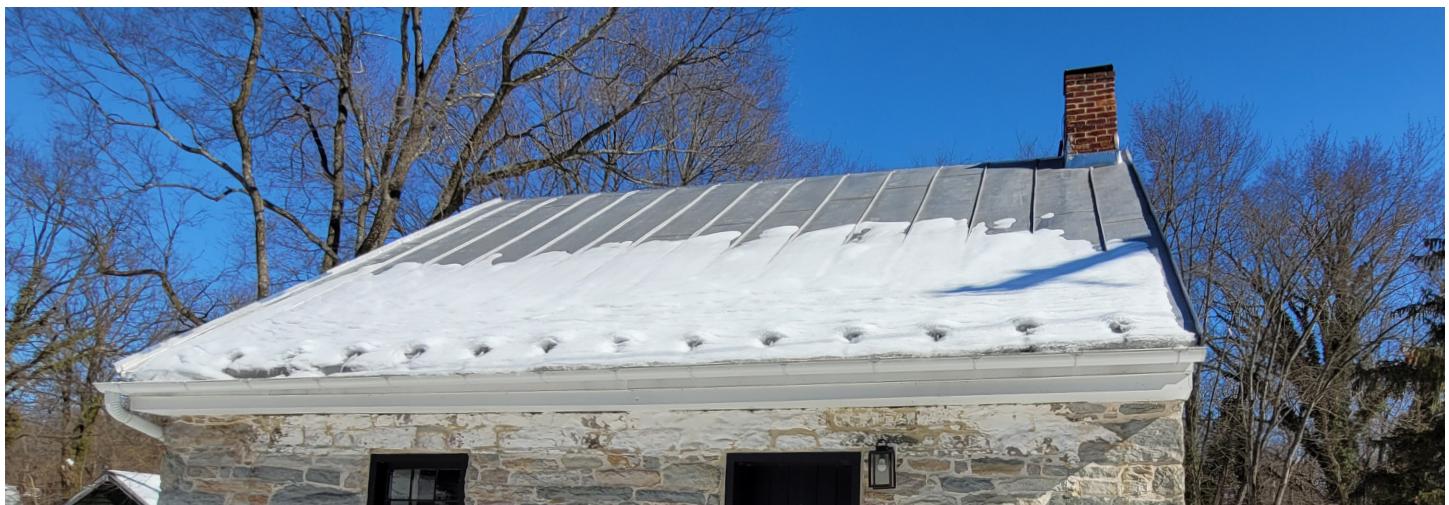
Standing seam metal roof of the Forgeman's House in Catoctin Furnace; notice the spacing of the seams and profile of the panels.
Photo by authors.

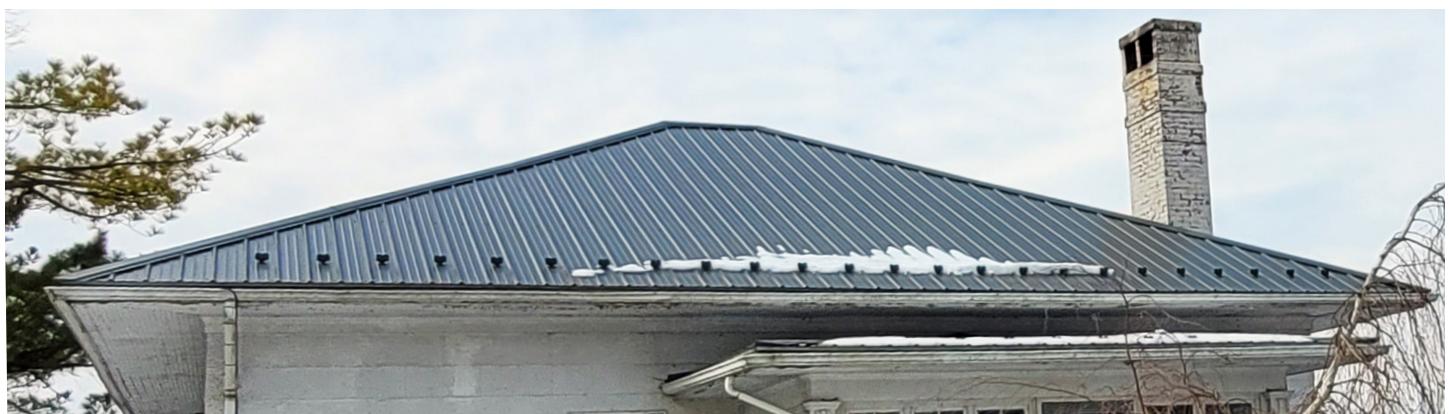
This modern metal roof has crimped, narrow panels and does not match the detailing found on an historic metal roof. Photo by authors.

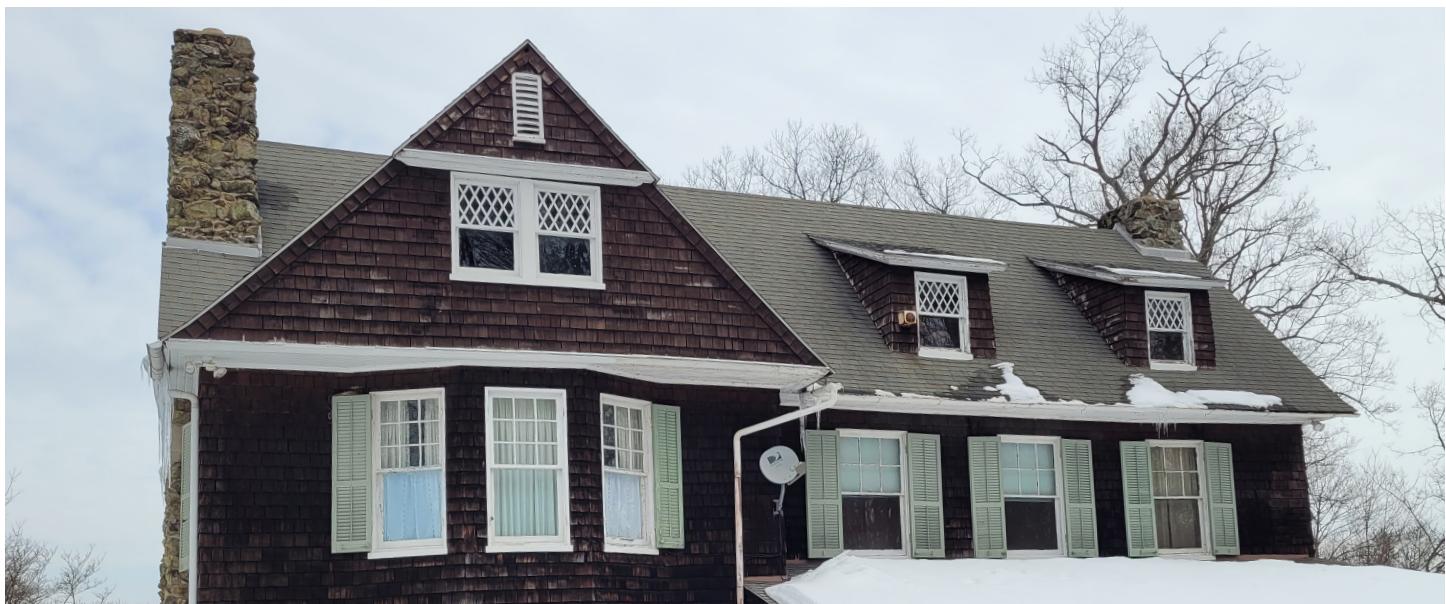
Asphalt shingle roofing is commonly found in Frederick County, like this roof on a house in Blue Ridge Summit. Photo by authors.

Asphalt shingle roofing is subject to damage from puncture, abrasion, and lifting from wind, and has

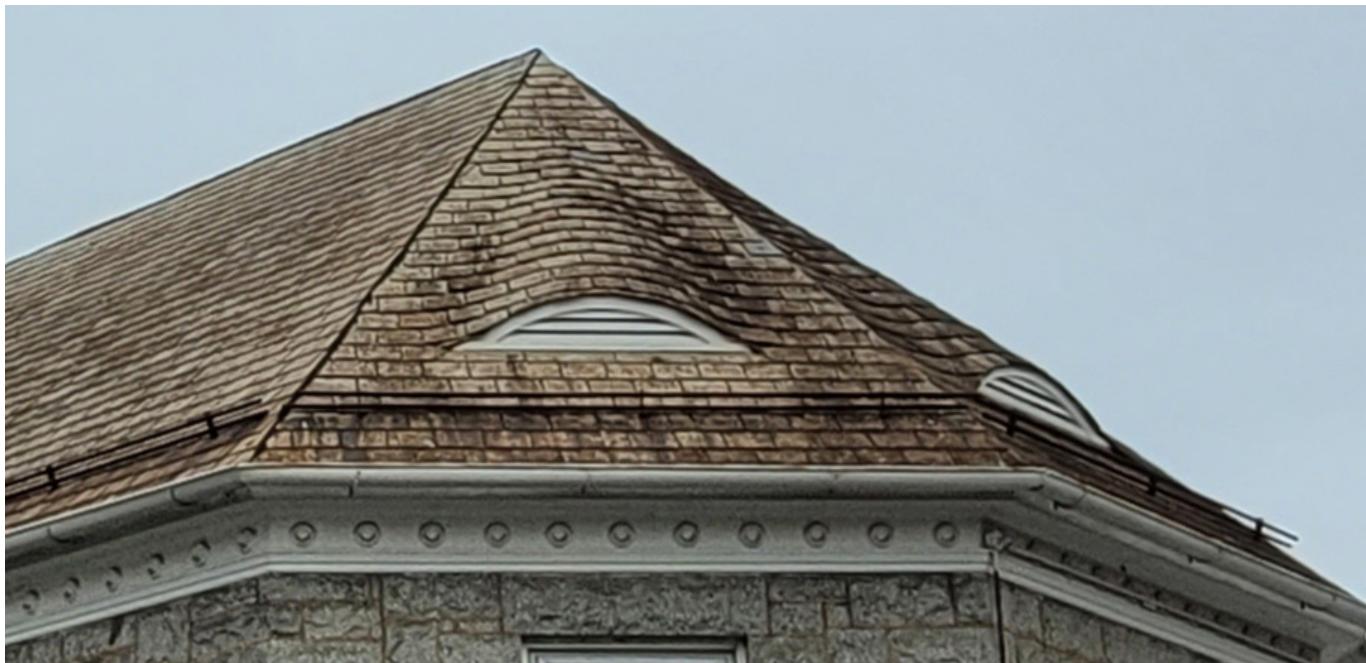
The louvers to vent the roof of Buckeystown United Methodist Church, Buckeystown, are set in small brow dormers. Photo by authors.

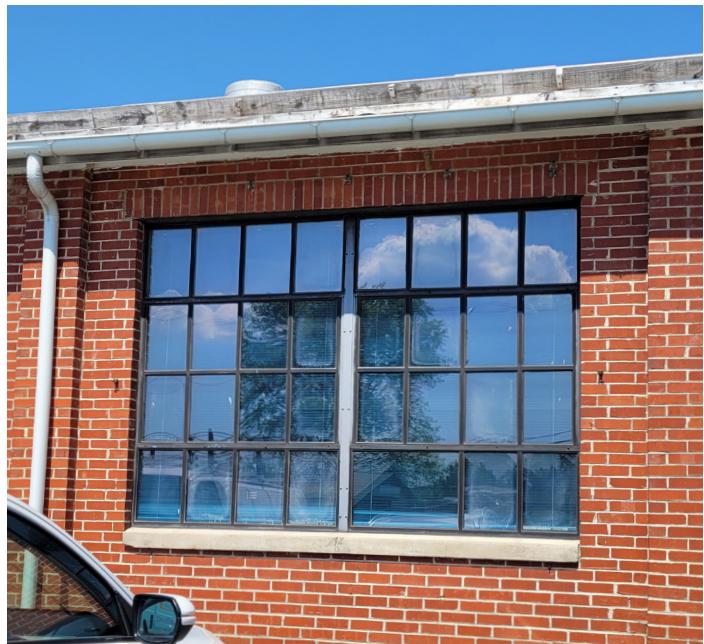
The American Red Cross building, formerly a garment factory, Walkersville, has metal windows. Photo by authors.

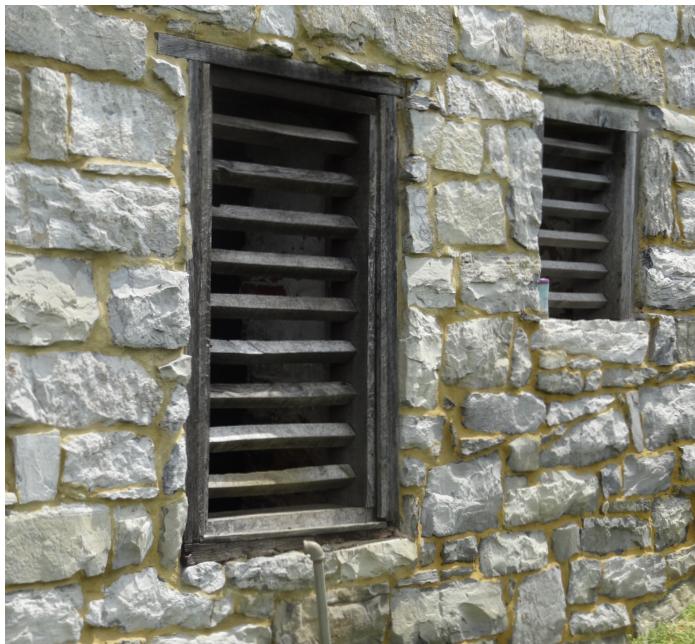
Wood louvers in a stone bank barn in Frederick County. Photo by Gary D. Baker, RA.

homes to barn structures. Typically located at the upper part of a wall, vents allow for natural air circulation from the lower levels up through the building or structure, and out through the attic. Often the louvers of a vent were made of wood with spaces in between to allow air to flow. An unobtrusive mesh screen may be used behind the louvers to prevent insects and birds from entering.

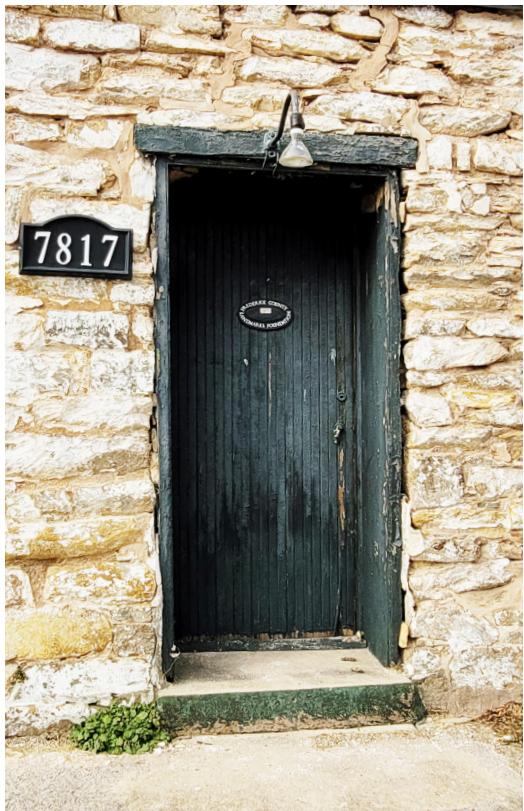
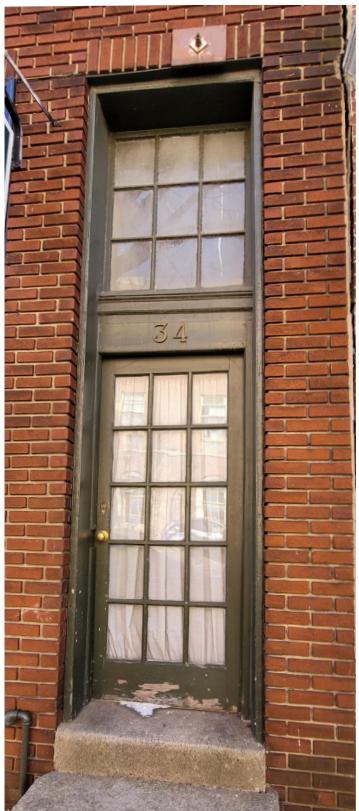
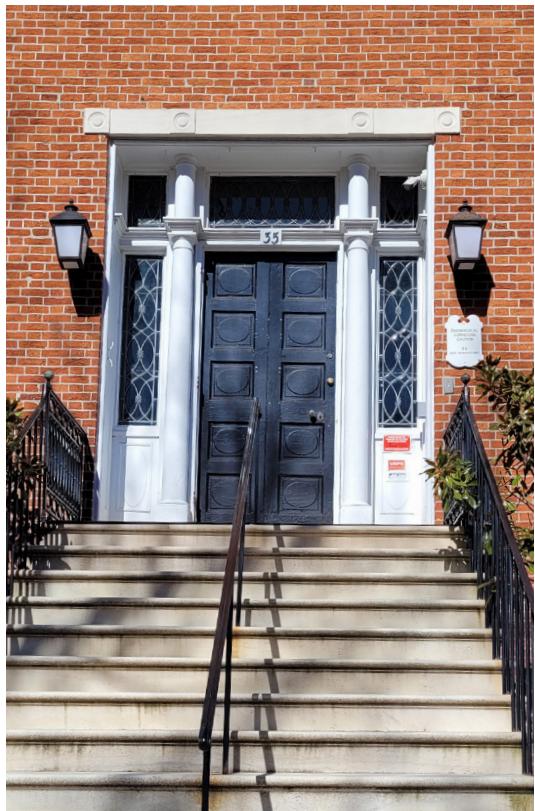
Examples of different door types, some with transoms above and some with sidelights, around Frederick County. Photos by authors.

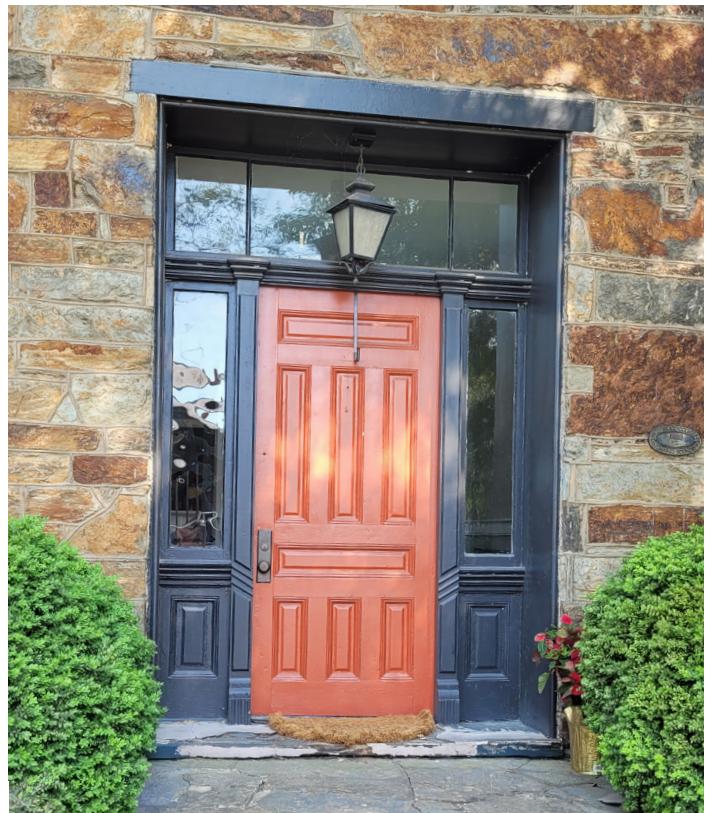
Main entrance door with transom and sidelights to the George Hosselback House, Buckeystown. Photo by authors.

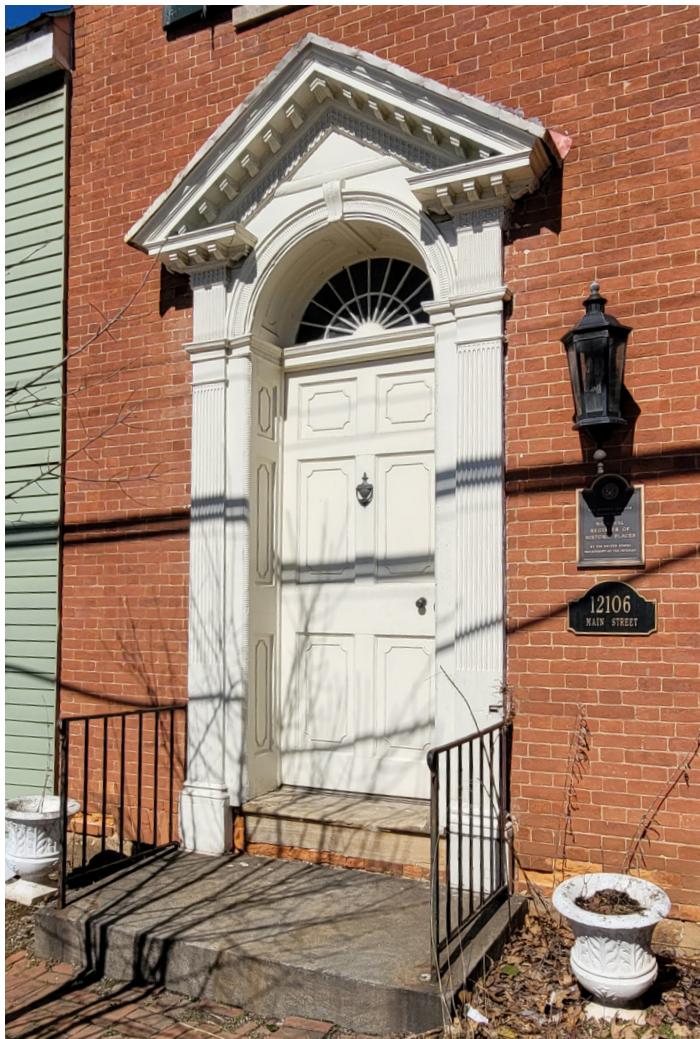
The pedimented entryway of the Abraham Jones House in Liberytown has a paneled wood door with fanlight above. Photo by authors.
