Frederick County Register of Historic Places

DESIGN GUIDELINES

2021 EDITION

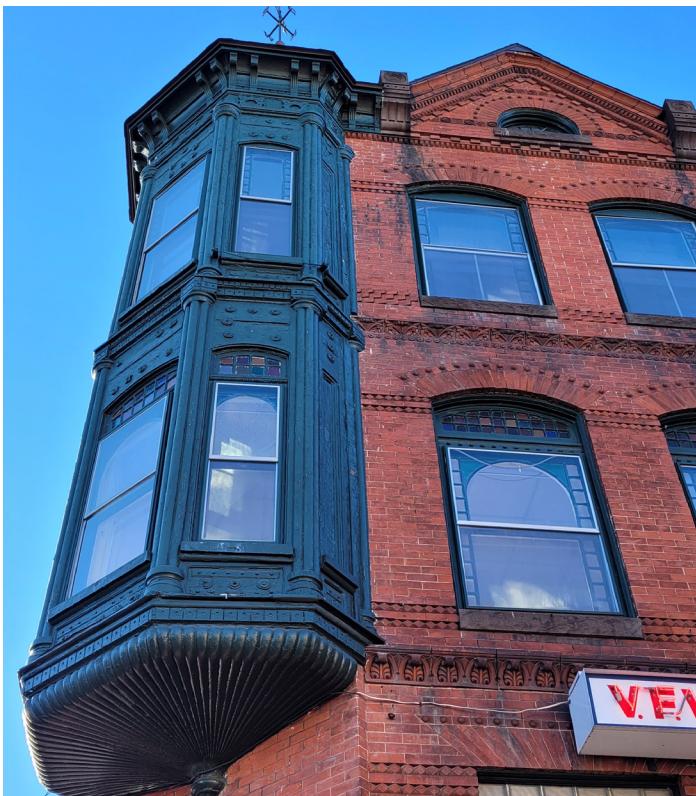
The storm windows on this building in Emmitsburg have narrow frames that align with the meeting rails of the windows, but should be painted a dark color to match the window frames.
Photo by authors.

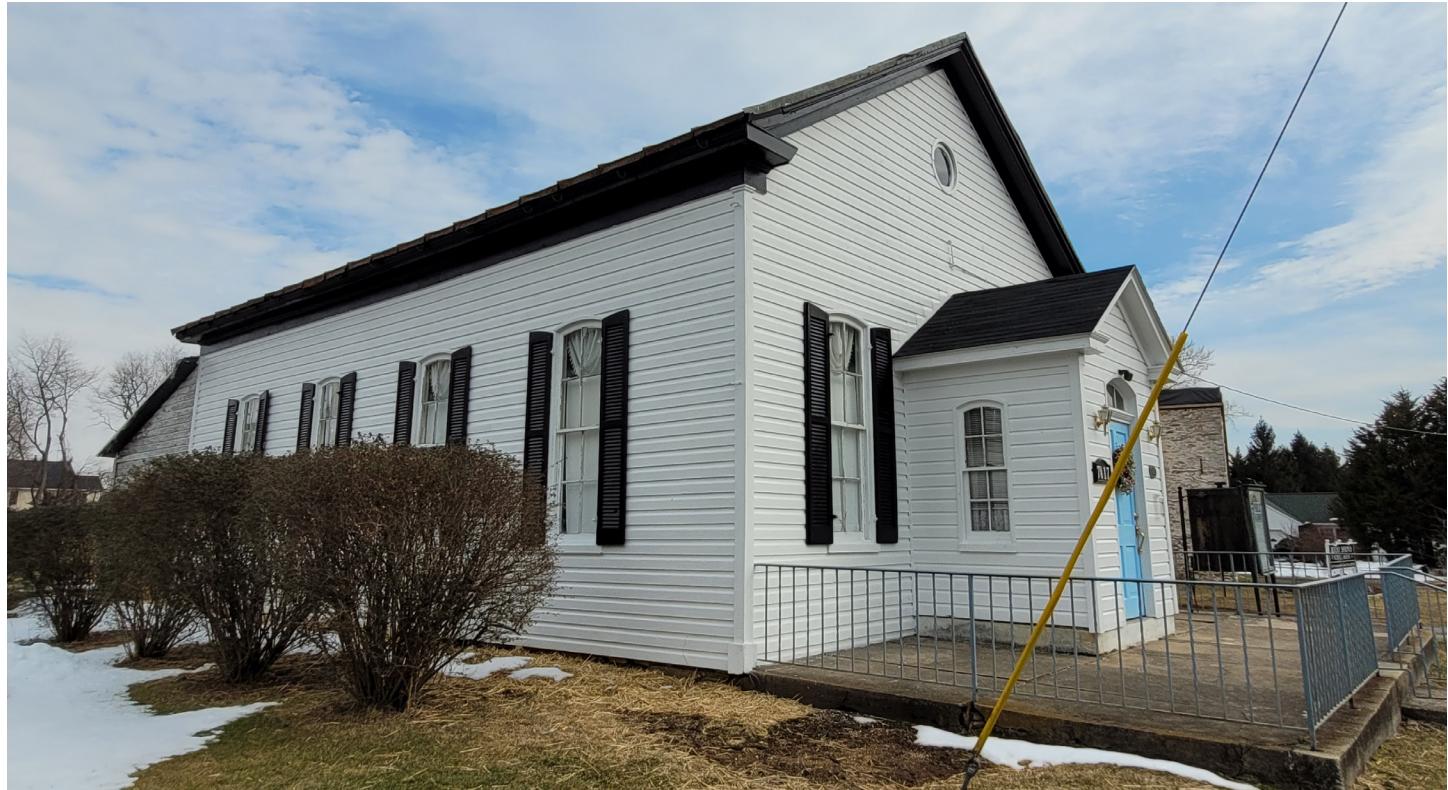
The Rocky Springs Chapel near Frederick has wood novelty drop siding. Photo by authors.

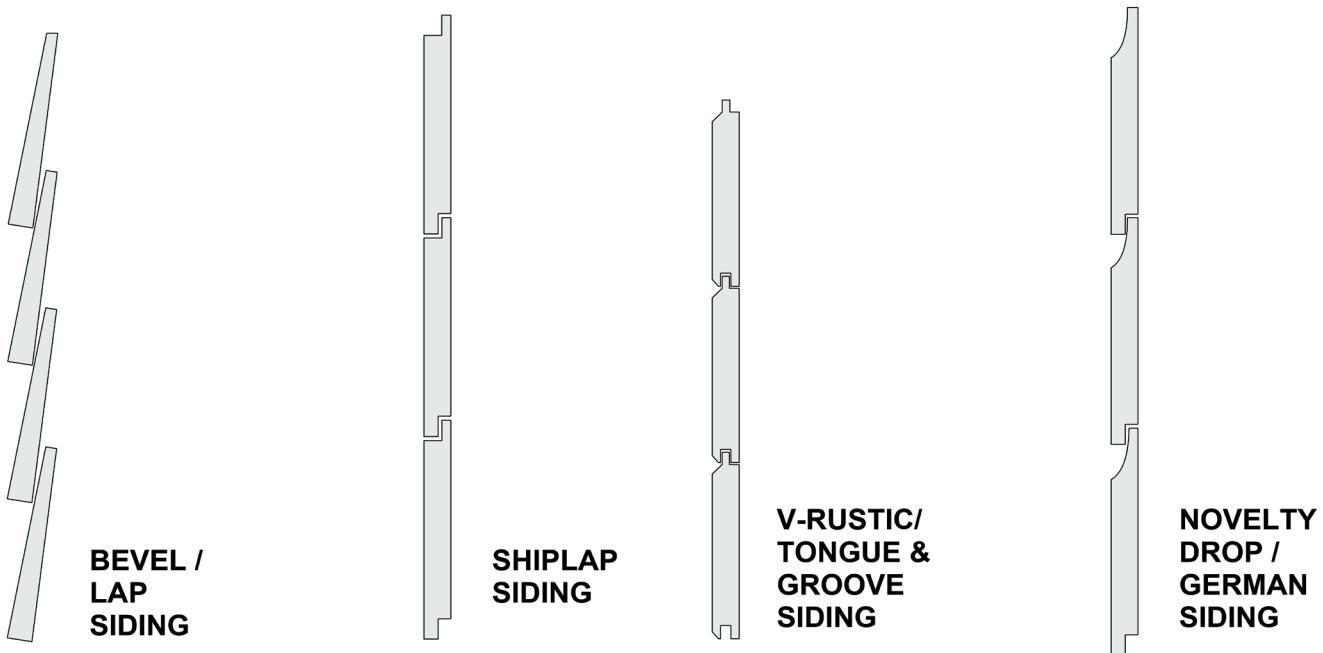
Example of wood siding profiles. Image by authors.

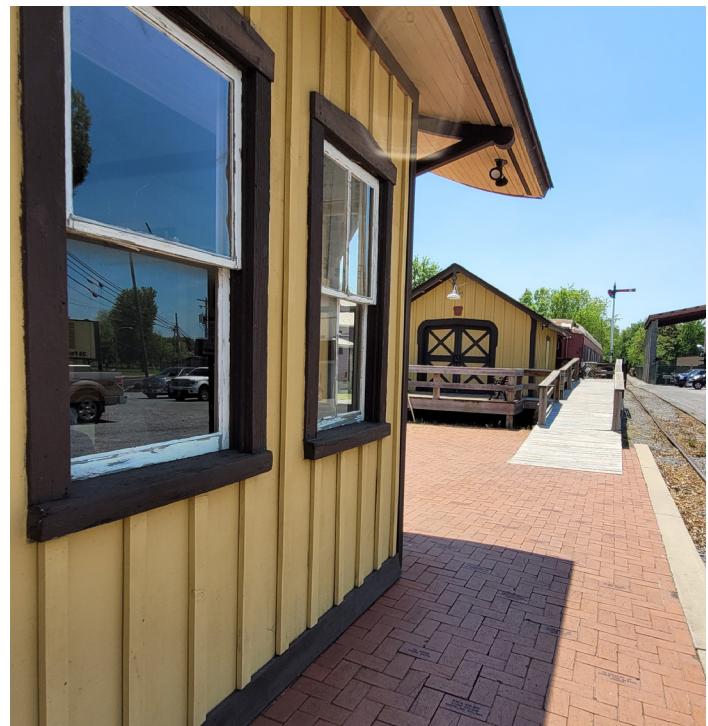
The Walkersville Railroad Station and Tool House have vertical board and batten wood siding. Photo by authors.

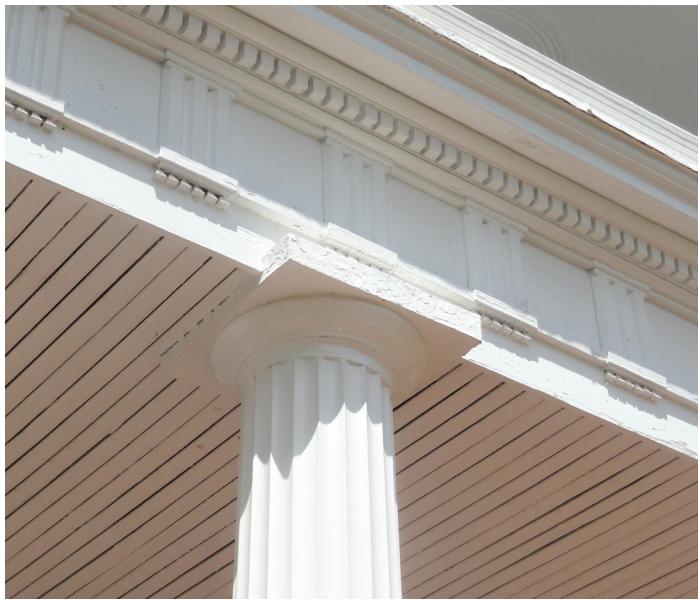
Elaborate entablature, frieze, and fluted column at Rose Hill Manor. Photo by Gary D. Baker, RA.

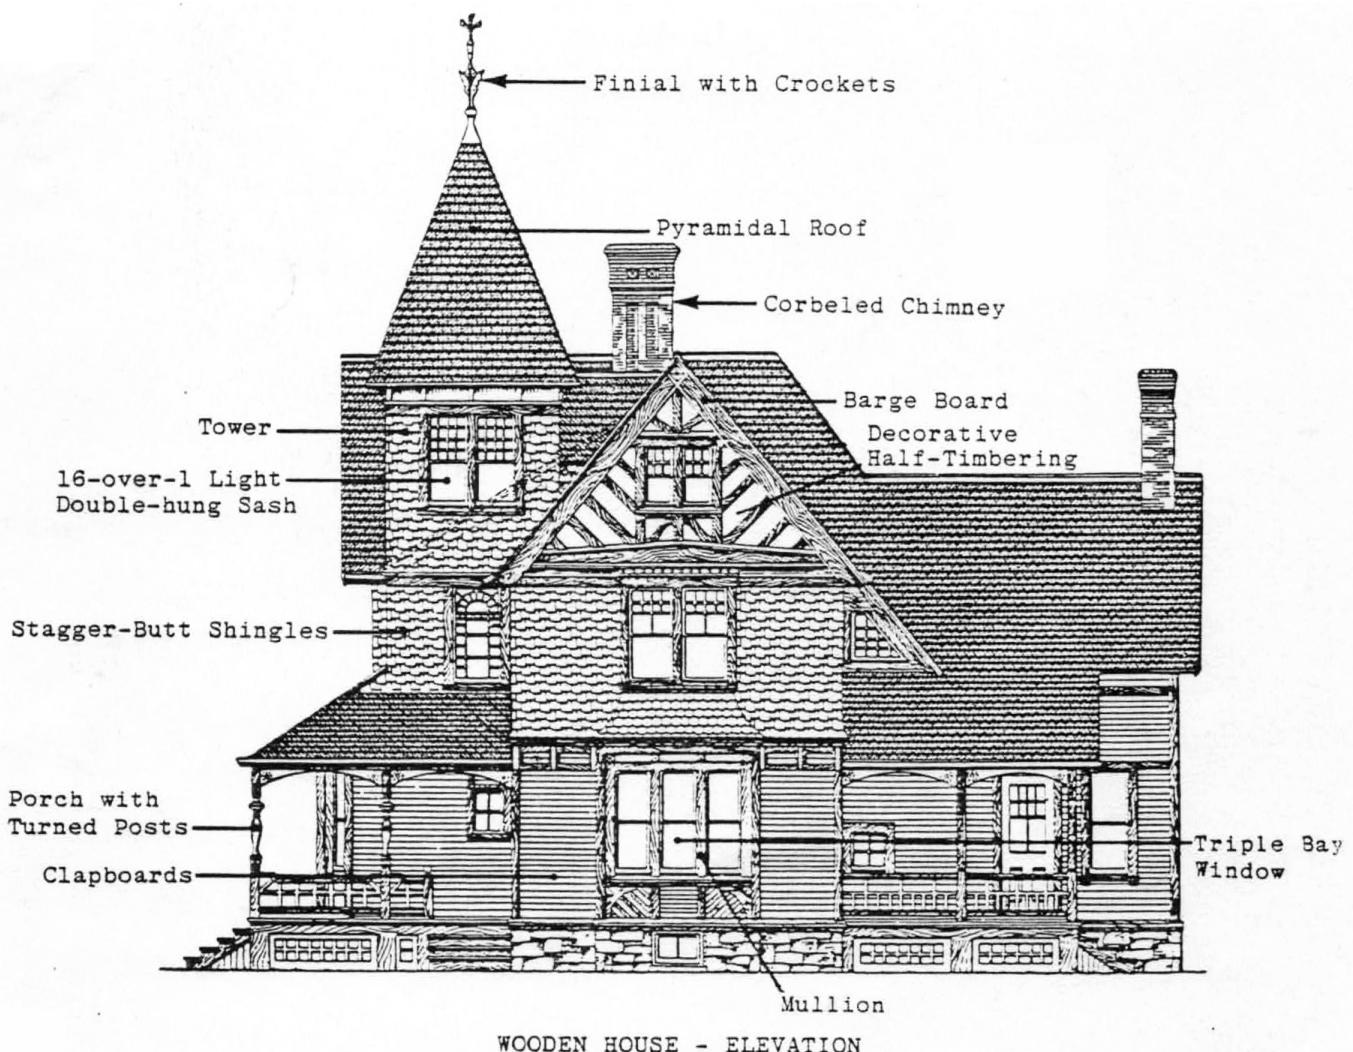
This image from Pallister's American Architecture, 1888 illustrates various elements that may be found on a wooden house.

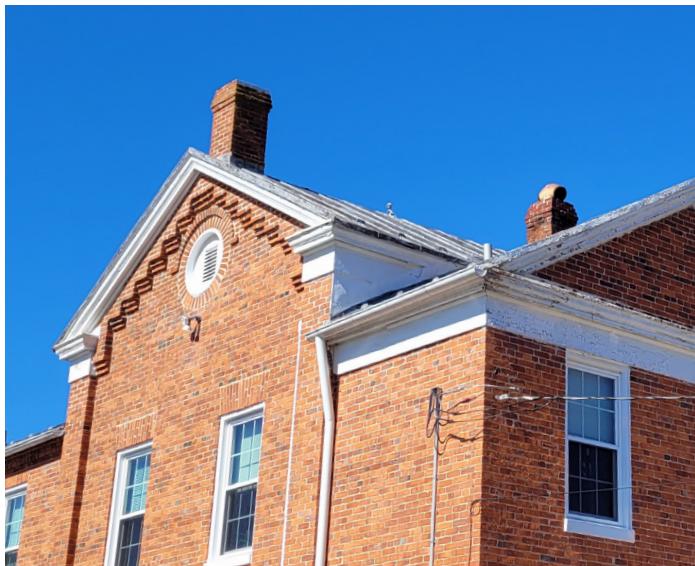
This church building in Libertytown has brick laid in Common Bond and corbelled brick at the cornice line of the gable. Photo by authors.

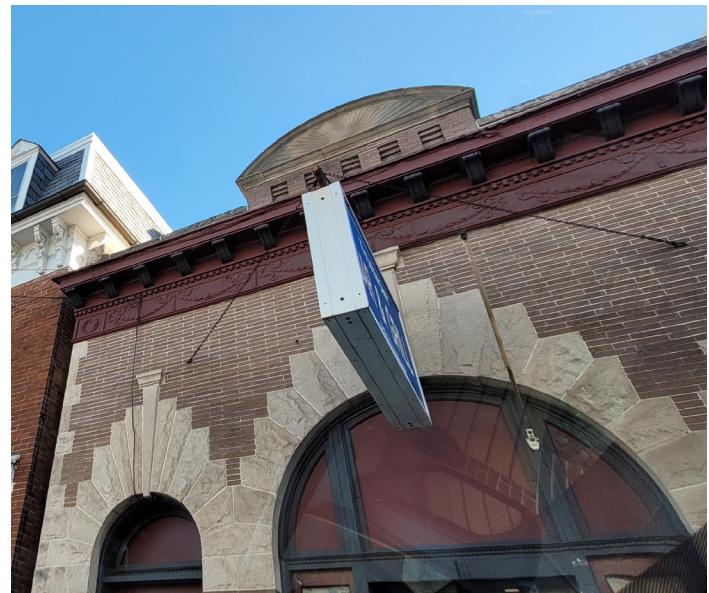
This building on Main Street in Thurmont has a brick facade with stone detailing around the windows. Photo by authors.

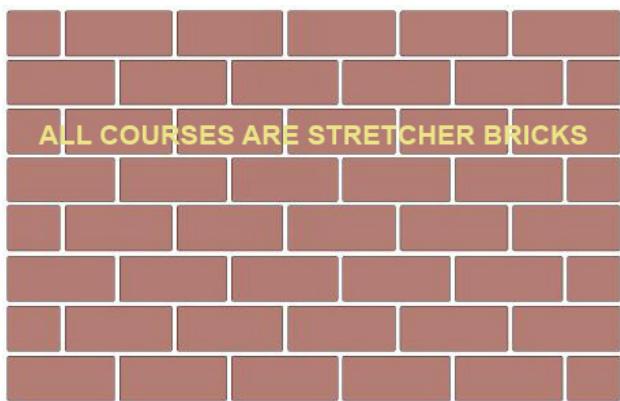
RUNNING BOND

Example of brick bond patterns and brick coursing. Image by authors.

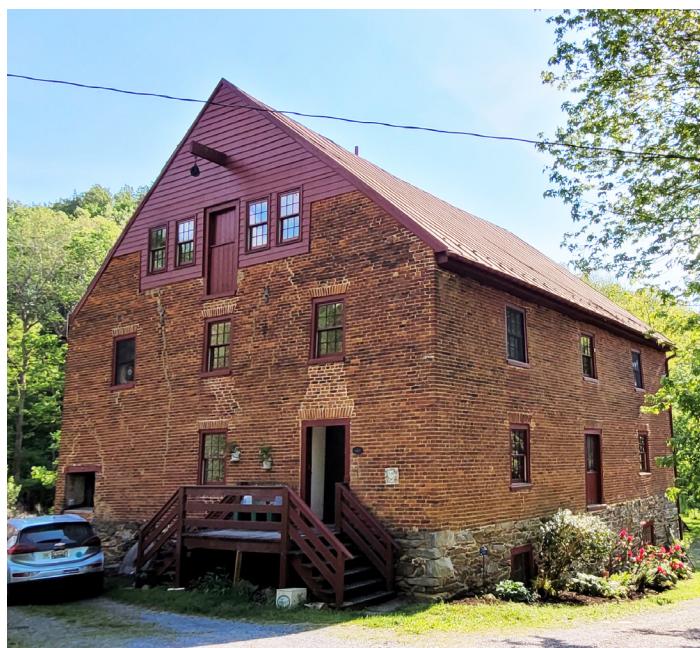
Common bond brick of the Lewis Mill, Jefferson. Photo by authors.

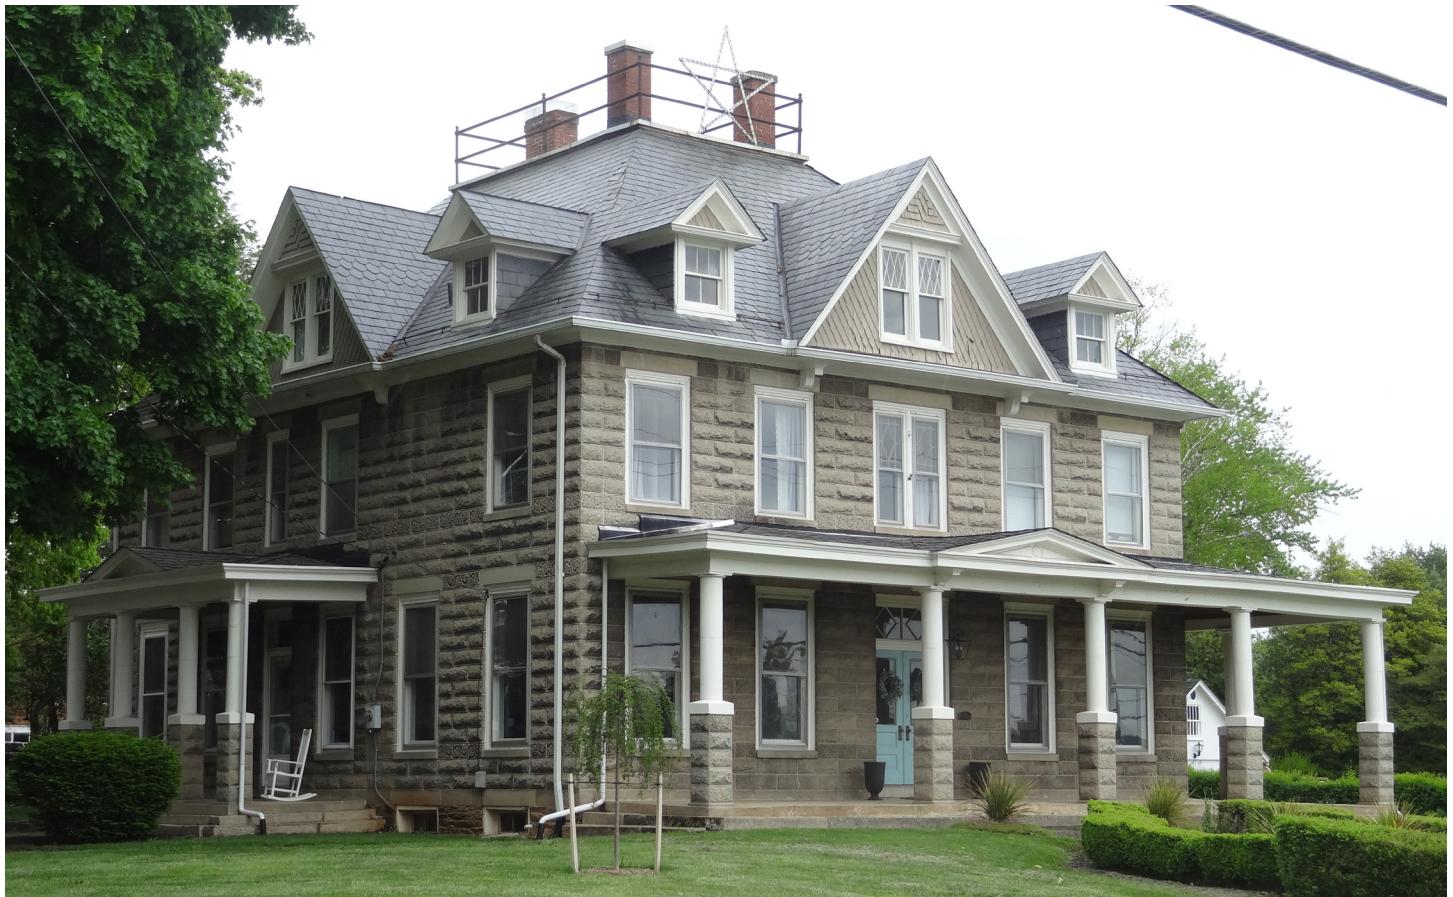
This house in Middletown has rusticated concrete block walls. Photo by Gary D. Baker, RA.

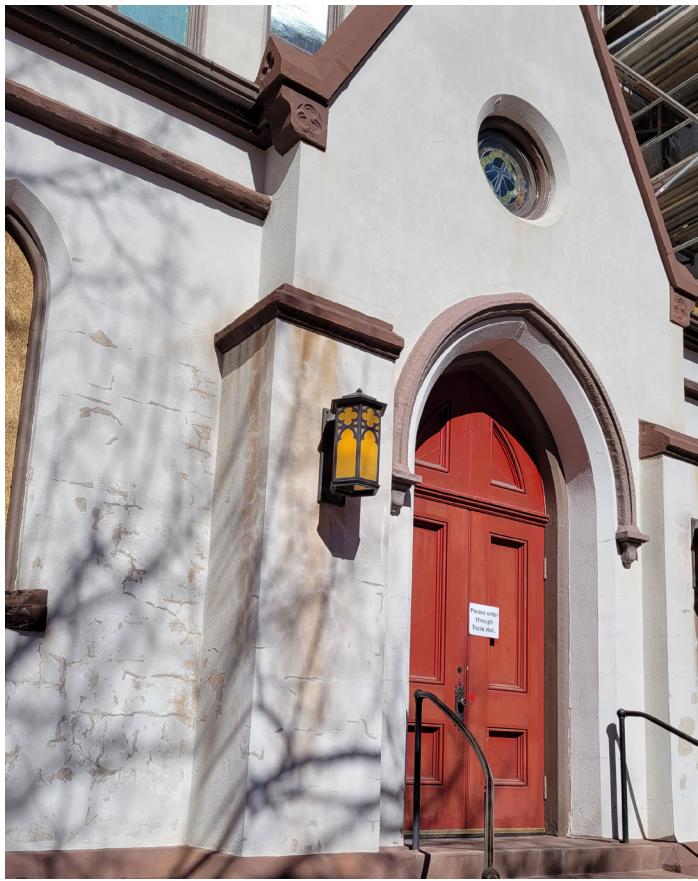
The Evangelical Lutheran Church in Frederick is made of brick walls covered in stucco. Photo by authors.

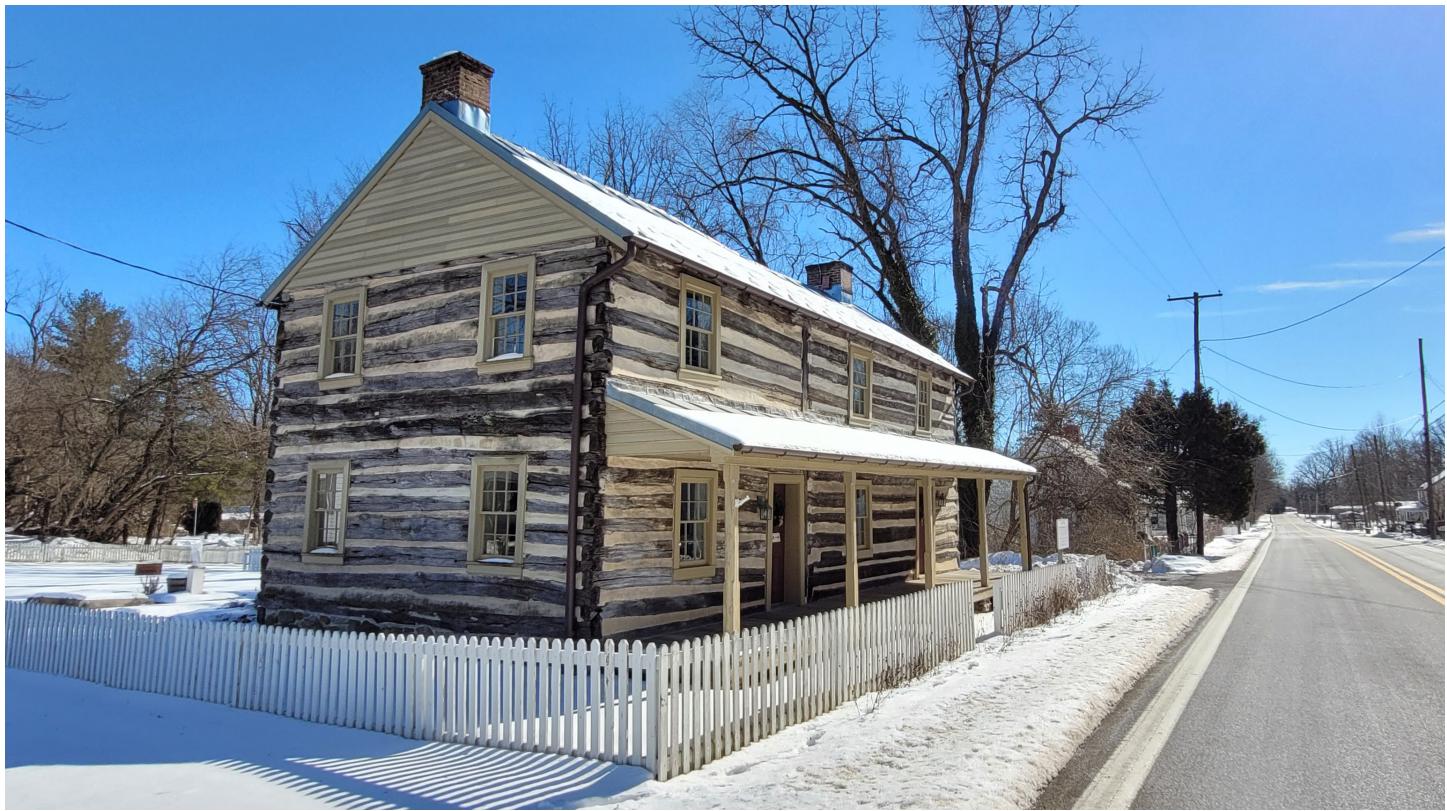
The Collier's Log House in Catoctin Furnace is an example of a double log building, which housed two families. Photo by authors.

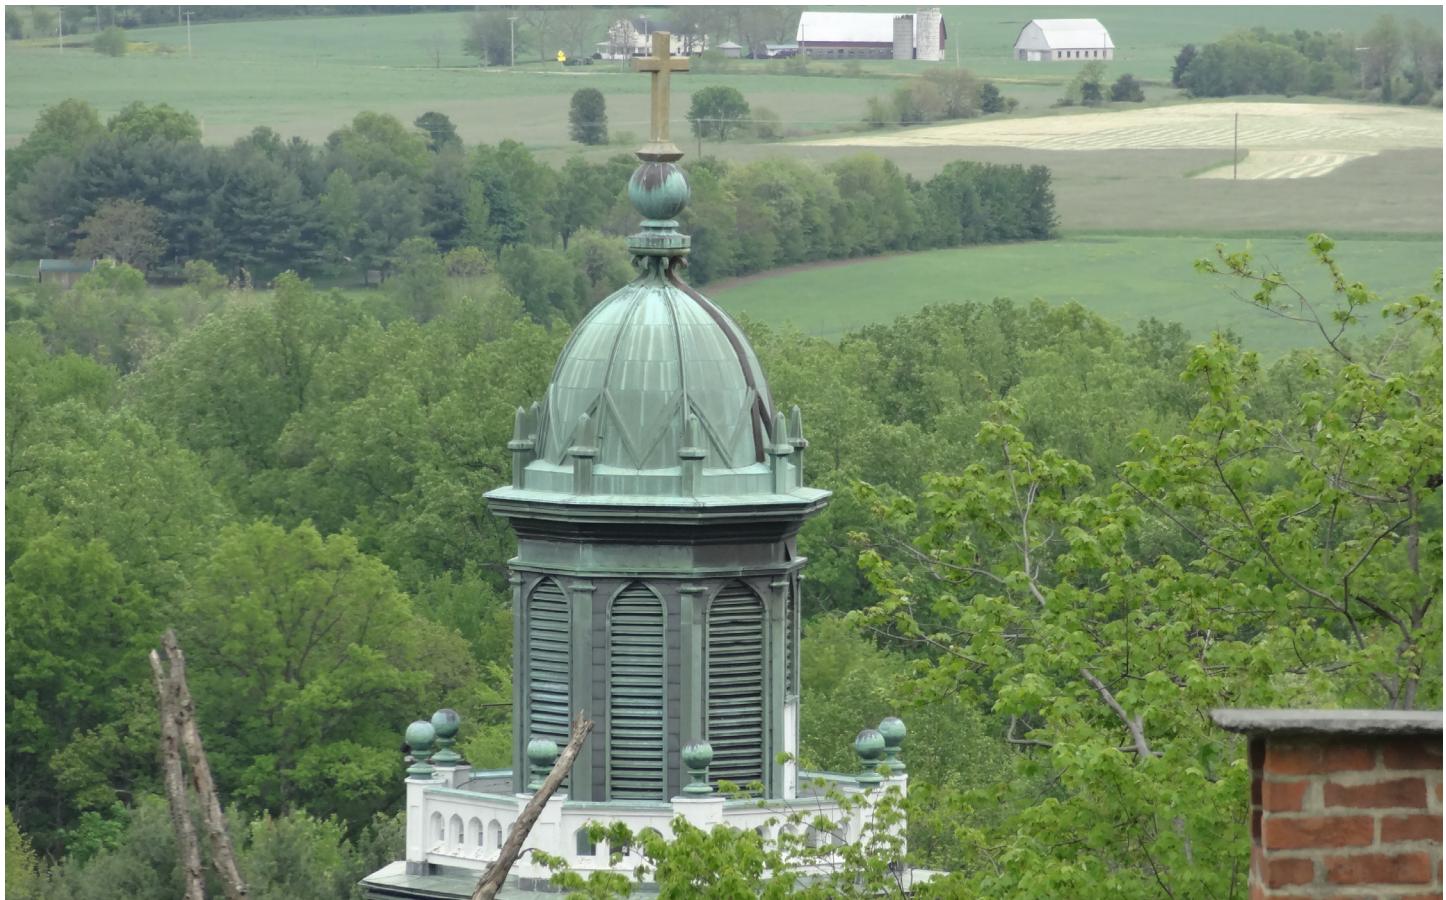
Copper-clad cupola at Mount Saint Mary's Seminary in Emmitsburg. Photo by Gary D. Baker, RA.

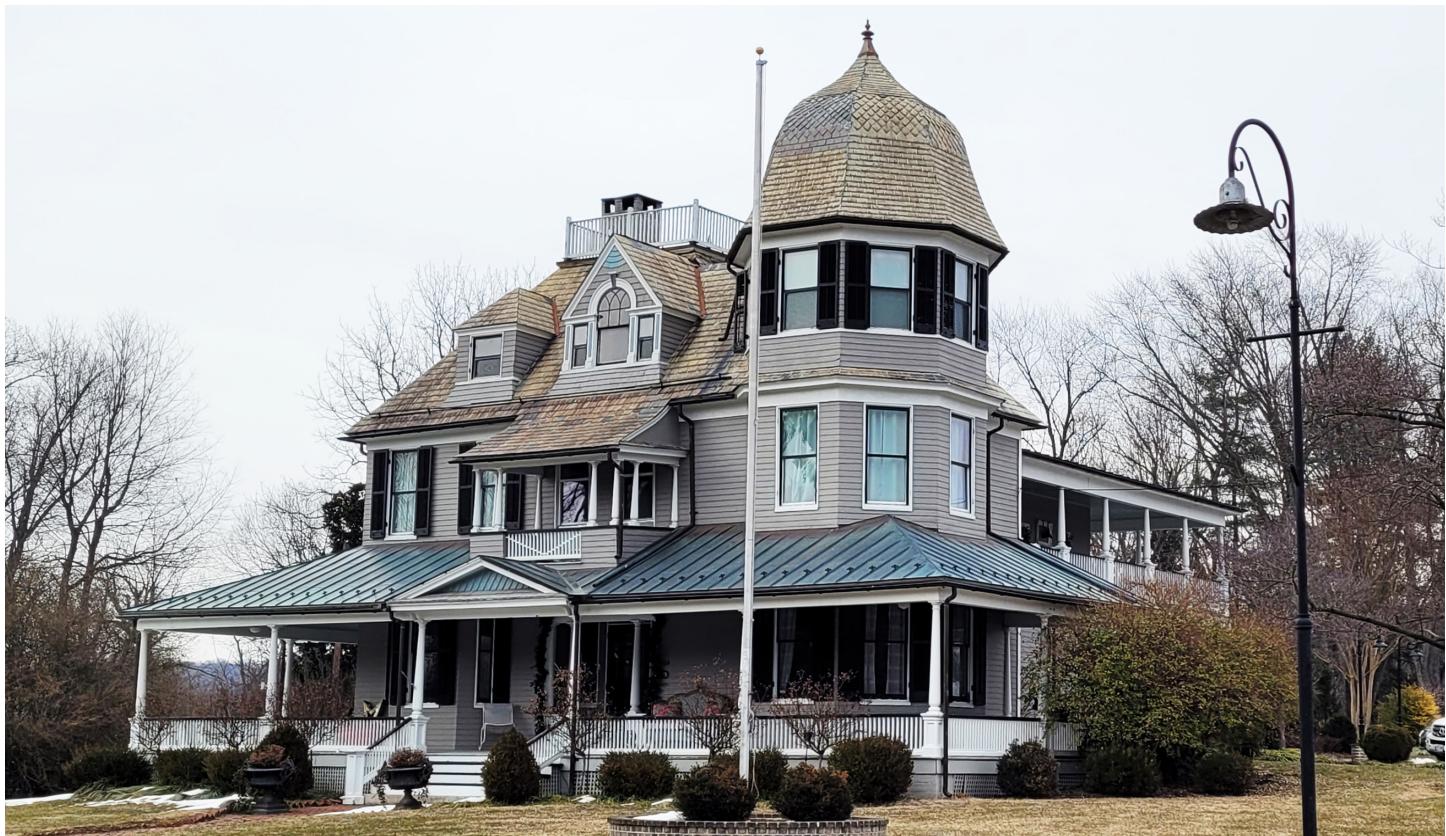
The John Baker House in Buckeystown has several examples of exterior building appendages, including a one-story wrap around porch at the first floor, a covered balcony at the center of the second floor, a second story porch on the side, and a widow's walk on the roof. Photo by authors.

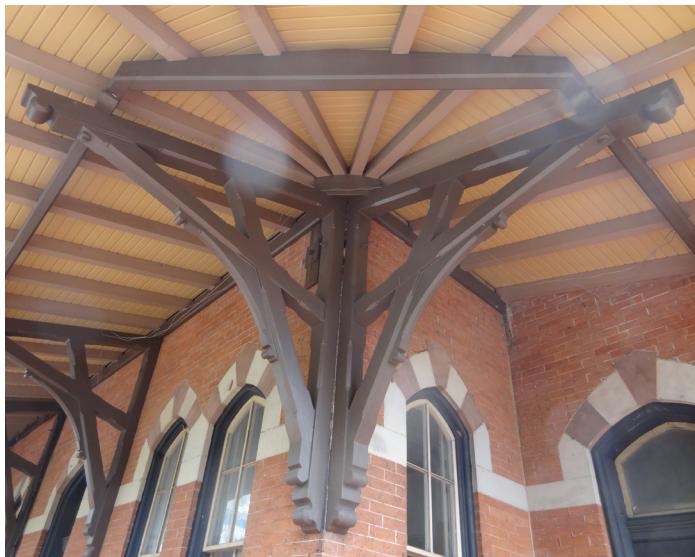
Point of Rocks Railroad Station structural framework supporting ceiling of protective overhang. Photo by Gary D. Baker, RA.

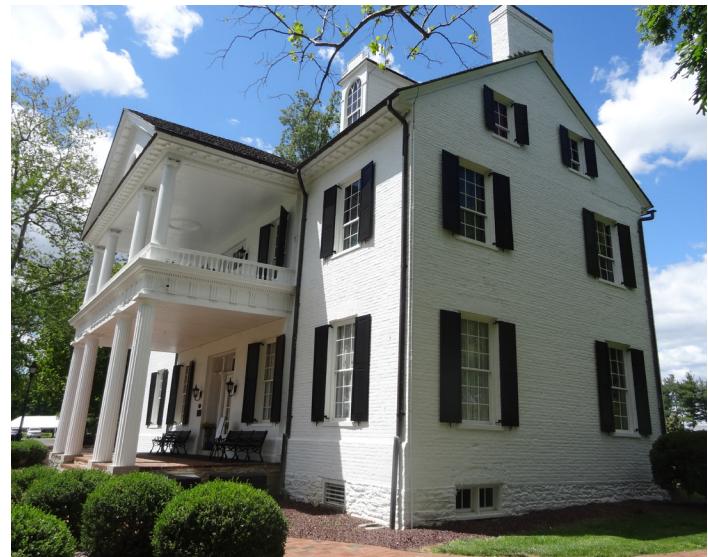
Elaborate two-story front porch at Rose Hill Manor. Photo by Gary D. Baker, RA.

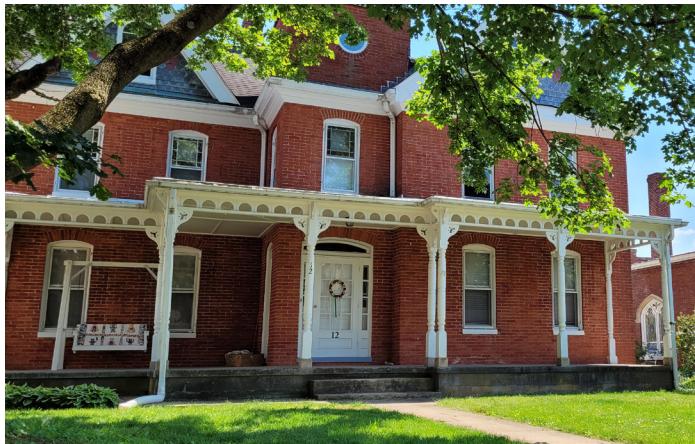
This porch on a residence in Walkersville has turned porch columns and decorative brackets. Photo by authors.

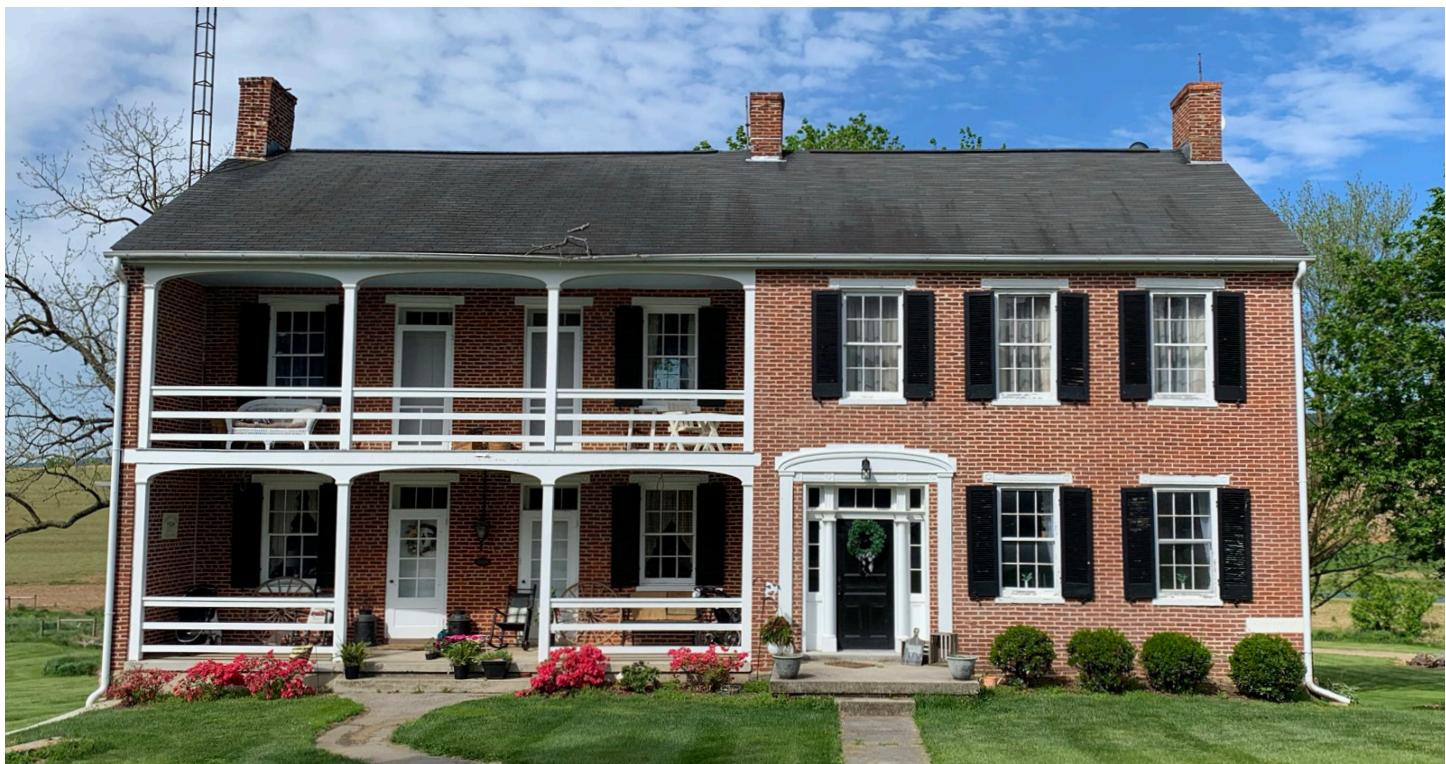
The main house at Ahalt Farm near Middletown has a two-story porch on the primary elevation. Photo by Amanda Whitmore.

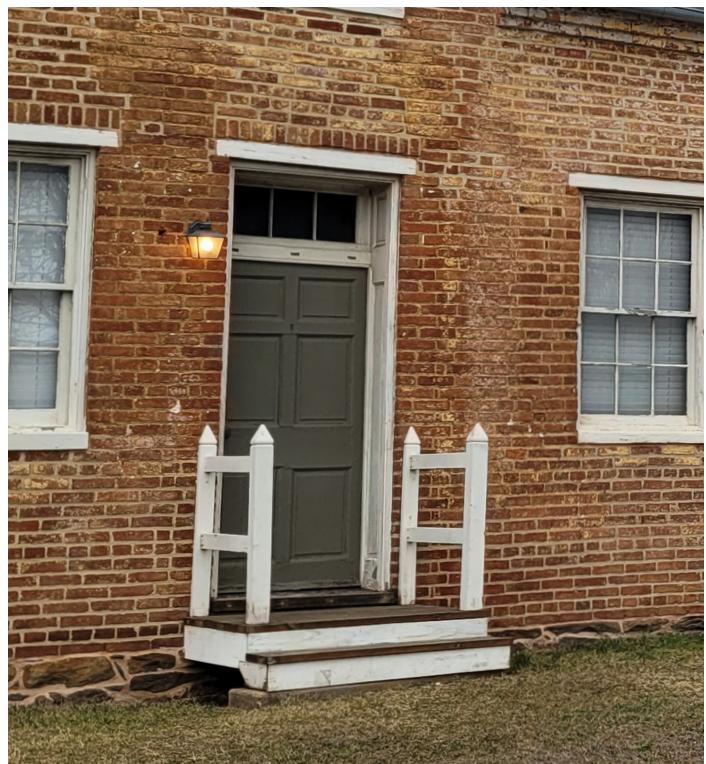
The wood stoops at Smith's Store in Urbana are replacements but are in-keeping with the historic building. Photo by authors.

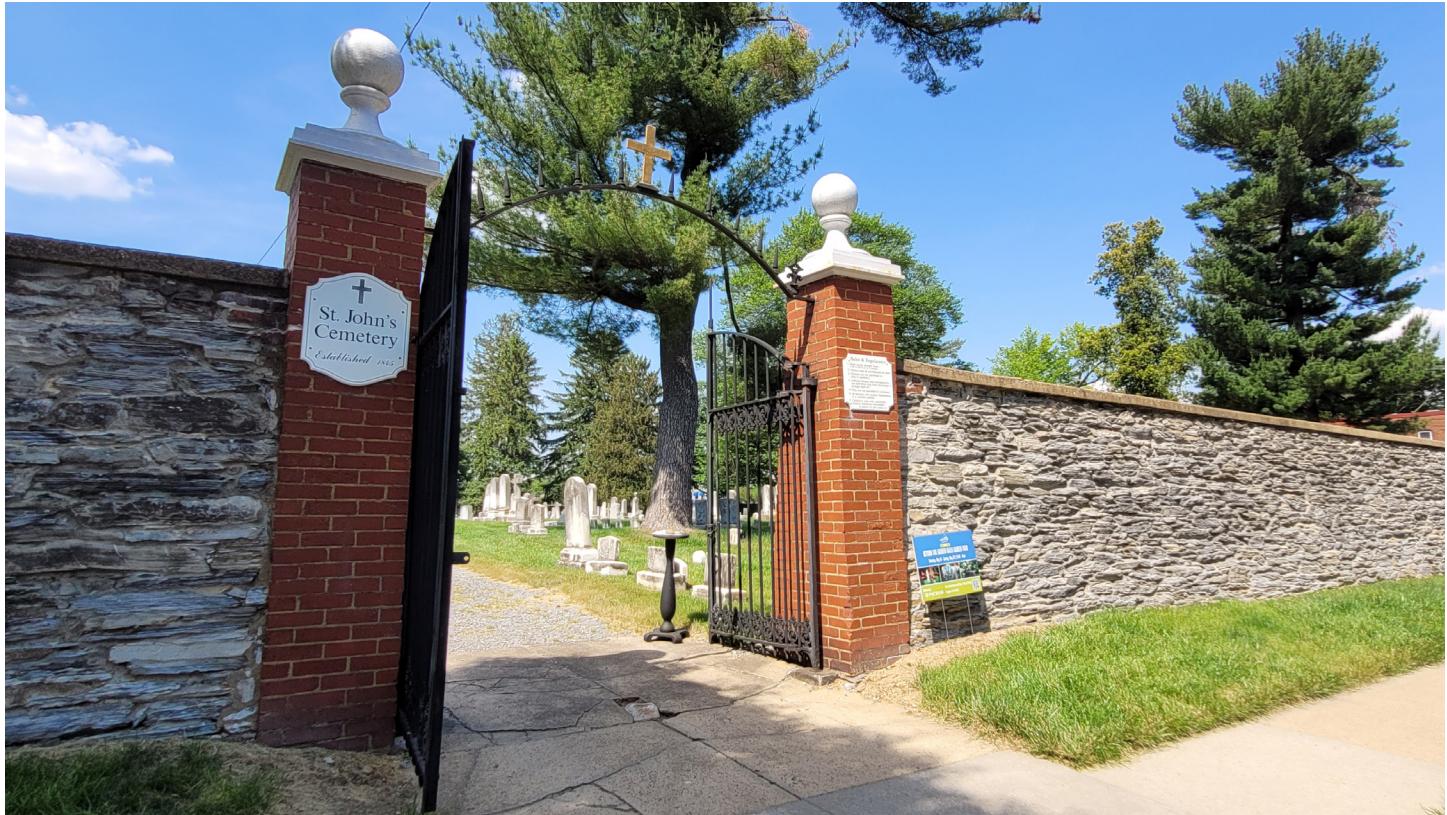
Masonry walls and entrance gate at St. John's Cemetery, Frederick. Photo by authors.

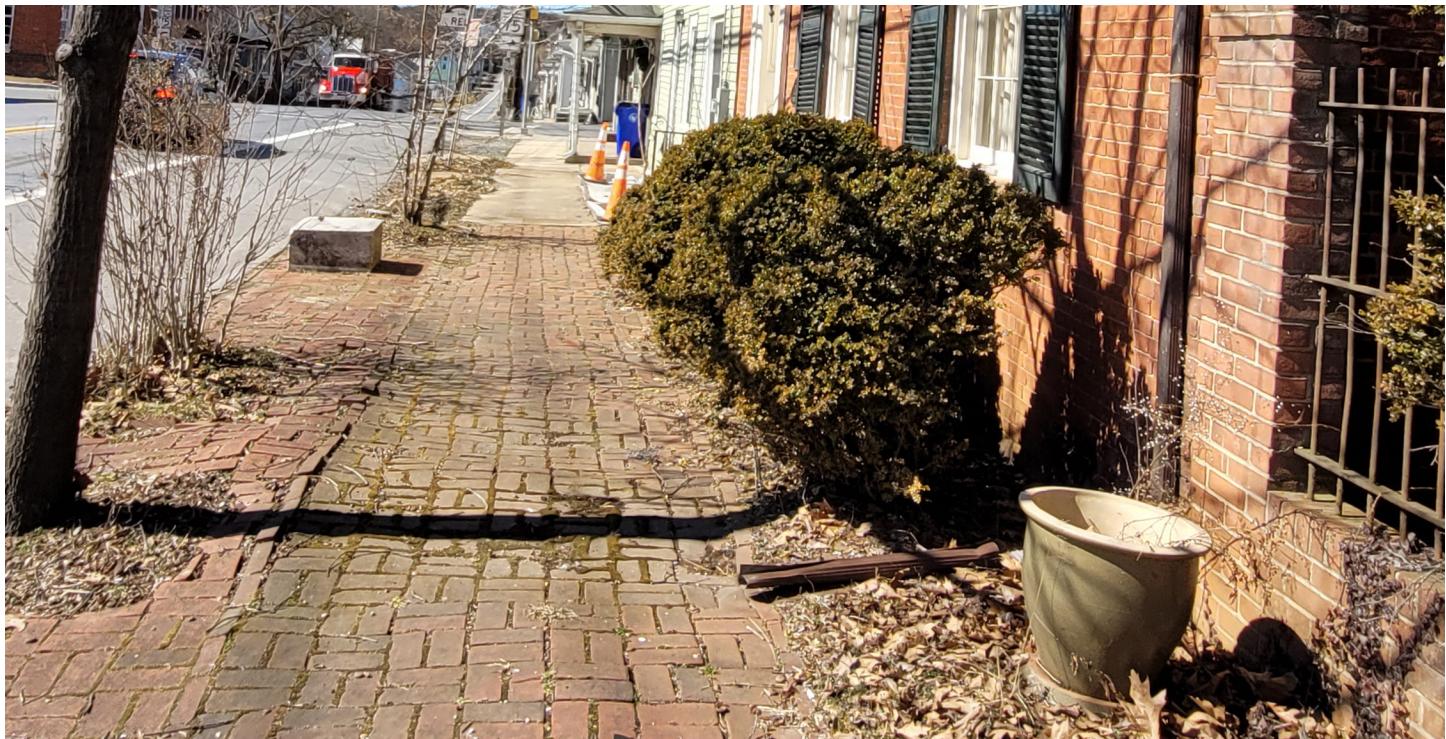
Brick paved sidewalks in Liberytown. Photo by authors.

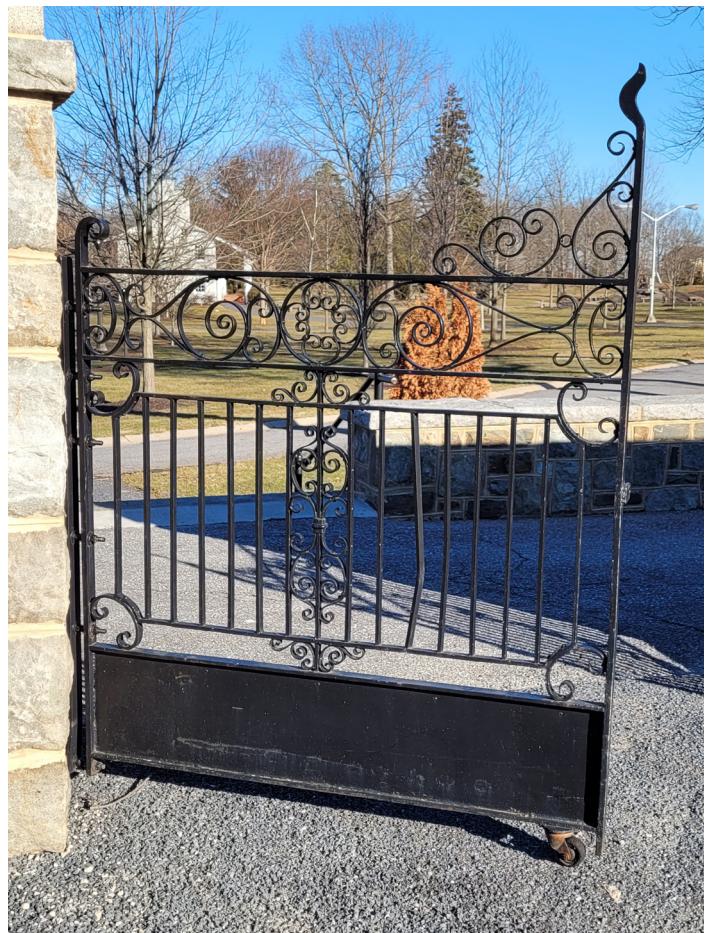
An iron gate at Mother Seton Shrine in Emmitsburg. Photo by authors.

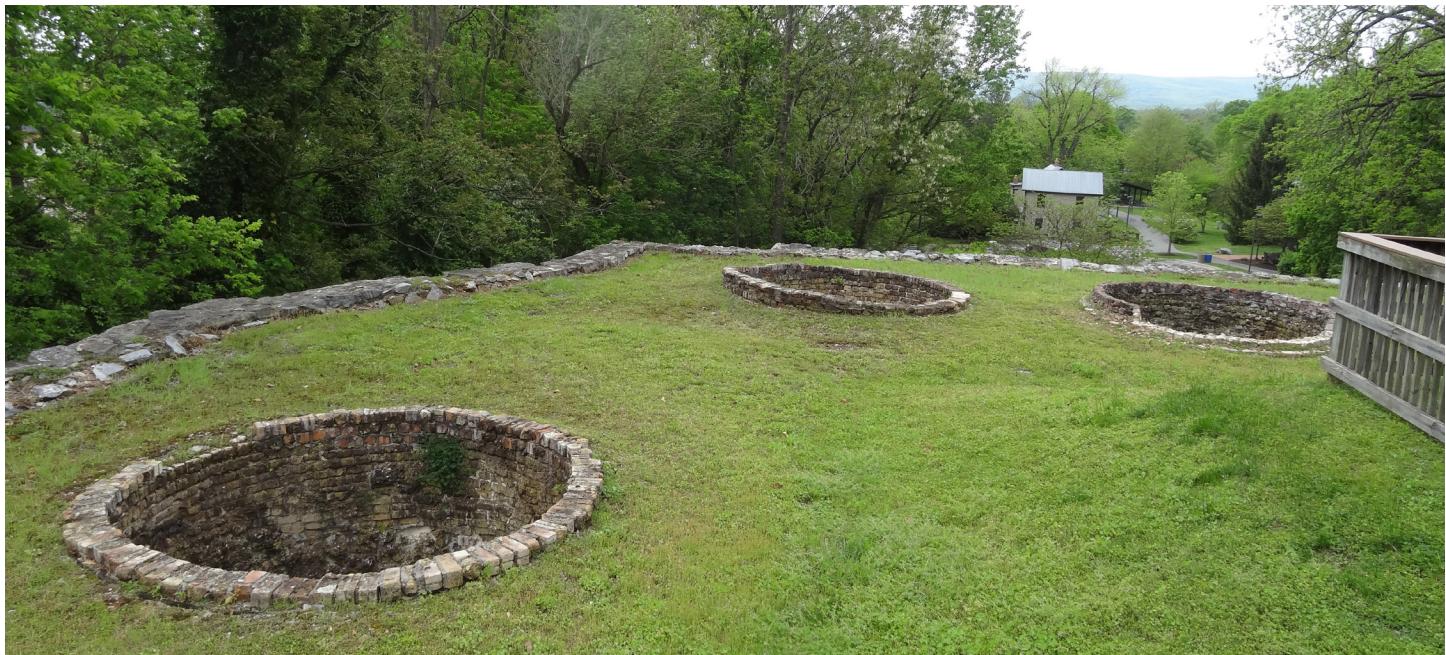
Tops of lime kilns where raw limestone was dumped to be heated to produce powdered lime at Fountain Rock Park and Nature Center in Walkersville. Photo by Gary D. Baker, RA.

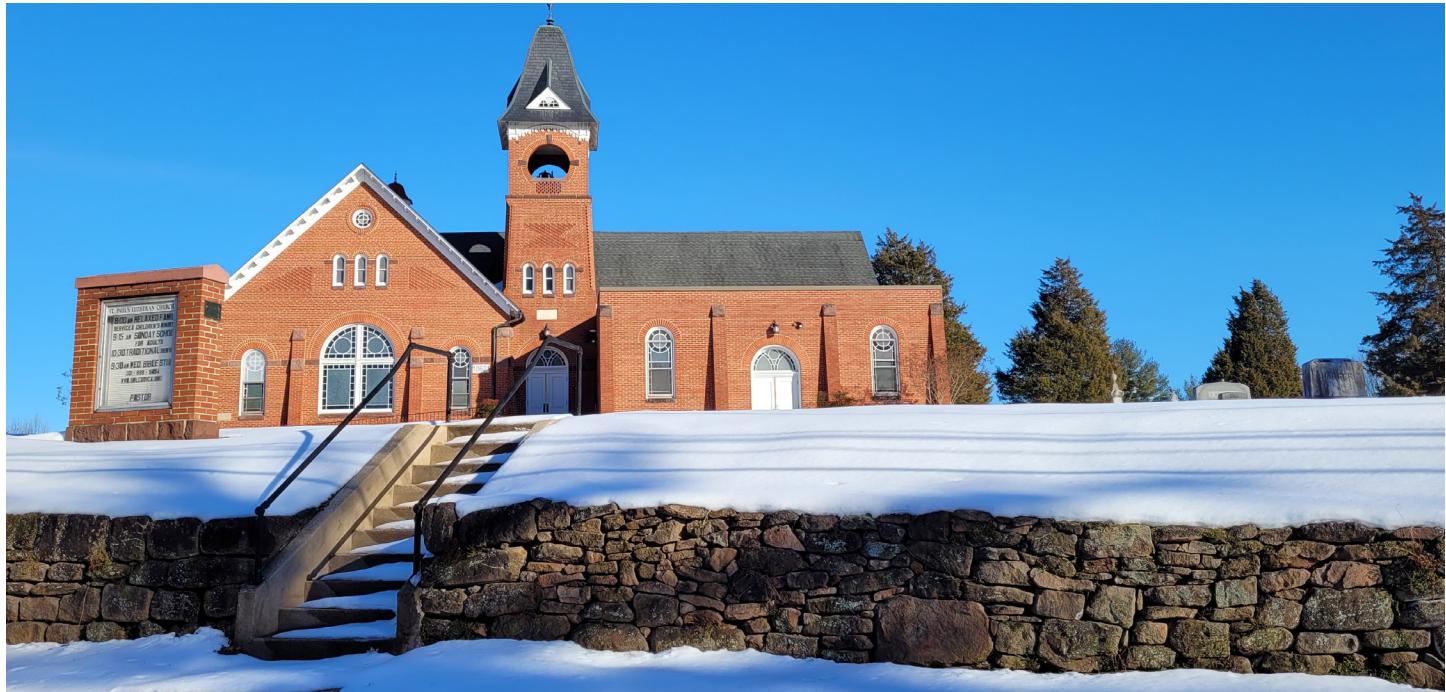
A stone retaining wall at the street edge of St. Paul's Lutheran Church in Utica. Photo by authors.

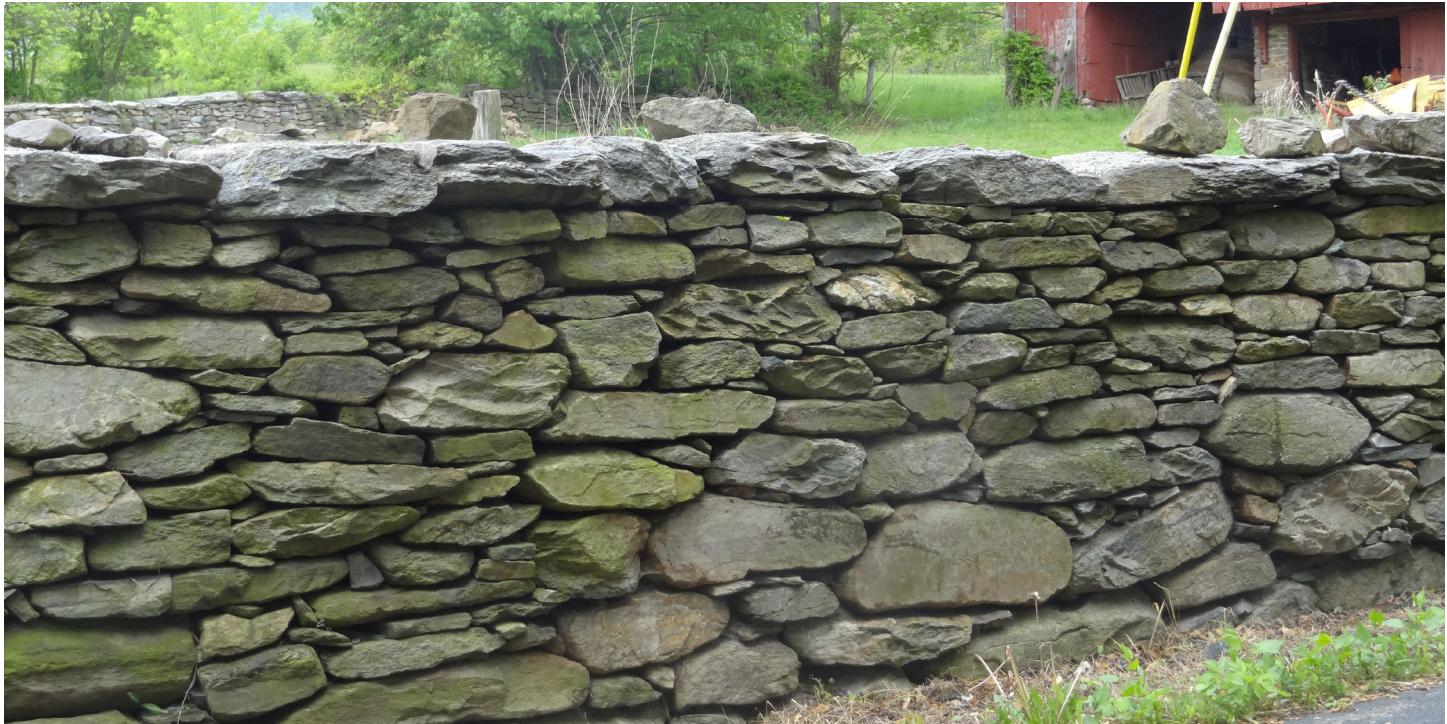
Coursed local stone wall in Burkittsville. Photo by Gary D. Baker, RA.

Site walls are typically constructed of brick, stone, poured concrete, and concrete block. They often serve as retaining walls to address changes in topography. Retaining walls may have a structural purpose but also contribute to a site's aesthetic and historic character. The masonry material, mortar joints, and coursing all contribute to the character of the wall and should be retained. Masonry walls should be maintained and repaired in a similar fashion to the masonry walls of a building, as addressed in Chapter 4.E.3 above.

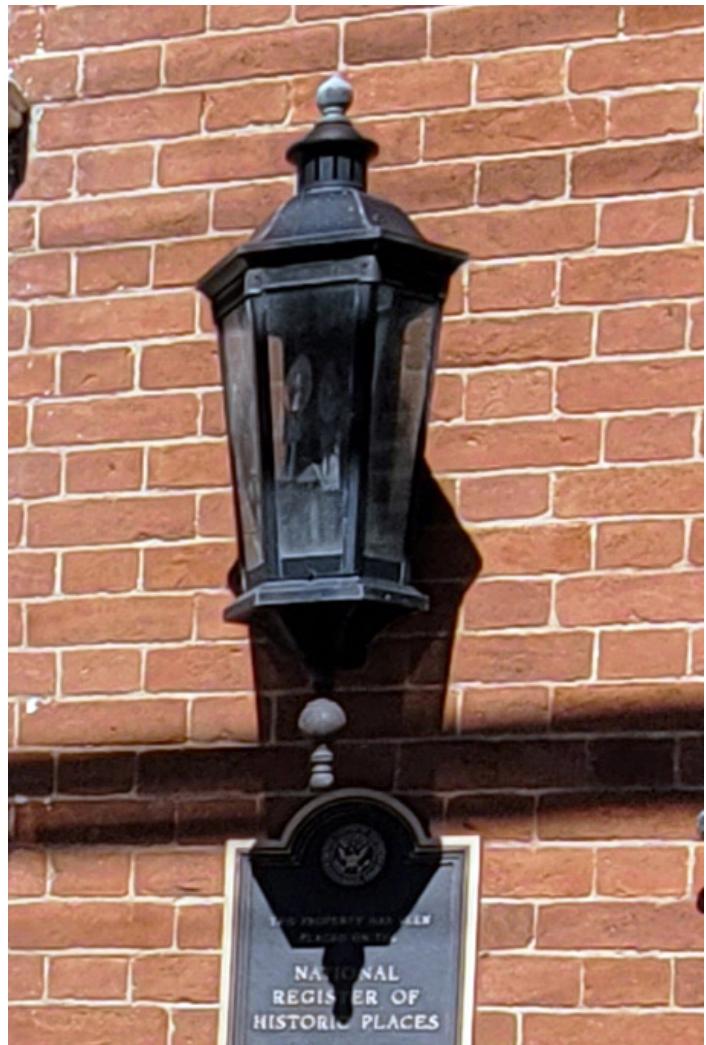
A wall-mounted light fixture at the Abraham Jones House in Libertytown that is in keeping with the historic building. Photo by authors.

On commercial properties, lighting is regulated by Section 1-19-6.5 of the County Code. In addition to meeting all code requirements, new light fixtures on historic properties should be designed at an appropriate scale to the historic buildings to which they will be attached. Fixtures for masonry walls should be attached in the masonry joints to prevent damage to the historic fabric. New fixtures should not mimic a specific historic style unless there is photographic or physical evidence that the style was used on the building.

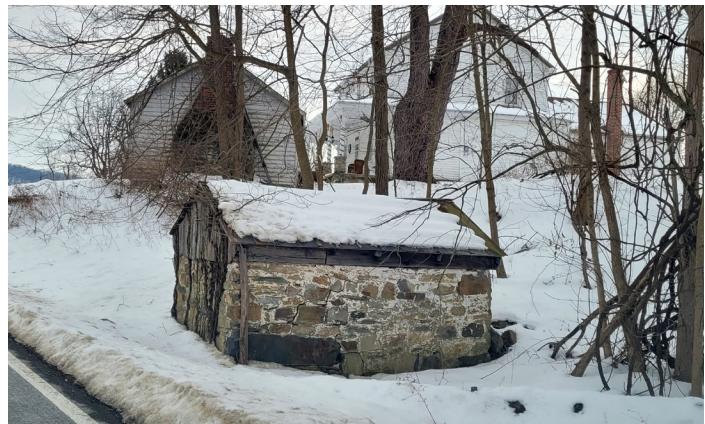
The stone used on this springhouse at Kinna's Miller's House in Sabillasville matches that of the mill building directly across the street. Photo by authors.

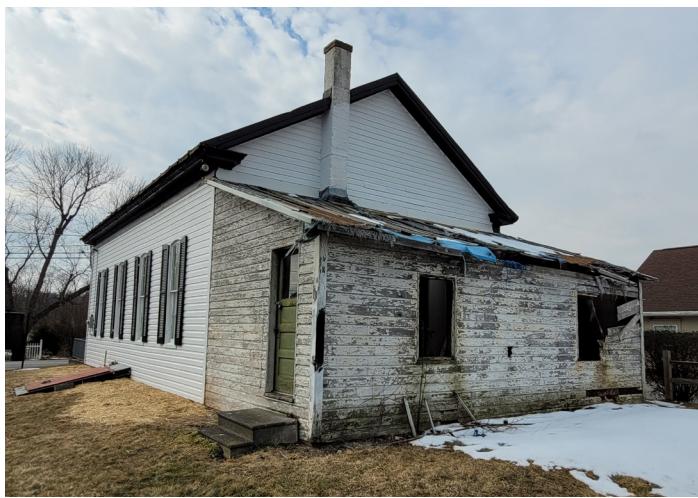
This shed roof rear wing was an early addition to the Rocky Springs Chapel near Frederick. It uses the same materials as the original and is well sited at the rear of the building. Photo by authors.
