Frederick County Register of Historic Places

DESIGN GUIDELINES

2021 EDITION

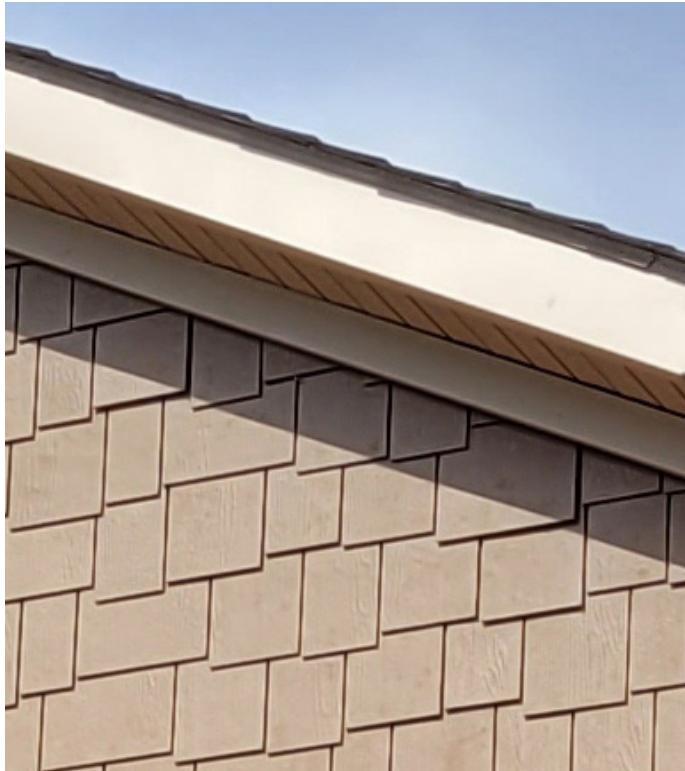
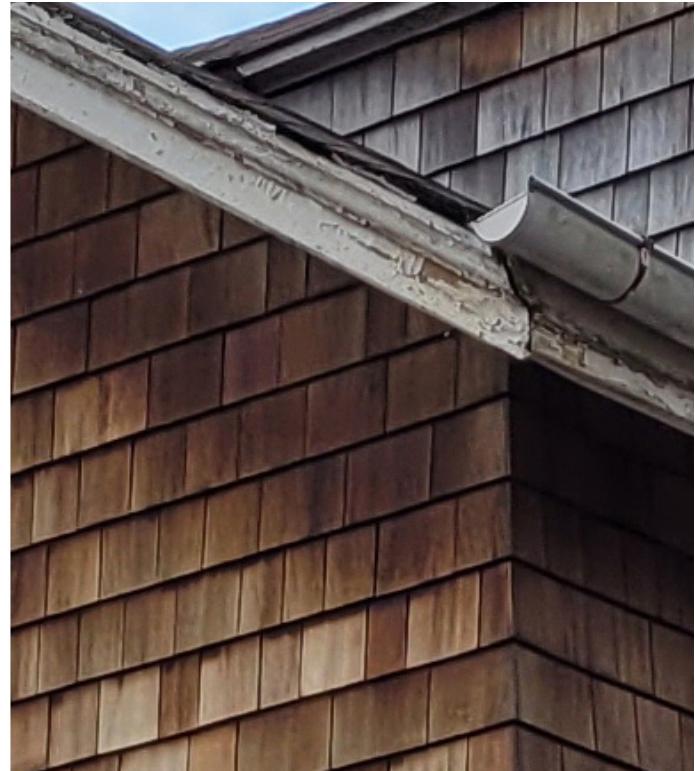
Example of a synthetic material (left) that is not an acceptable alternative for the traditional material. The synthetic shingles are too thin and flat to achieve the same profile and depth of the original. Photos by authors.

Alternative materials considered for approval by the Commission should be visually, physically, and chemically compatible with the original material. The appearance of the alternative material should match the original in color, texture, size, shape, and profile to maintain the historic character of the building. The Commission will consider the location of the feature and its visibility from the public right-of-way as well as the level of detail and significance of the feature to be replaced. The alternative material must be compatible with the original materials remaining on the building. Durability of the alternative material should be carefully evaluated.

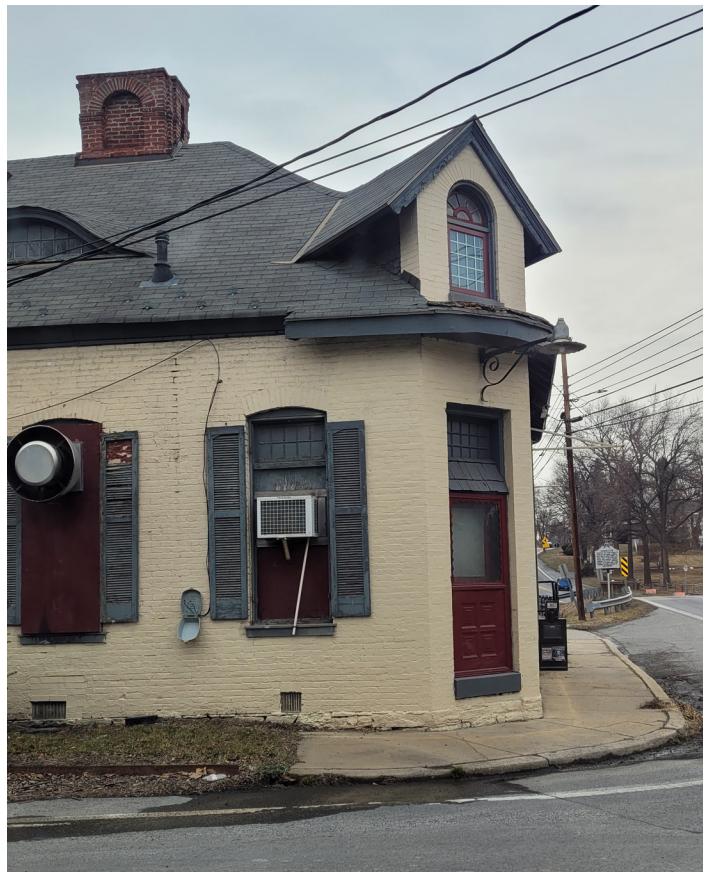
It is not recommended to modify window openings to accommodate the installation of equipment, particularly on a highly visible facade. Image by authors.

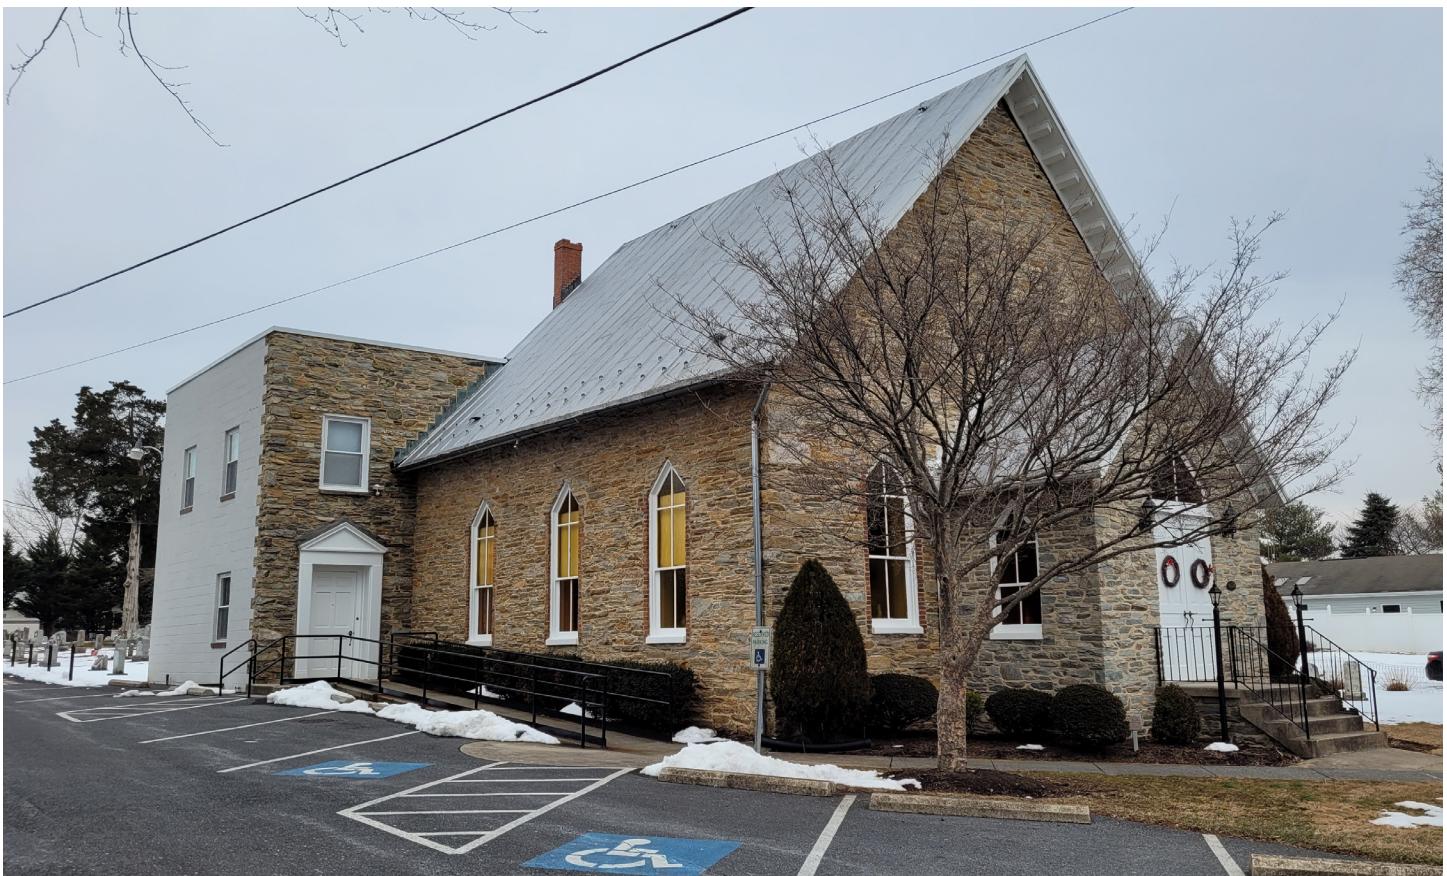
An accessible ramp and entry door was added to the Methodist Episcopal Church in Jefferson at the modern flat-roofed addition on the west side in order to keep the historic fabric of the original church entrance intact. Photo by authors.

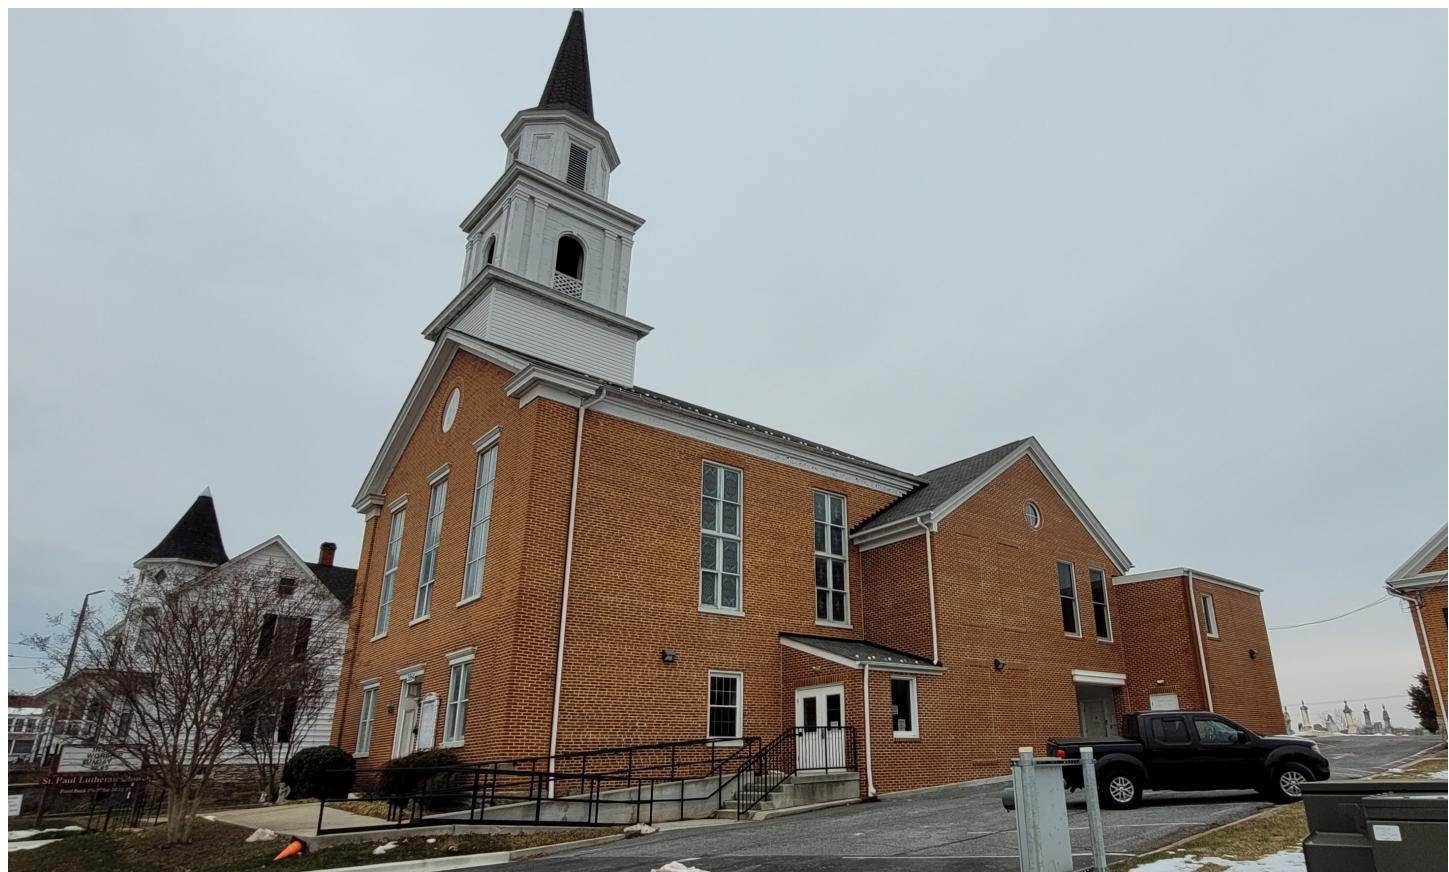
An added accessible ramp and entry steps at the side entrance of St. Paul Lutheran Church in Jefferson. Photo by authors.

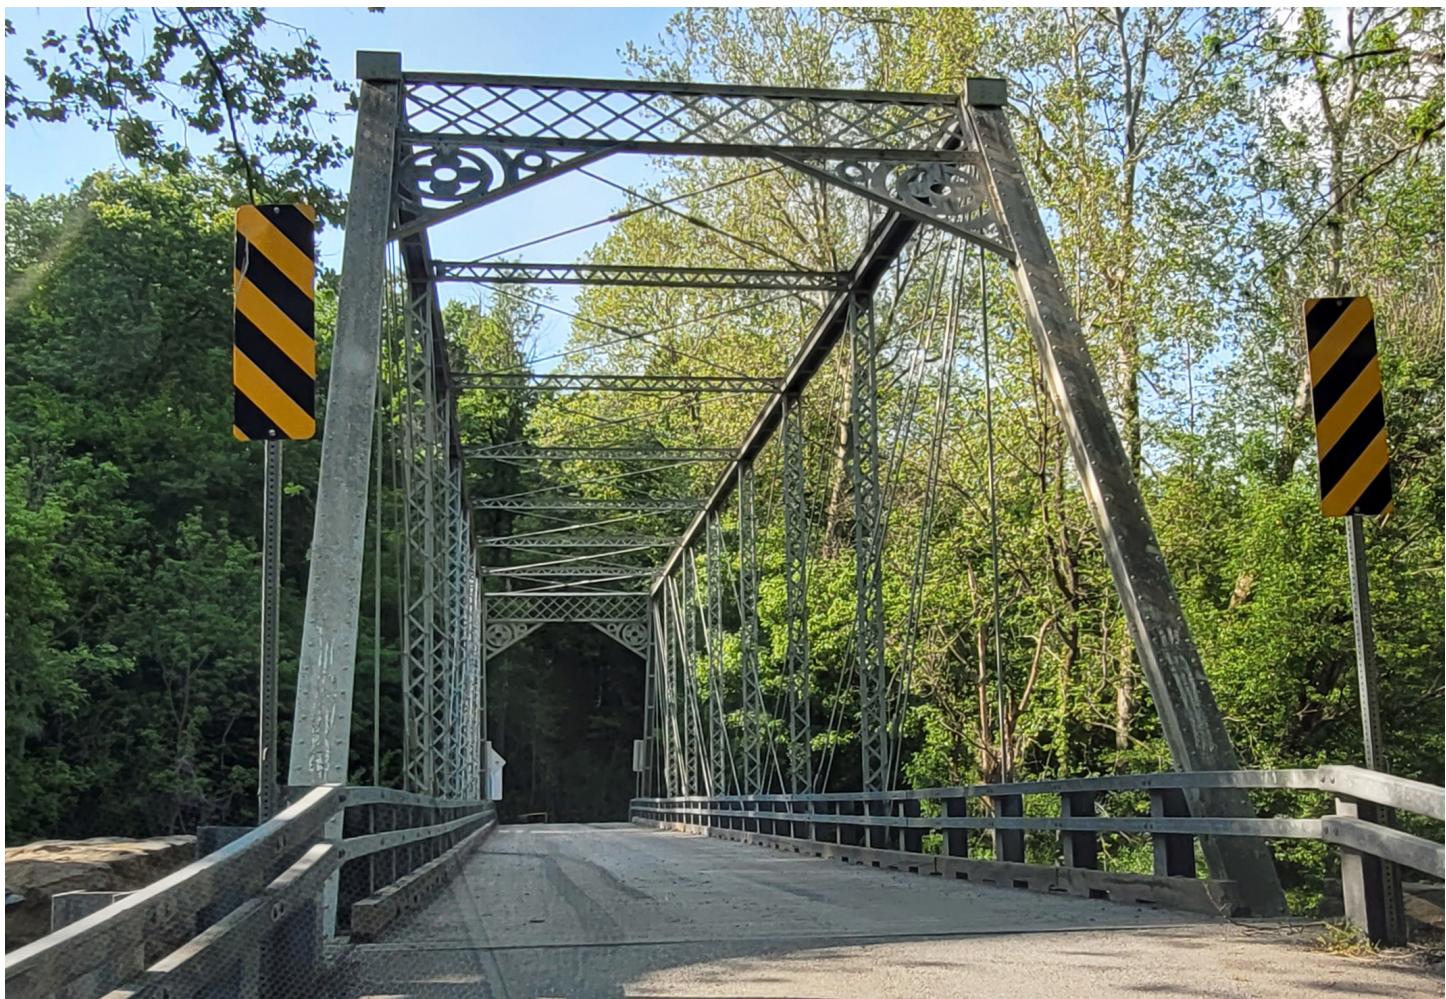
The Poffenberger Road Bridge near Middletown is an example of a Whipple thru truss iron bridge. Poffenberger Road is a designated Frederick County Rural Road and one of the few gravel roads that includes a metal truss bridge. Photo by authors.

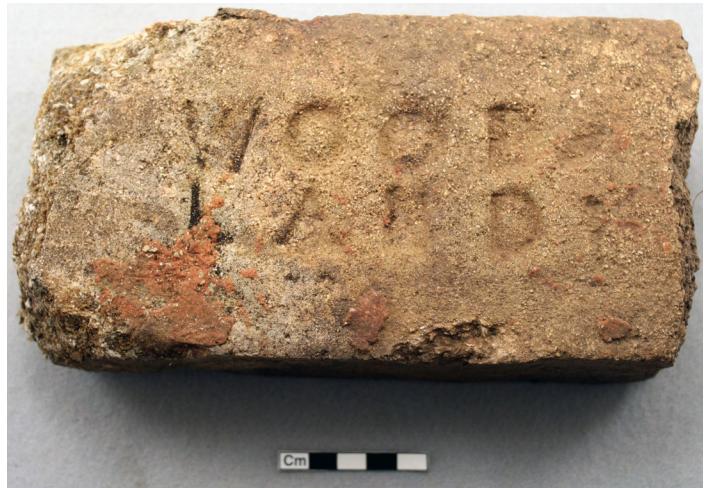
Firebrick discarded during routine blast furnace relining at Catoctin Iron Furnace, Frederick County. This brick was manufactured by Woodland Fire Brick Co, Clearfield Co., Pennsylvania. Image courtesy of Elizabeth A. Comer.

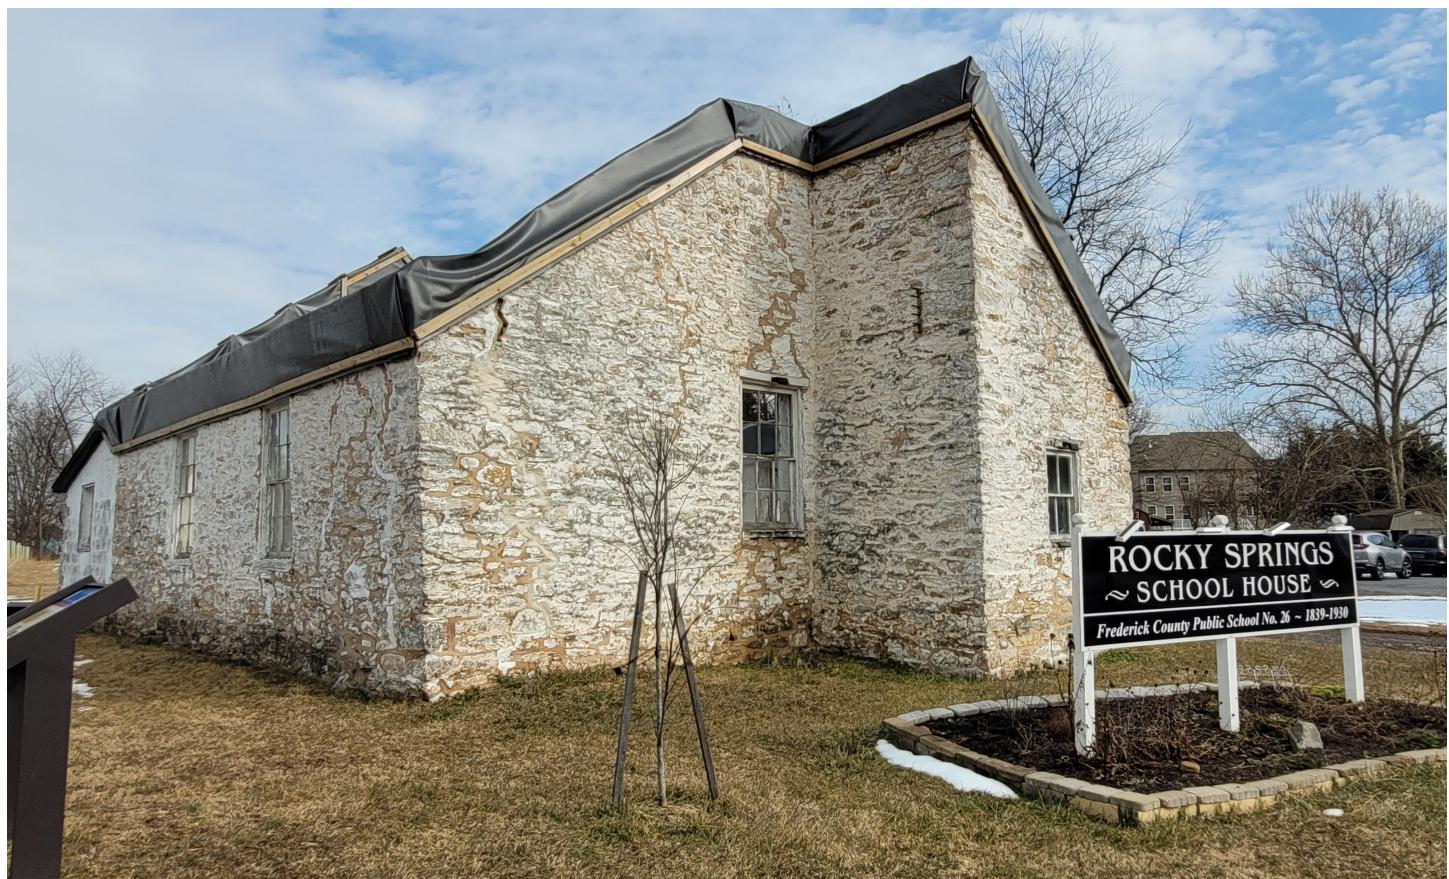
The Rocky Springs School House near Frederick was neglected by the previous owners and is in need of an entirely new roof. The current owners, Rocky Springs Chapel, Inc., are rehabilitating the building and have designated it to the County Register. Photo by authors.

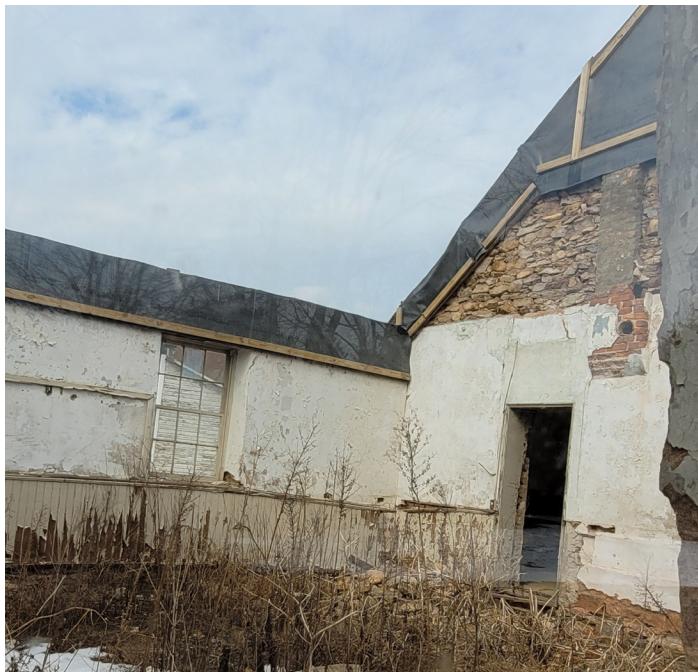
A view inside of the roofless Rocky Springs School House. Photo by authors.

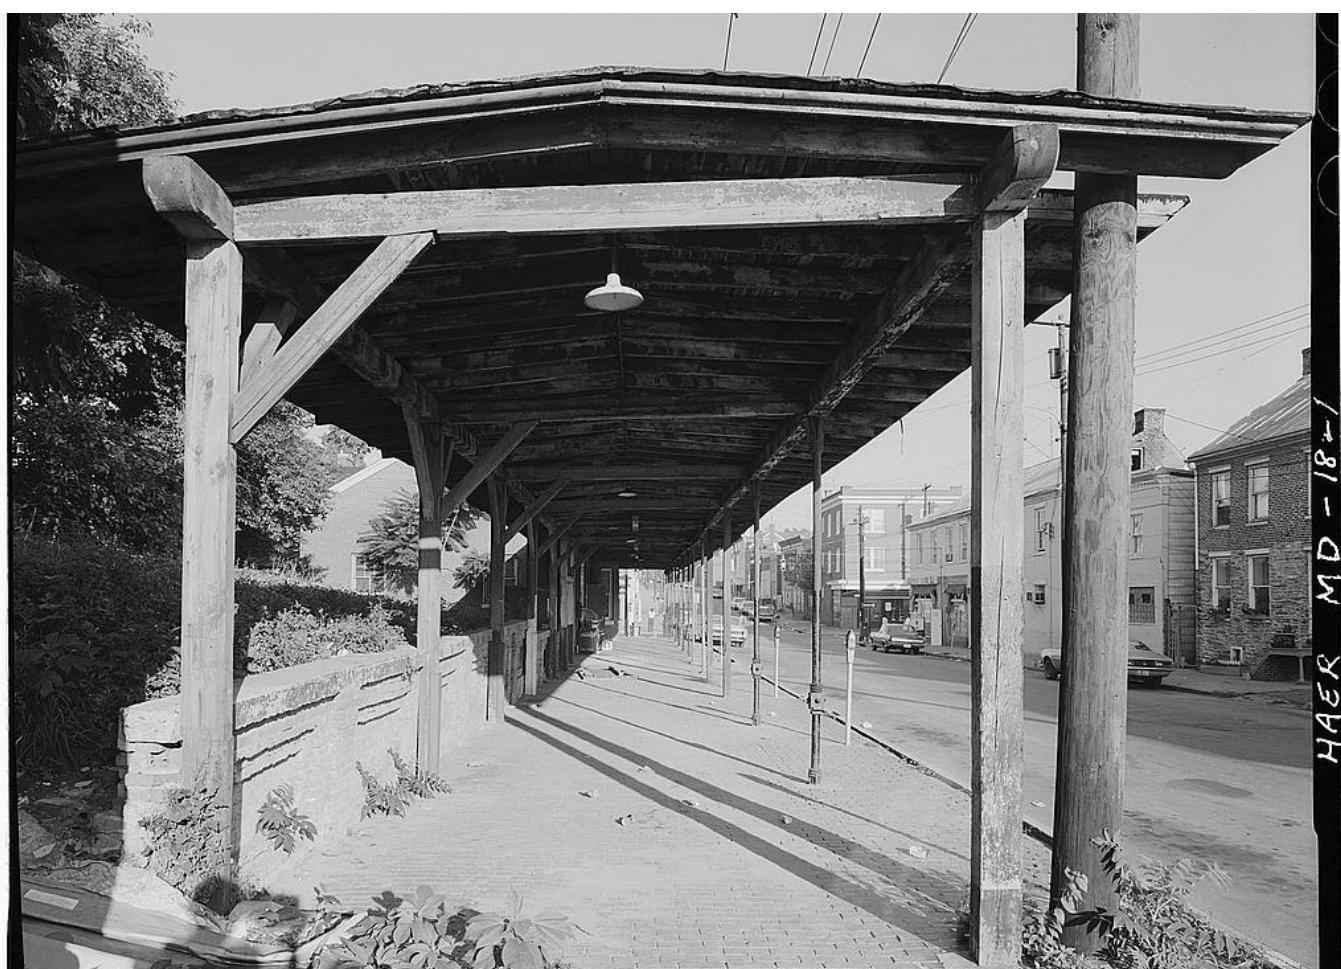
Photograph of the former passenger canopy at the B&O Railroad Station in Frederick. The canopy was photographed as part of the HABS documentation of the station, which is filed at the Library of Congress.

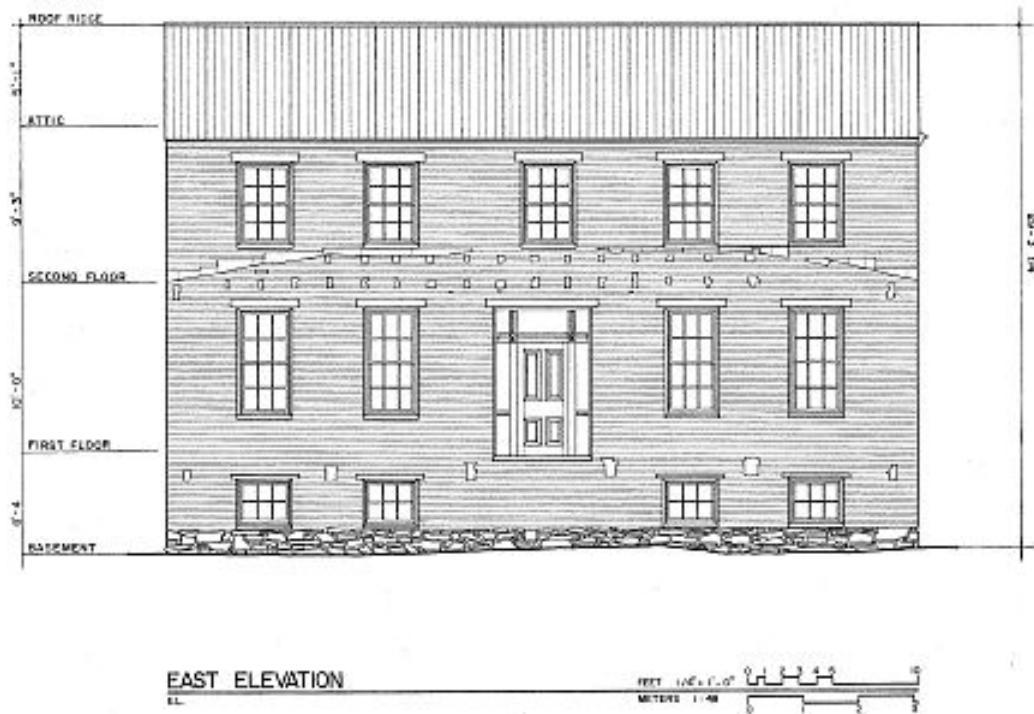
HABS documentation includes floor plans and elevation drawings. This drawing shows part of the HABS documentation on file at the Library of Congress for the Clifton Farm, located off Baker Road in Frederick County.

- Written description and history of the building or structure to be demolished.
- Photo documentation, which may include photos taken according to standards of the
