HOW HEALTHY IS YOUR STREAM?

A Summary Report for the Fishing Creek Watershed

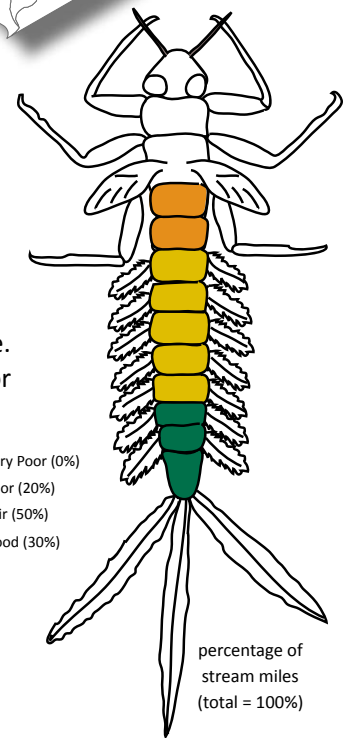
many pollution-sensitive bugs are found, the stream is likely to be cleaner and have a good BIBI score. In a stream where most of the bugs found are pollution-tolerant, the stream is likely to be more polluted and have a poor to very poor BIBI score. The average BIBI score for the Fishing Creek watershed is 3.53, telling us that the average health of the Fishing Creek watershed is fair. 80% of the sites sampled scored as good or fair while 20% scored as poor and 0% scored as very poor.

Very Poor (0%)
Poor (20%)
Fair (50%)
Good (30%)

percentage of stream miles (total = 100%)

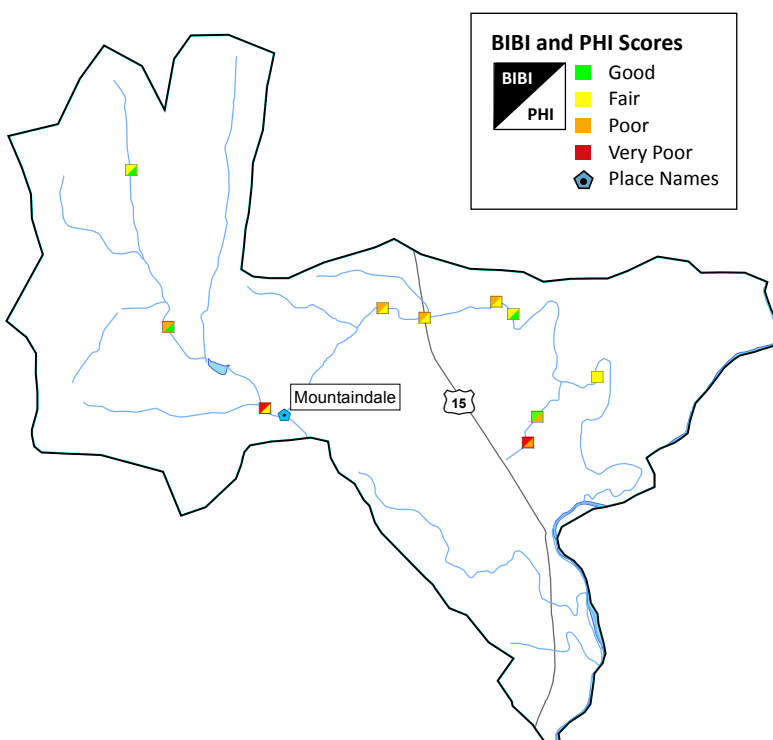
The map to the left shows the BIBI and PHI scores for each site where information was collected within the Fishing Creek watershed.

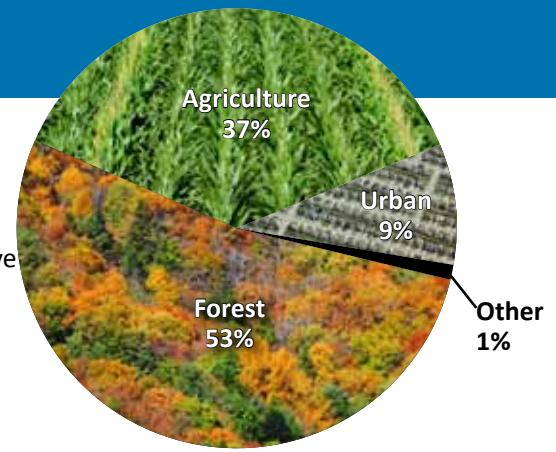
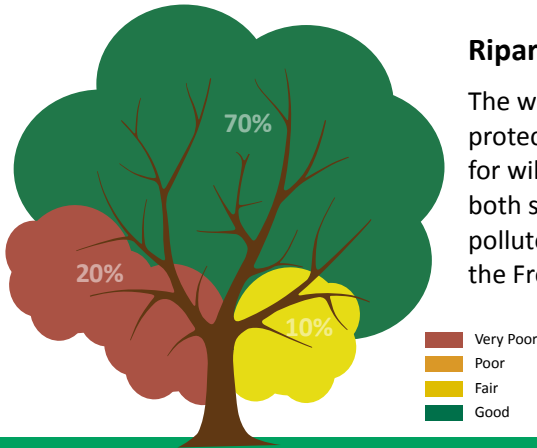
Often the health of a stream is closely related to land use - the type of land or land activities – near the stream. For example, a stream that runs through a city with few trees but many highways and parking lots (also called impervious surfaces) may receive large amounts of hot, polluted stormwater runoff. Trees can slow and absorb large amounts of stormwater runoff and also shade streams to keep water temperatures cool during summer months. The leaves and branches that drop into the stream can also provide food and shelter for bugs and fish. For all of these reasons, forests are considered to be very good for stream health. Because of the important relationship between land use and stream health, the Frederick County Stream Survey evaluates the type of land use and amounts of forest near each stream. Within the Fishing Creek watershed, 53% of the land is forested, 37% of the land is farms or agricultural land, 9% is developed towns and cities (urban), and 1% is other types of land uses.
