APPENDIX B
PHOTOGRAPHIC LOG OF THE WATERSHED MONITORING STATIONS

APPENDIX C
PHOTOGRAPHIC LOG FOR THE VISUAL INSPECTION

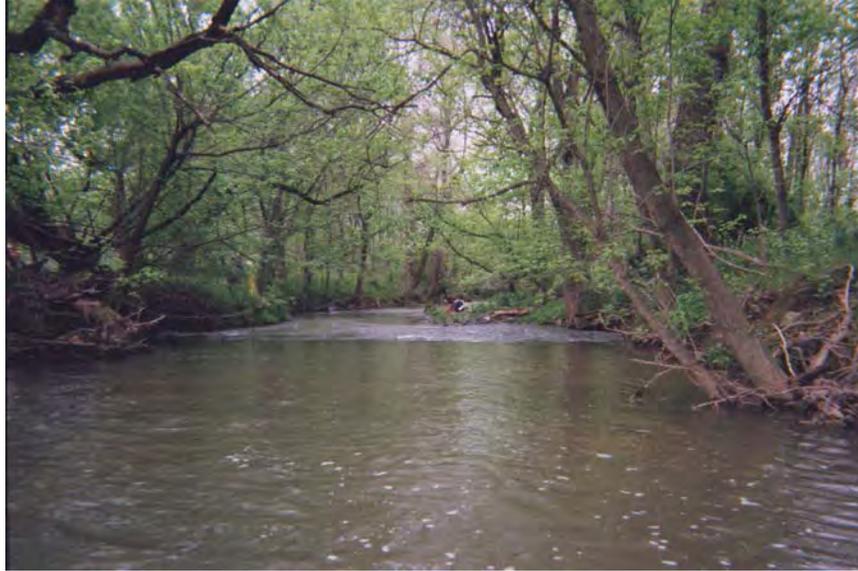
Photo 1. Station BALL-01 on Ballenger Creek, facing downstream towards the site's midpoint. A bedrock outcrop creates the riffle section shown in the photograph.

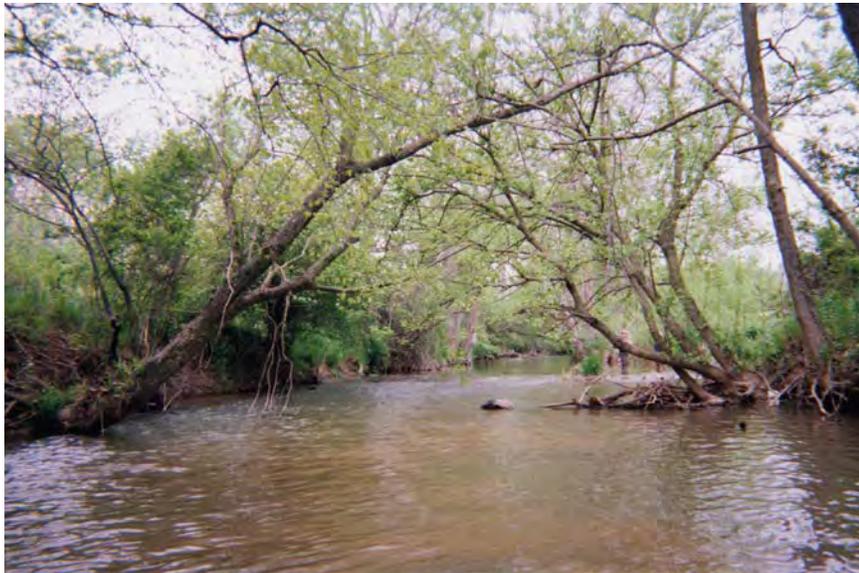
Photo 2. Station BALL-02 on Ballenger Creek, facing upstream towards the site's midpoint. Many of the large trees lining the banks in this section have been undercut.

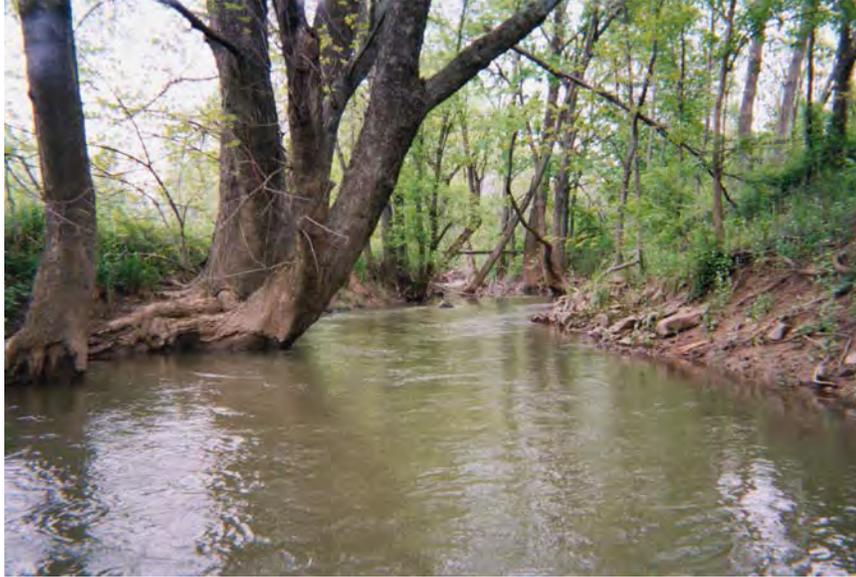
Photo 3. Station BALL-03 on Ballenger Creek, facing upstream towards the site's midpoint. A bedrock outcrop is located on the right side of the photograph. This section of Ballenger Creek is very narrow and deep.

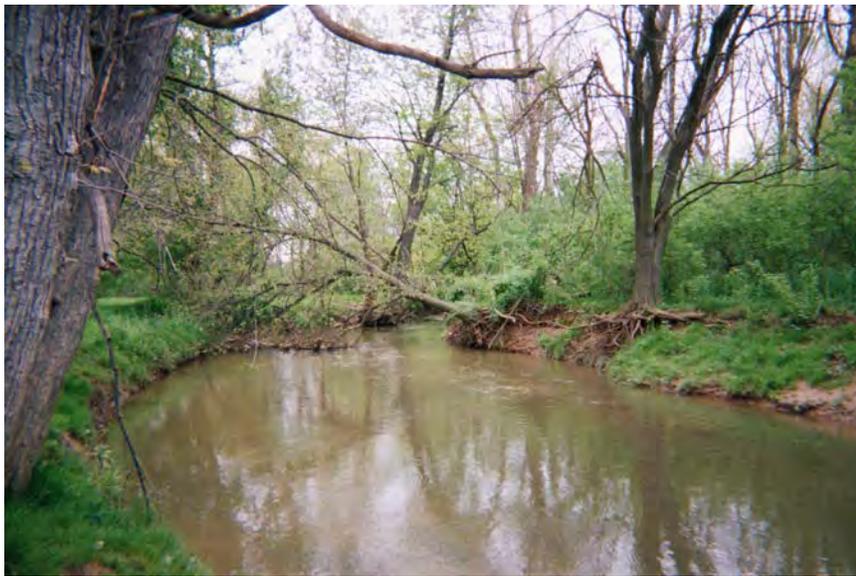
Photo 4. Station BALL-04 on Ballenger Creek, facing downstream towards the site's midpoint. This site is located behind Ballenger Creek Elementary School. Note the eroded bank and toppled tree on the right side of the photograph.

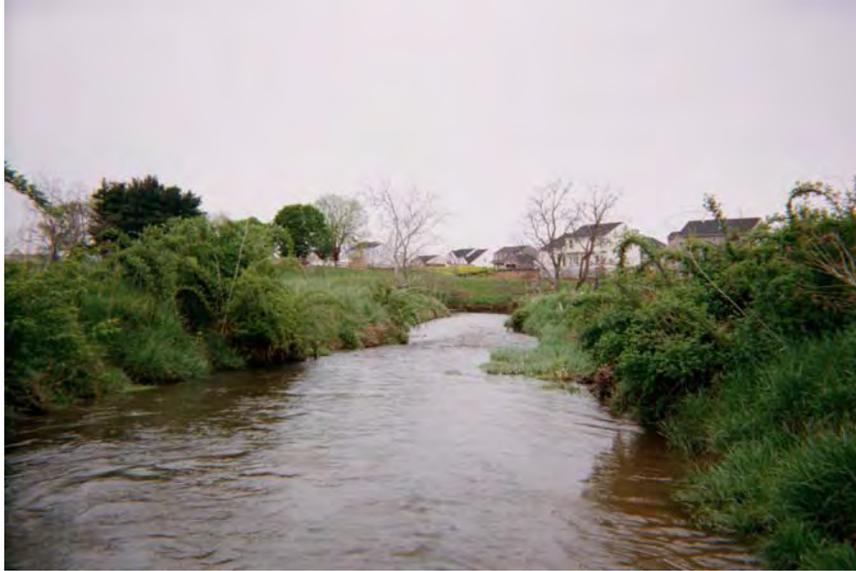
Photo 5. Station BALL-05 on Ballenger Creek, facing downstream towards the site's midpoint. Note the recent construction and lack of shading along this stream reach.

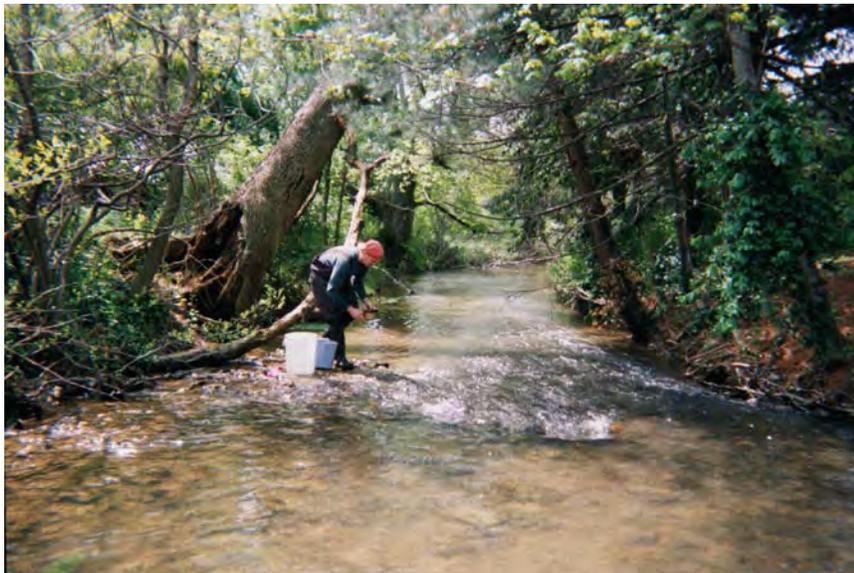
Photo 6. Collection of benthic macroinvertebrates at Station BALL-06 on Ballenger Creek, facing downstream towards the site's midpoint. A thin row of trees acts as a vegetated buffer between this section of Ballenger Creek and a pasture on the left side of the photograph.

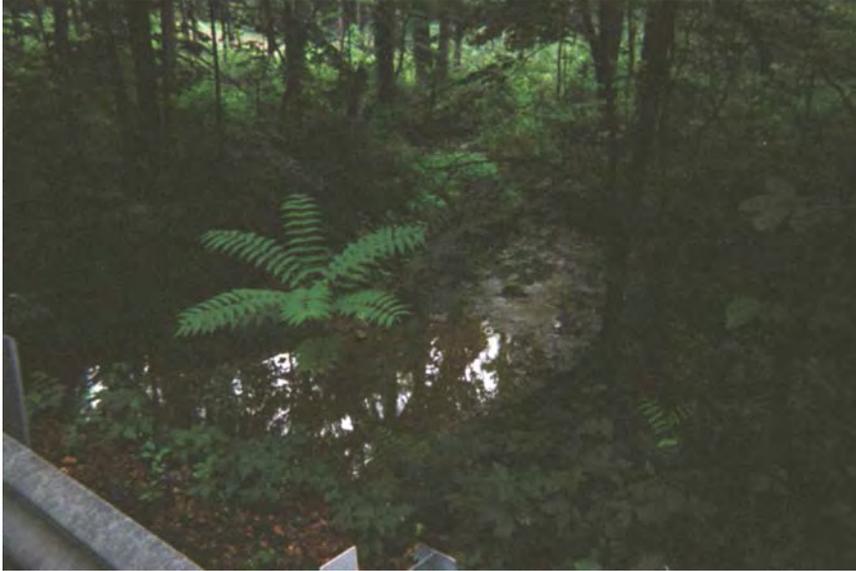
Photo 1. Unnamed tributary to Ballenger Creek at Clifton Road, facing downstream. Ballenger Creek is formed as water drains from the relatively steep, forested Catoclin front.

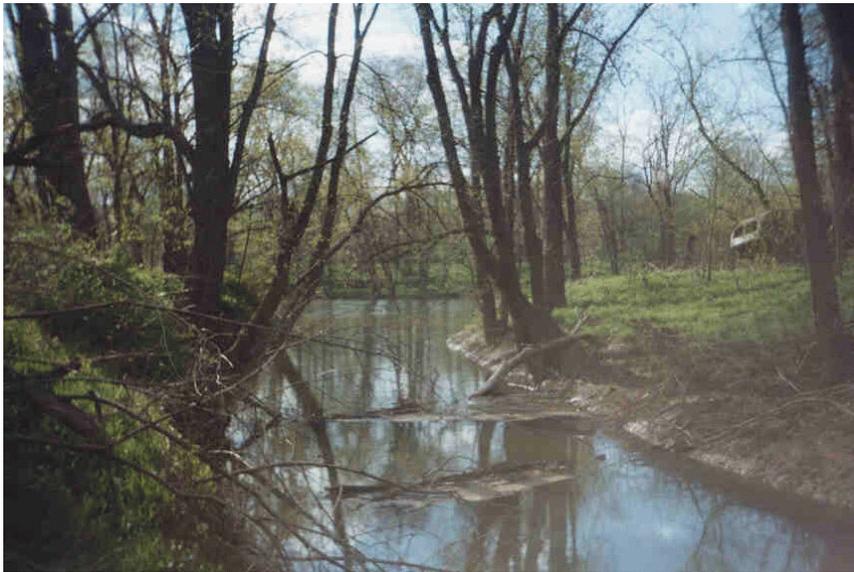
Photo 4. Confluence of Ballenger Creek and the Monocacy River.

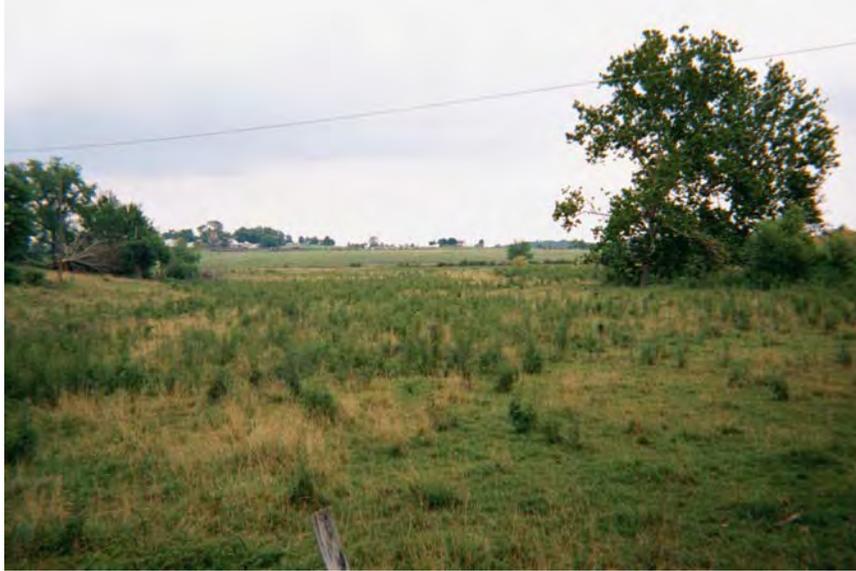
Photo 5. Livestock pasture located at the intersection of Renn Branch and Renn Road. Agriculture remains active in much of the western watershed; however, a golf course and an associated housing development have recently been constructed just upstream from where this photograph was taken. Note that livestock have unrestricted access to the stream channel at this location.

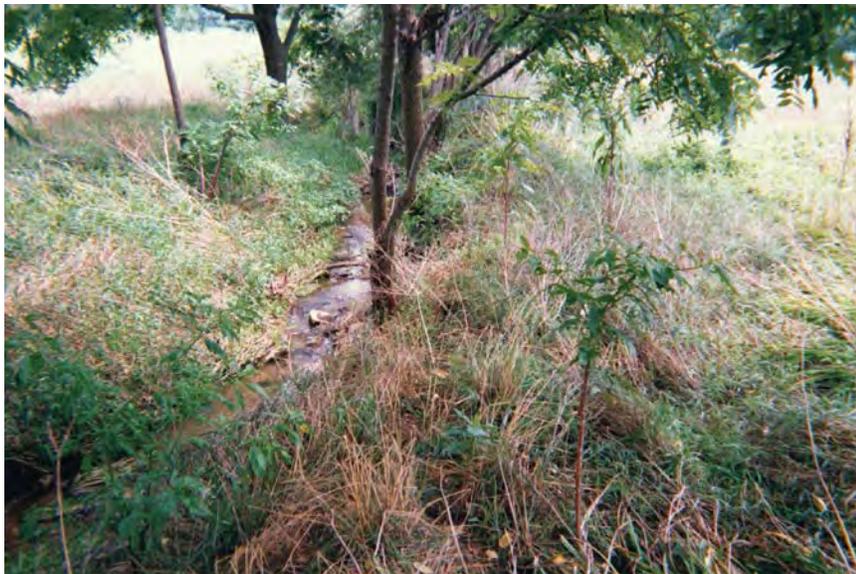
Photo 6. Unnamed tributary to Renn Branch at Elmer Derr Road, facing downstream. This reach appears to have been channelized at some point, as evident by its uncharacteristically straight path and a berm of excavated material along the stream's right side. This reach contained a large amount of cinder block and stone rubble.

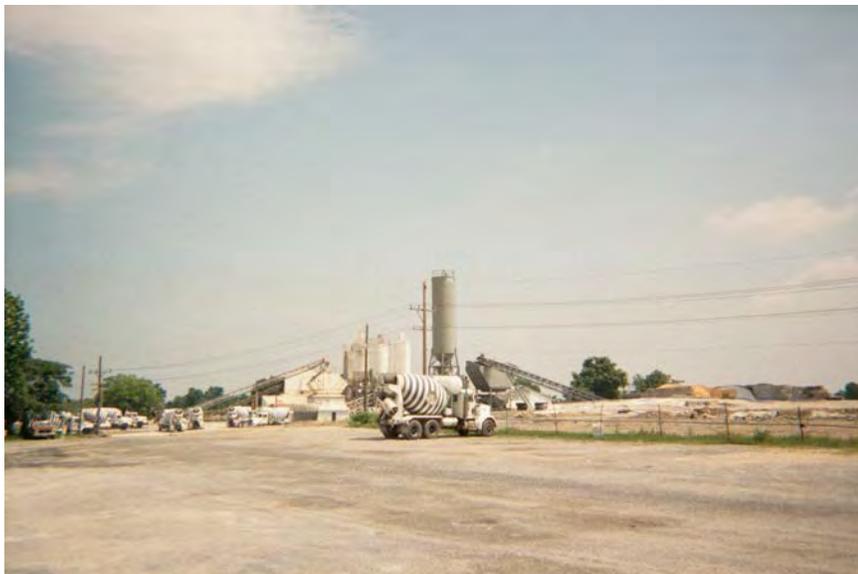
Photo 8. Superior Concrete facility located at 5823 Urbana Pike. Limestone beneath the eastern portion of the watershed is actively quarried, supporting a number of related industries including Portland cement, agricultural lime, and building materials.

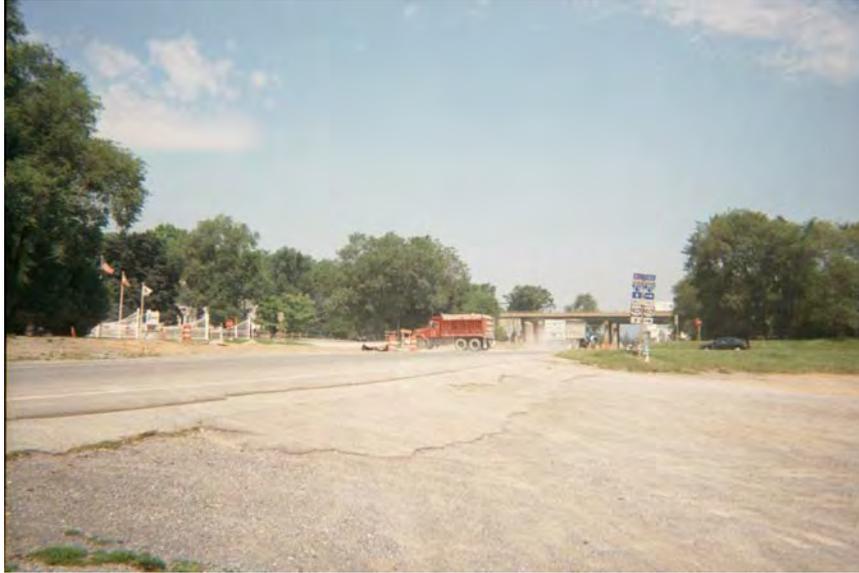
Photo 9. Trucks entering and exiting the LaFarge facility on Reichs Ford Road. Stone dust from quarrying, crushing, and transporting limestone can impair the growth of vegetation, cause respiratory distress in humans, and wash into streams where it can affect water chemistry and physical habitat.

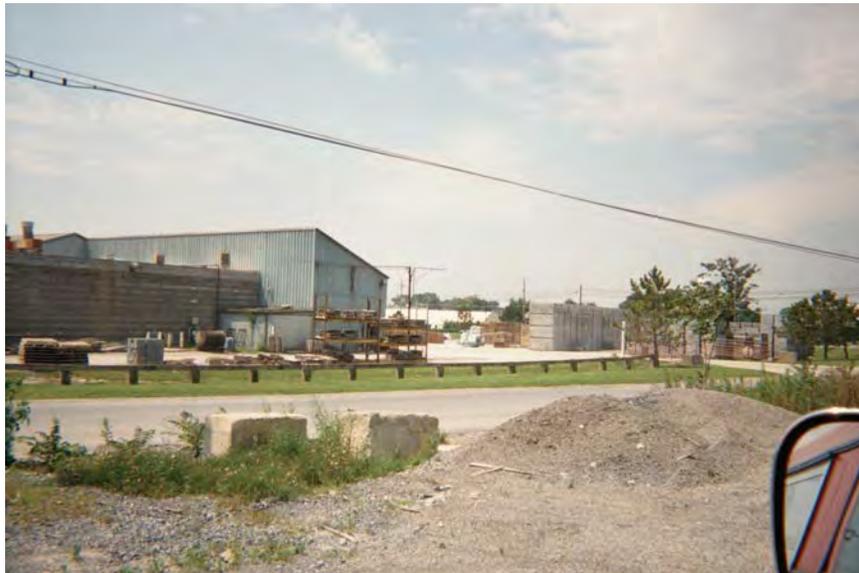
Photo 10. United Concrete Products Block Plant located at 5703 Urbana Pike. Note that a sweeper (center of photograph) is being used to control dust at this facility.

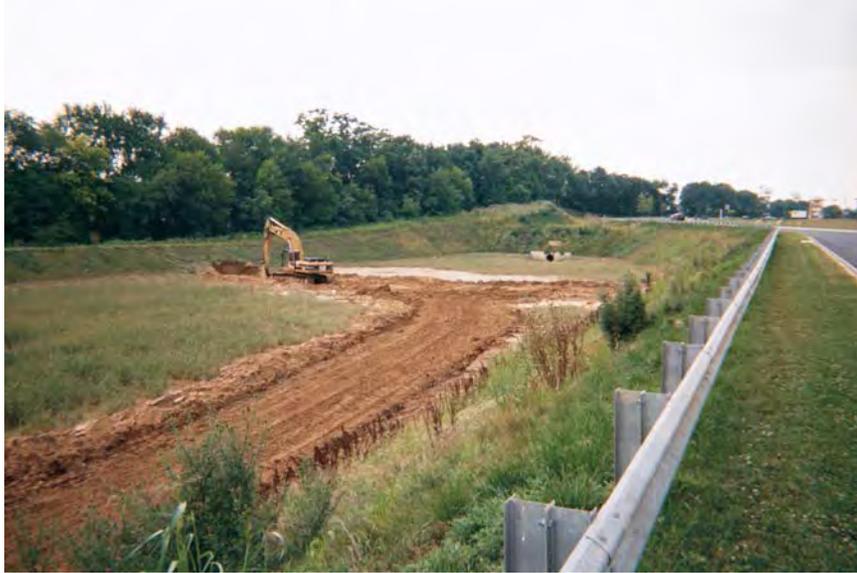
Photo 11. Stormwater pond on Guilford Road across from Wal-Mart. Heavy equipment was being used to fill two sinkholes (each approx. 20 feet wide, 10 feet long, and 9 feet deep) that had opened up in the bottom of the pond during heavy rains in mid-July 2000.

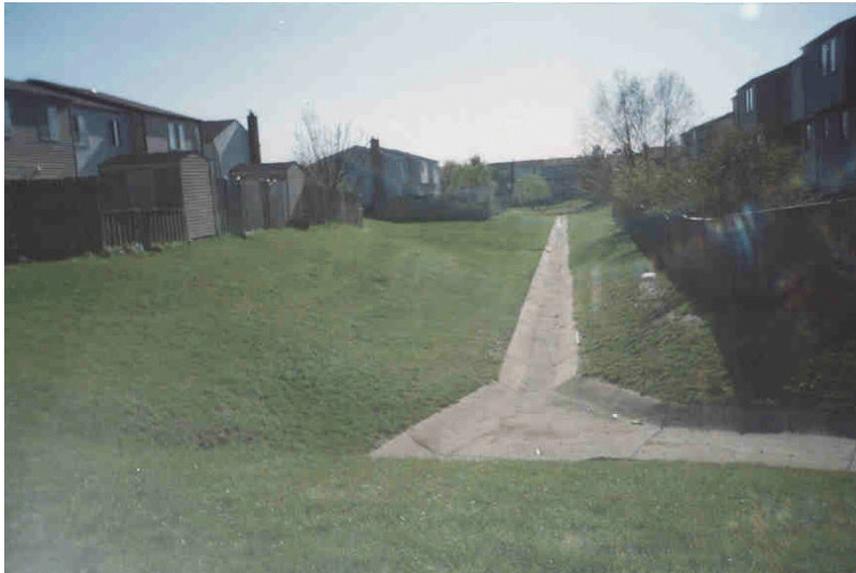
Photo 12. Unnamed tributary to Pike Branch of Ballenger Creek at Double Brand Court. Concrete lined channels in areas of older development rapidly convey and collect stormwater flows. However, rapid flows can alter natural flow patterns and channel stability in receiving streams.

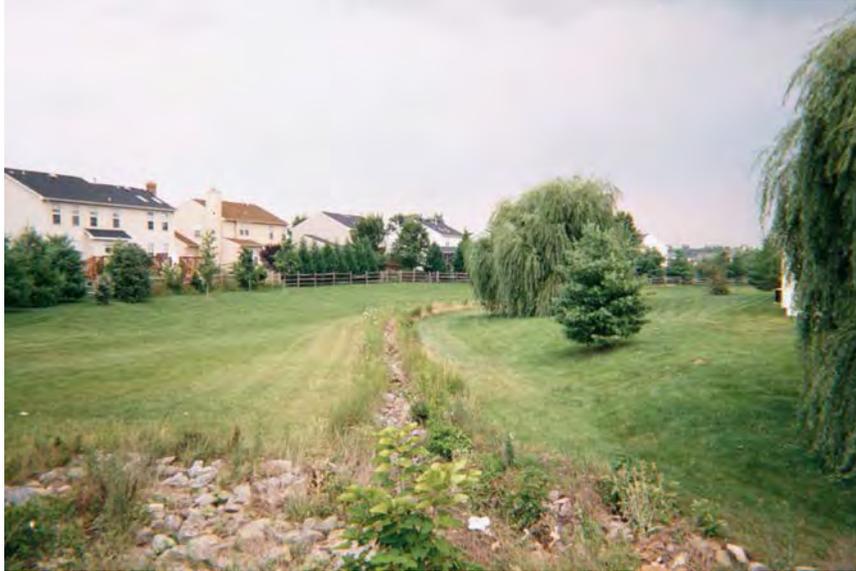
Photo 13. King Branch of Ballenger Creek at Corporate Boulevard, facing downstream. Riprap has been used to line intermittent channels in newer developments. The riprap and tall grass adjacent to the channel slow runoff and help trap sediment.

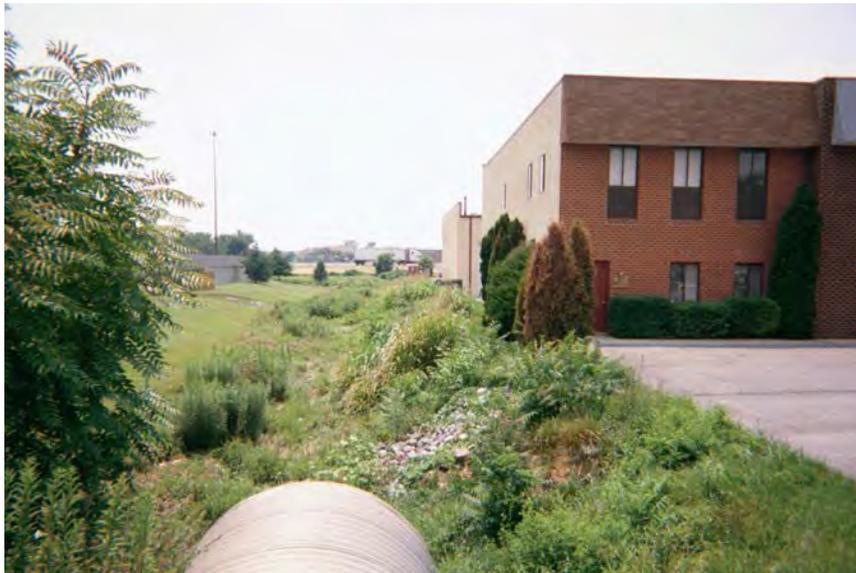
Photo 14. A culvert beneath Industry Lane drains into a vegetated swale prior to entering an unnamed tributary to Arundel Branch of Ballenger Creek. The heavy vegetation in this swale will help stabilize banks, slow flow velocities, and trap sediments.

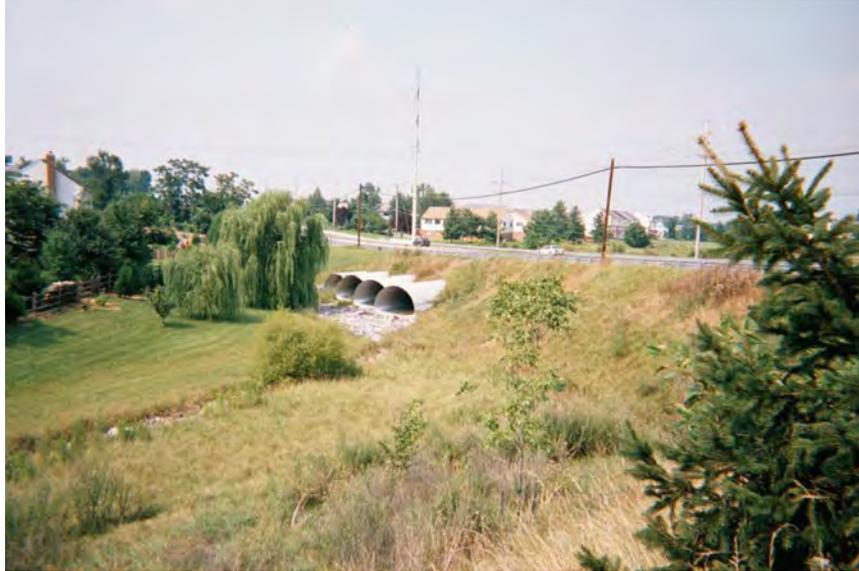
Photo 15. Arundel Branch of Ballenger Creek at New Design Road, facing upstream. Note the size of the four culvert pipes in relation to cars on the road. This channel was dry in mid-July 2000.

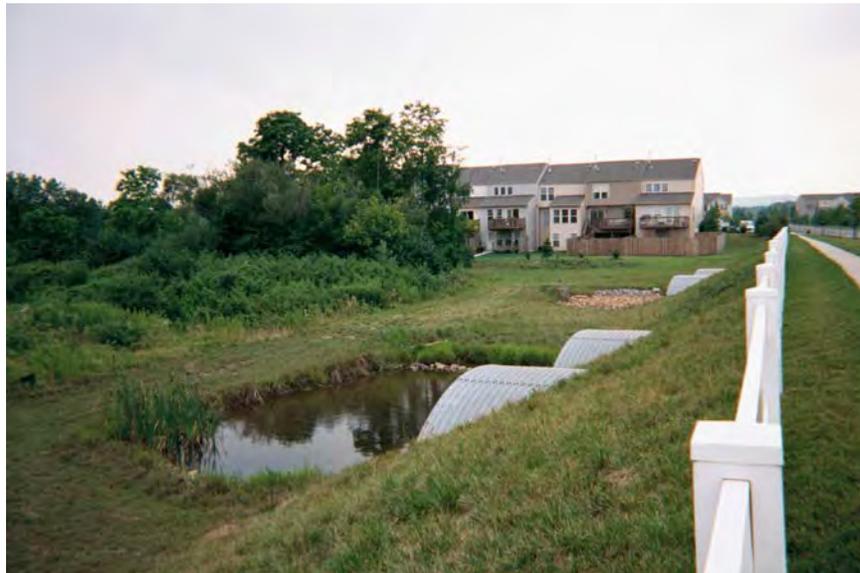
Photo 16. Pike Branch of Ballenger Creek at Corporate Drive, facing downstream. Note that sediment and water have accumulated at the outlet openings.

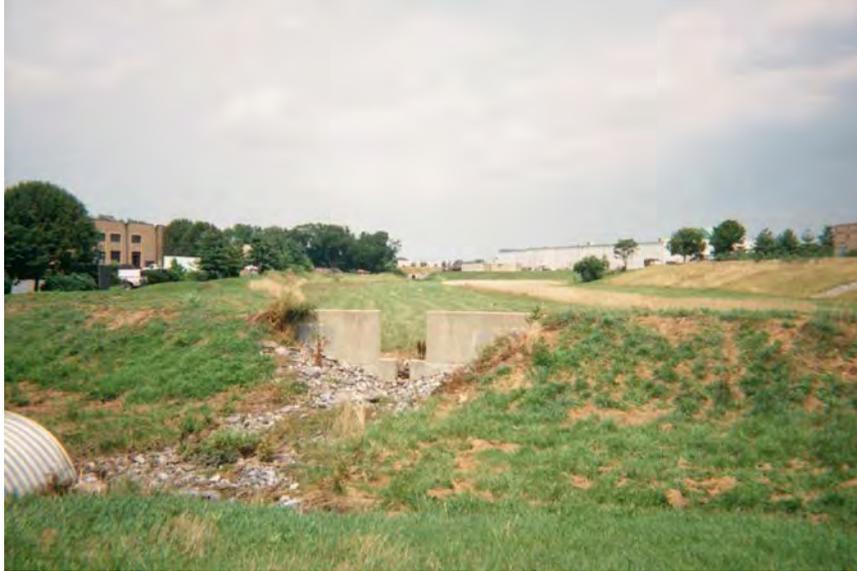
Photo 17. Stormwater detention basin east of Industry Lane, facing northeast. Signs of animal burrows and erosion were evident in the berm and a moderate amount of trash had accumulated in the basin.

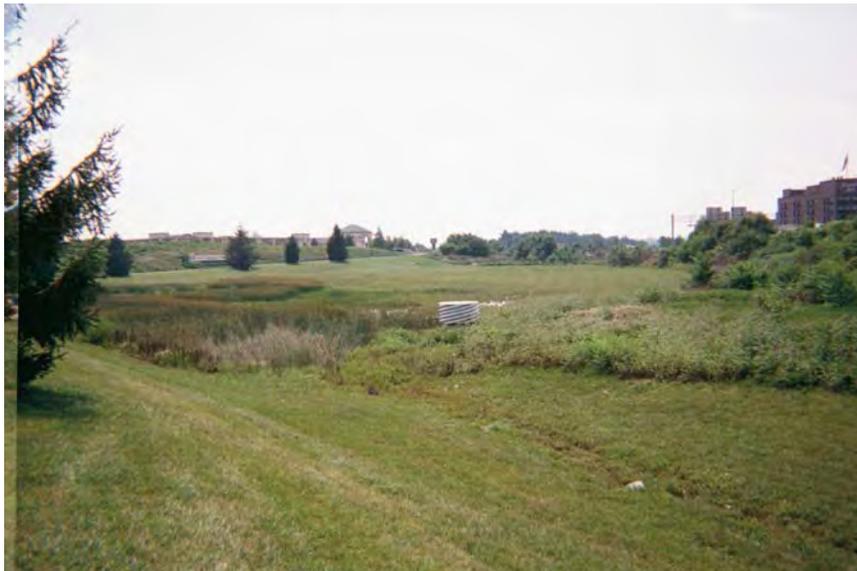
Photo 18. Wet pond at the southwest corner of the Francis Scott Key Mall. A fair amount of trash had accumulated in the sedges. Wildlife was observed using the open water and meadow areas.

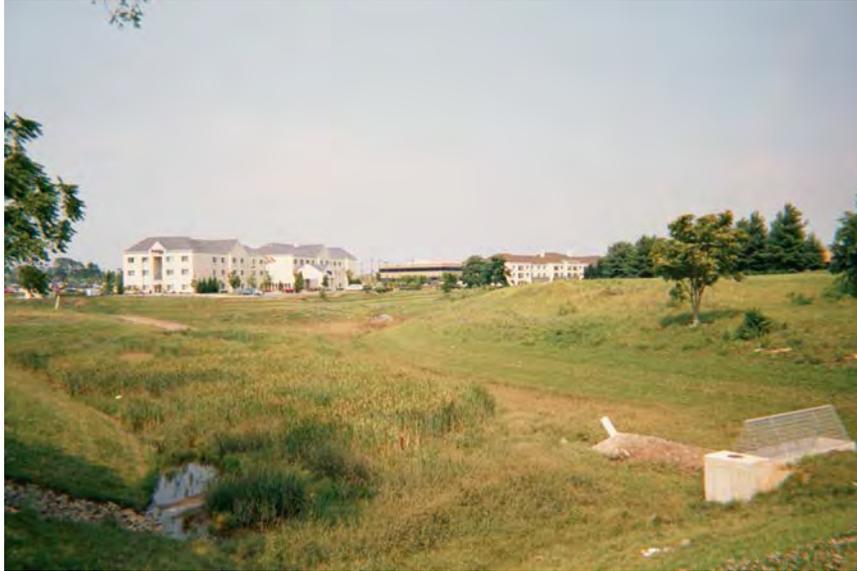
Photo 19. Wet pond in-line with Quarry Branch of Ballenger Creek at Crestwood Boulevard, facing upstream. Quarry Branch may disappear underground at or above this point as no signs of the stream were visible between this pond and the mainstem of Ballenger Creek during field surveys conducted in April and July 2000.

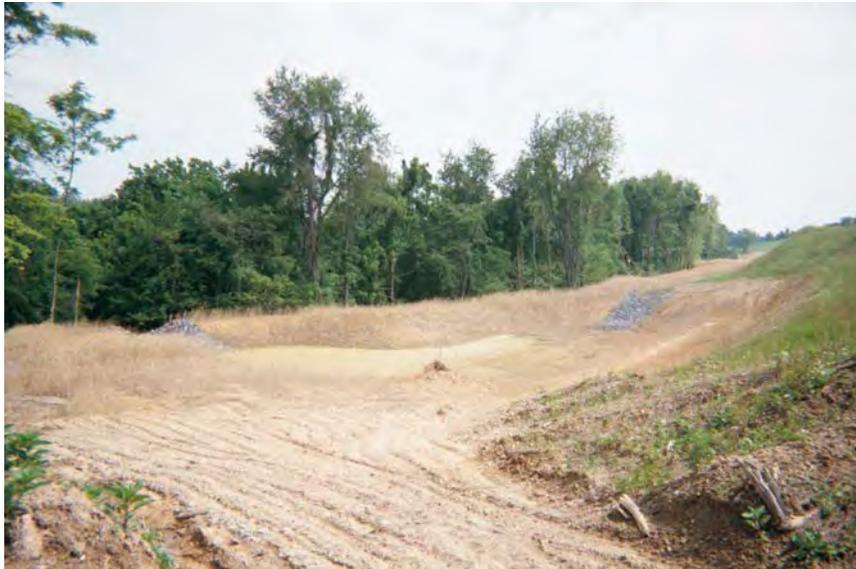
Photo 20. Sediment basin for the Country Meadows Retirement Community construction site located on Ray Smith Road. This basin appears to be actively maintained and in good condition.

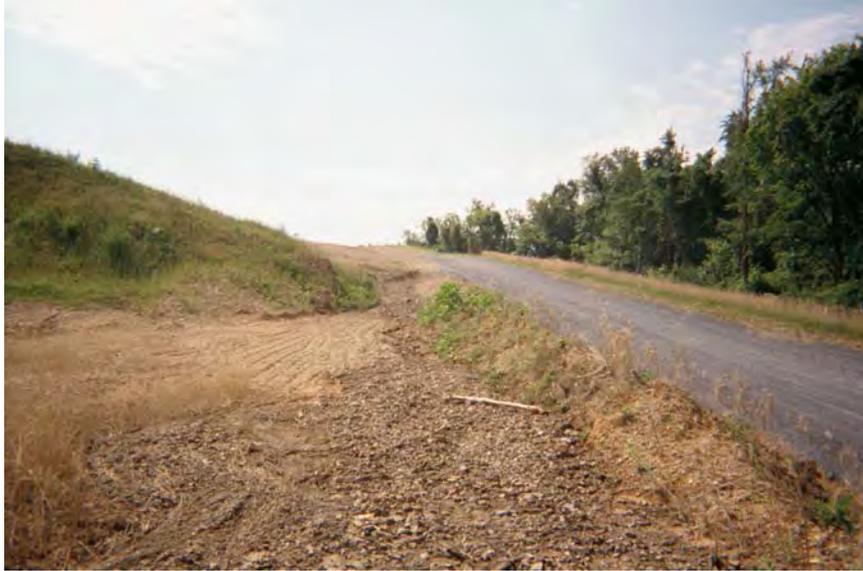
Photo 21. Construction access road for the Country Meadows Retirement Community site located on Ray Smith Road. Note that the erosion along the left side of the road flows into the sediment basin shown in Photo 20.

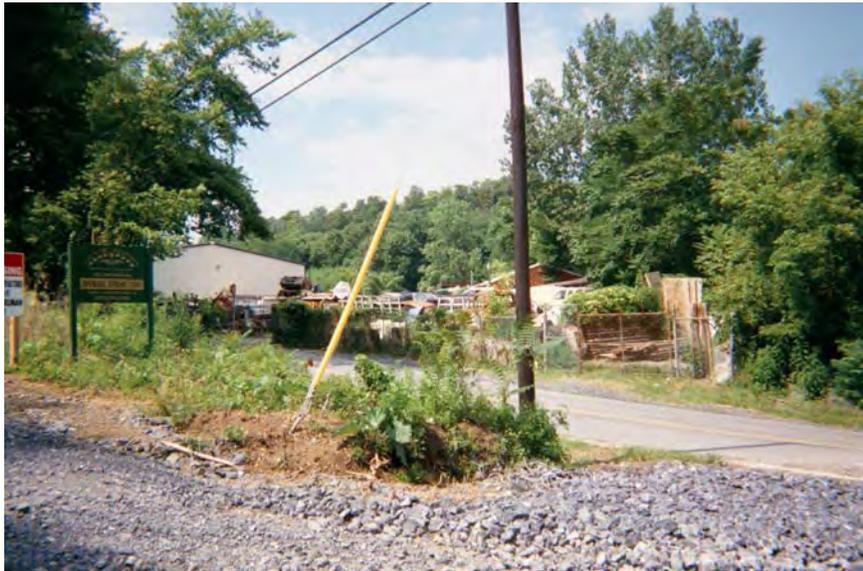
Photo 22. Construction access road for the Country Meadows Retirement Community site (foreground) and an automobile scrap yard (background) located on Ray Smith Road. The scrap yard did not appear to have adequate stormwater controls and pollutants may be washed from the site.

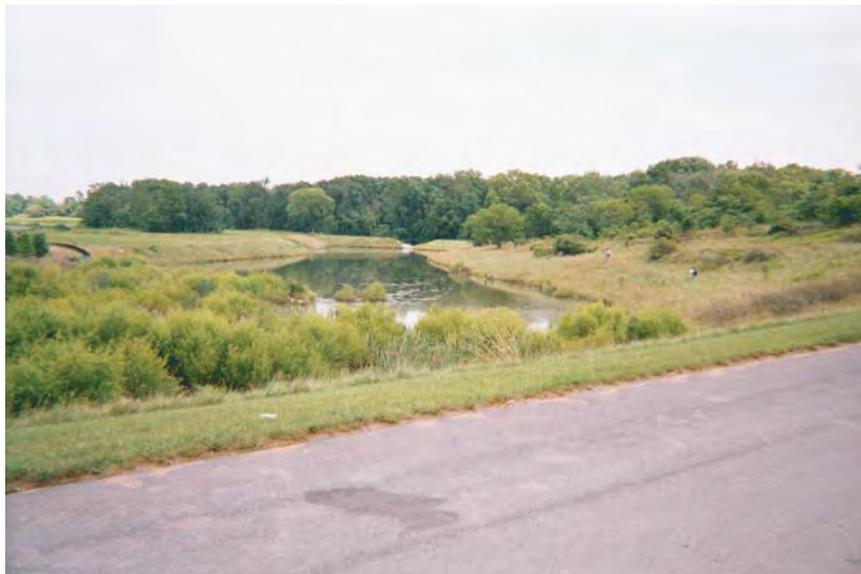
Photo 24. Large sediment basin located along the north side of Wedgewood Boulevard, facing east. Sediment has accumulated in the western edge of the basin (foreground), as indicated by the heavy growth of shrubs and other vegetation.

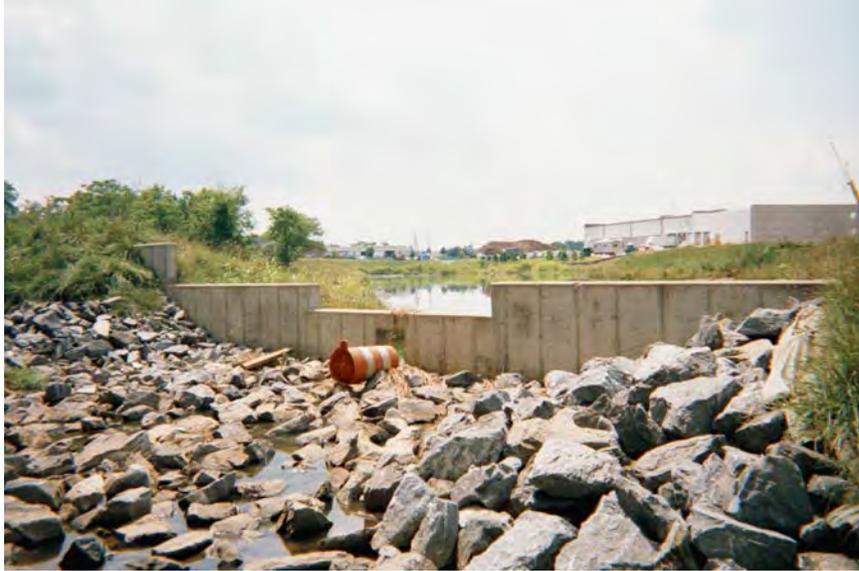
Photo 25. Outlet structure for the sediment basin north of Wedgewood Boulevard, facing west. Presumably, flows were sufficient to carry the construction drum over the weir during a recent storm.

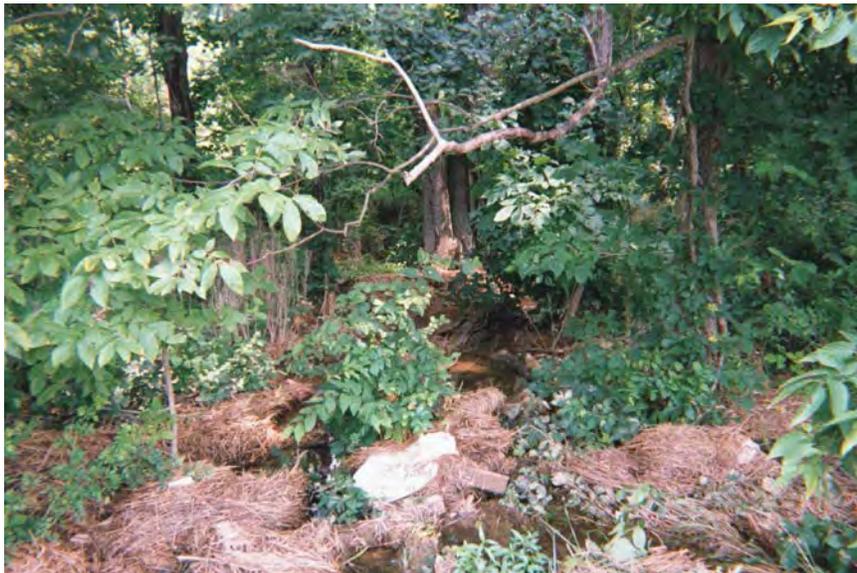
Photo 26. Debris washed past the sediment basin north of Wedgewood Boulevard, facing southeast. Grass, trash, and other debris from upstream have been captured by vegetation as stormflows flooded the stream channel through the woods.

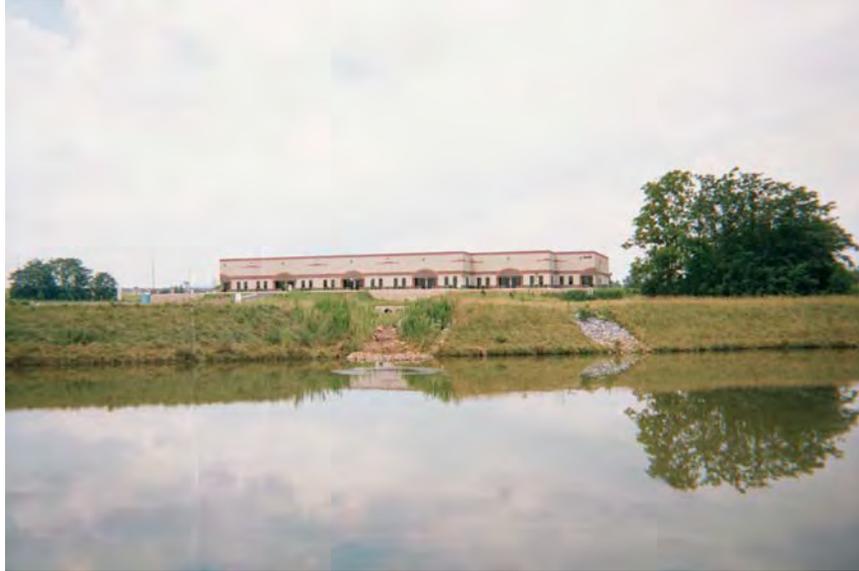
Photo 27. Inlet into the sediment basin located along the north side of Wedgewood Boulevard, facing north. Stormflow from a summer 2000 storm severely eroded the drainage channel.

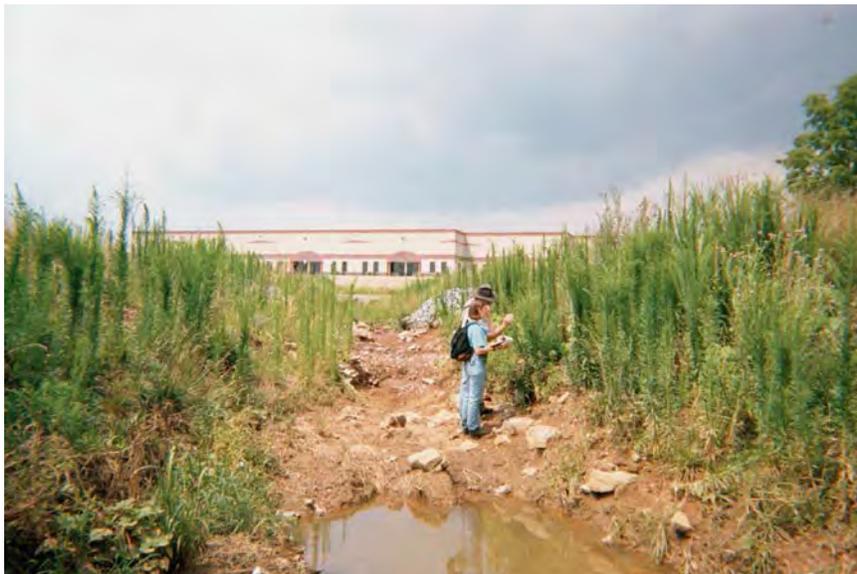
Photo 28. Close-up view of the inlet shown in Photo 27. Riprap and soil eroded from this drainage channel had been deposited in the sediment basin, forming a delta approximately 15 feet wide and 10 feet long.
